**October 20, 2023**

## Safety Recall: 2022-24 Civic Touring/Sport EPS Inspection (Service Parts)

Due to a manufacturing error, certain electric power steering (EPS) service part assemblies were set with the incorrect rack stroke specifications. An incorrect rack stroke may cause the tire, or if so equipped, tire with snow chains, to interfere with the lower control arm, possibly causing tire and/or chain damage.

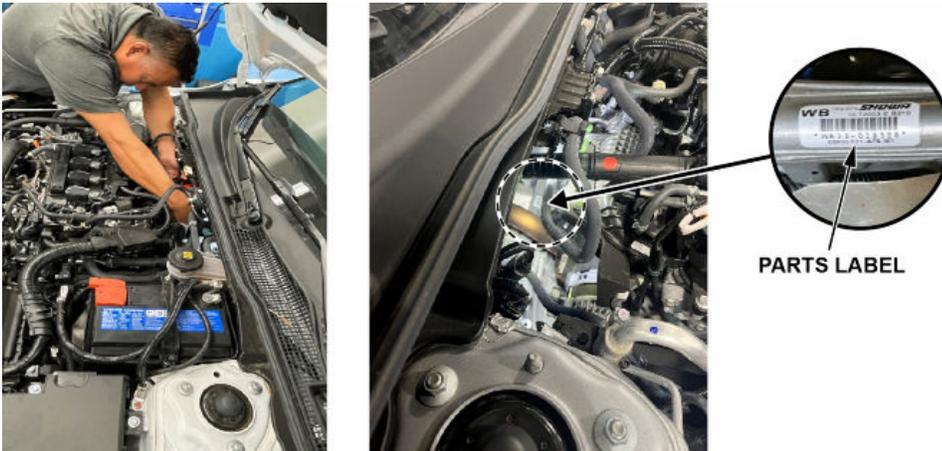
1. Open the hood and wait for the engine to cool down.
2. Locate the parts label on the EPS gearbox.

3. Inspect the label on the EPS and check the ID and part number on the label.
  - If the ID and part number is WA with P/N 53640-T2-3050-M1 or WB with P/N 53640-T21-3060-M1, go to the REPAIR PROCEDURE. Take a picture of the label and attach it to the warranty claim

- If the EPS has any other ID or part number, this service bulletin does not apply. Take a picture of the label and attach it to the warranty claim.

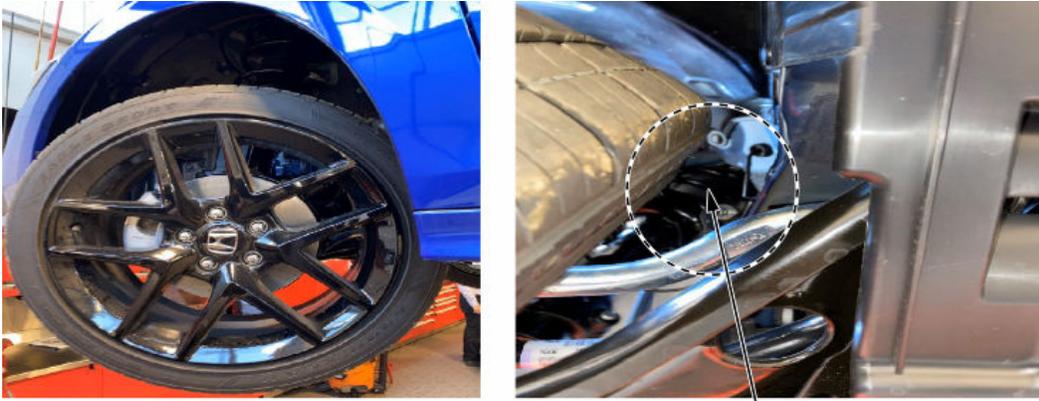
4. Place the vehicle on a lift and inspect both front tires inner side walls of the tire. Check both the front left and right for interference/rubbing marks with the lower control arm and/or outer tie rod.

INNER TIRE CONTACT WITH LOWER ARM AND/OR OUTER TIE ROD

Is there any sign of interference/damage marks on the inner tire with the control arm?

**YES** - Any tire with signs/evidence of interference requires replacement. Provide a clear image showing the interference condition and write the last seven characters of the VIN on the damaged tire. Contact your DPSM for consultation/approval. Go to the REPAIR PROCEDURE.

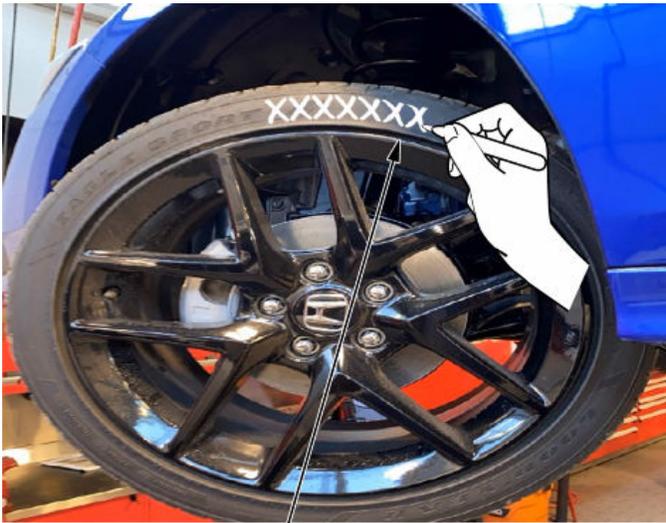
Write the last seven characters of the vehicles VIN.

NOTE: Failure to provide clear photos for tire replacement will be subject to debit.

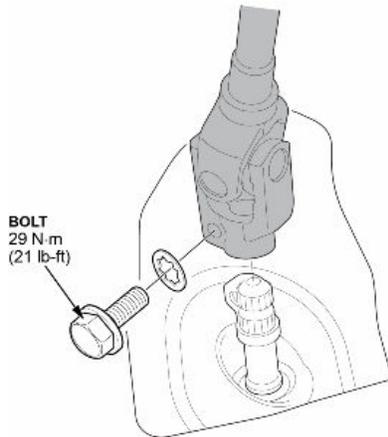
3. Remove the front wheels **108 N·m (80 lb-ft)**.
4. Disconnect the steering joint.

- Set the steering wheel straight ahead before disconnecting the shaft.
- **Do not turn** the steering wheel while disconnecting the steering joint.

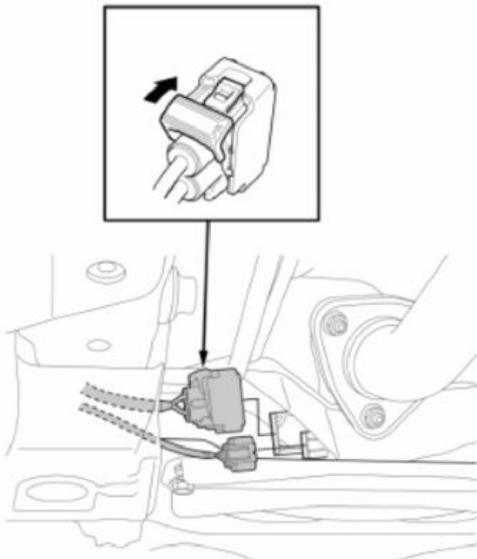
5. Remove the engine undercover.
6. Disconnect the EPS harness connectors.

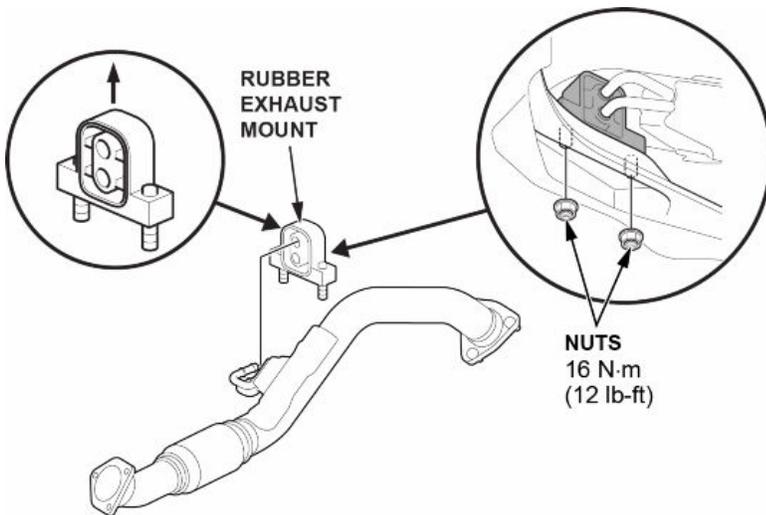
7. Remove the rubber exhaust mount.

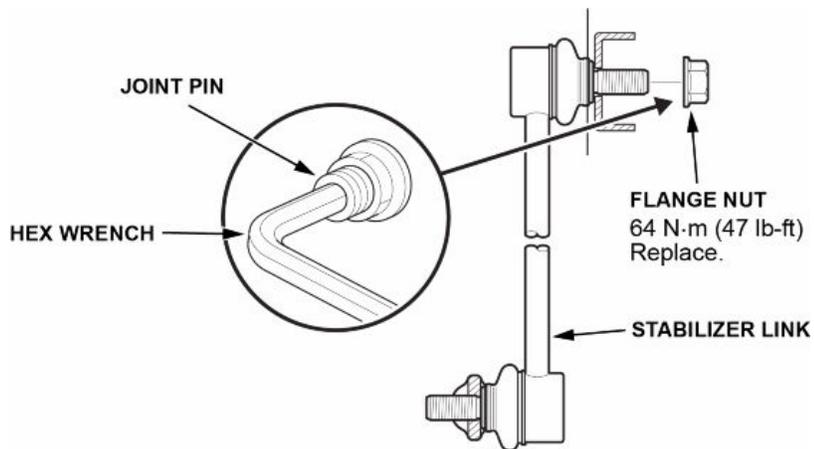
8. Disconnect the stabilizer links located on top.

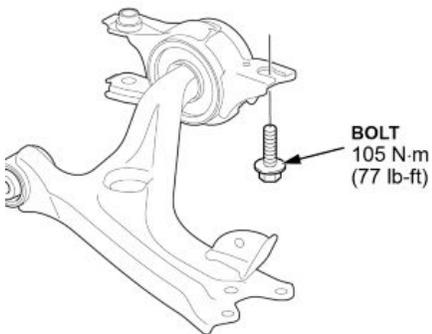
9. Remove the front lower assembly bolt (both sides).

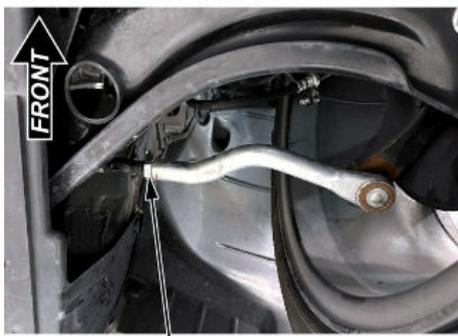
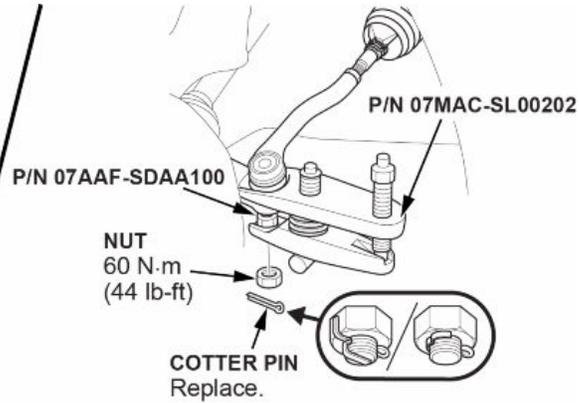
10. Loosen the outer tie-rod end nut (both sides).

NOTE: Always use a ball joint remover to disconnect a ball joint. Do not strike the housing or any other part of the ball joint connection to disconnect it.

OUTER TIE-ROD NUT

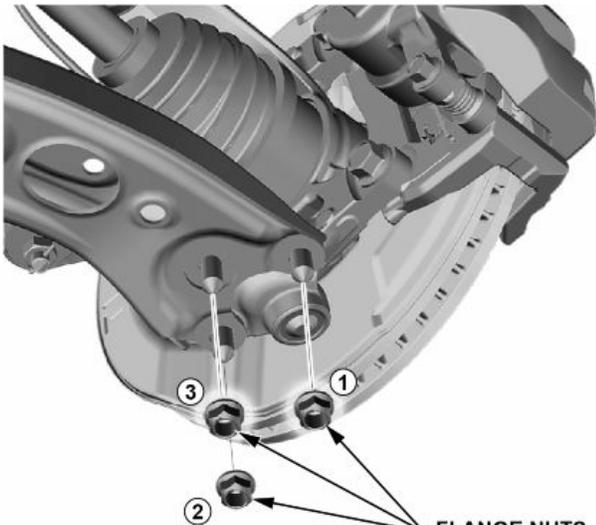
11. Disconnect the front lower arms.

NOTE: During reassembly, loosely install the new flange nuts, then tighten them to the specified torque in the numbered sequence shown.

FLANGE NUTS  
Replace.  
64 N·m (47 lb-ft)

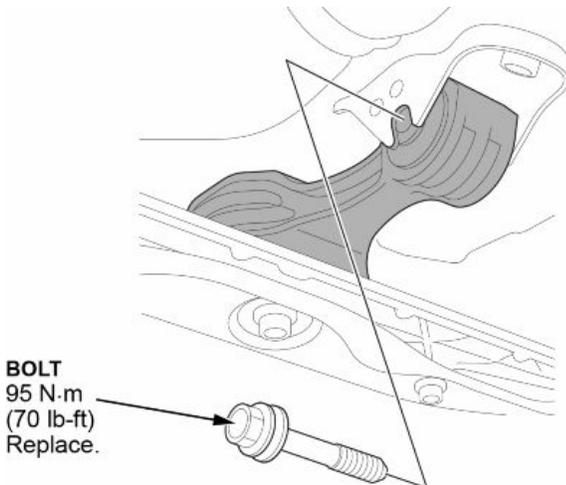
12. Remove the engine torque rod front bolt.

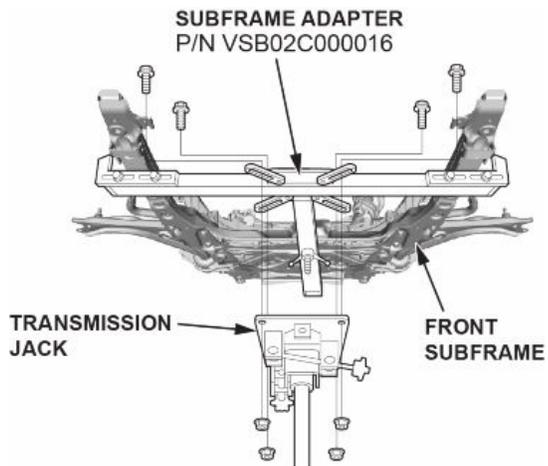
13. Attach the subframe adapter to the front subframe.

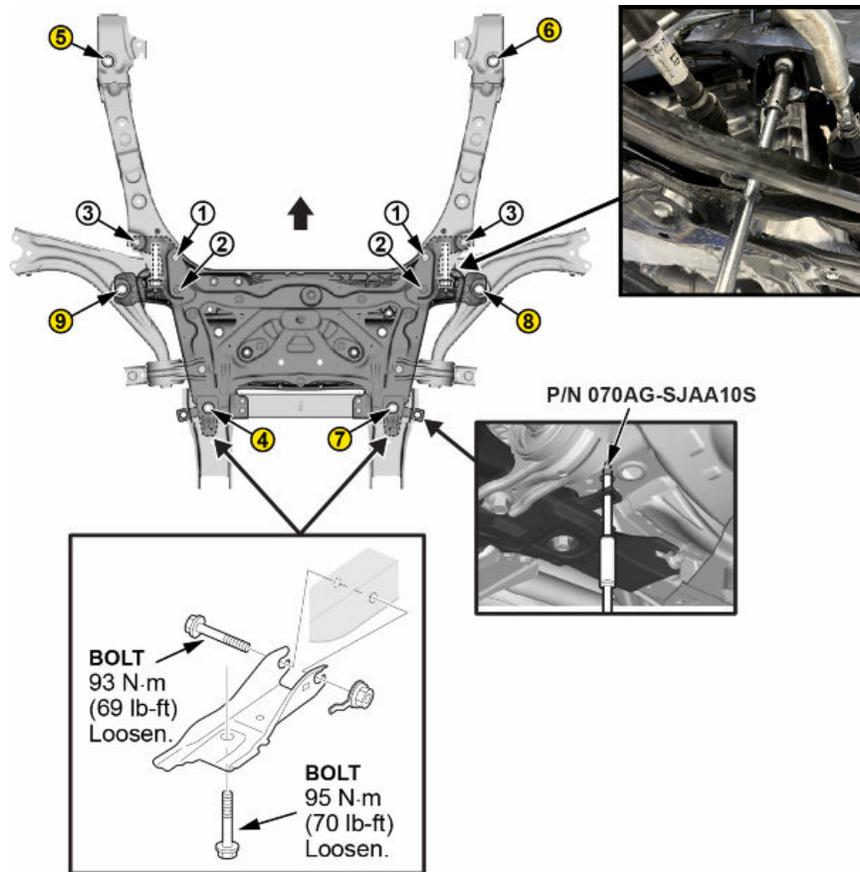
14. Raise a transmission jack and line up the slots in the subframe adapter arms with the bolt holes on the transmission jack base, then securely attach the four bolts. Then, remove the bolts highlighted in yellow only.

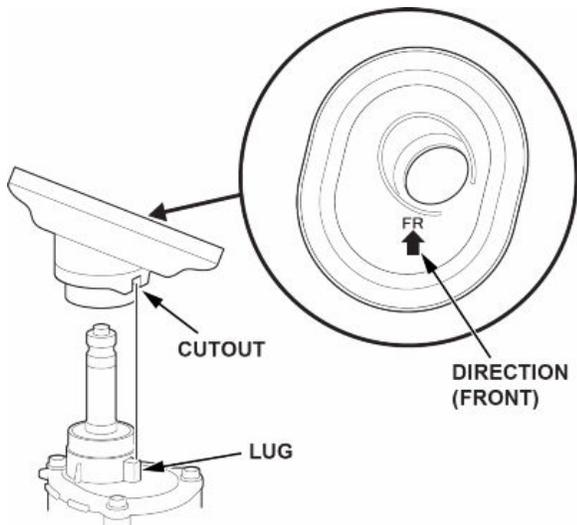
15. Remove the front subframe.

16. Transfer the tie rod ends to the replacement gearbox.

17. Transfer the steering shaft boot to the replacement gearbox.

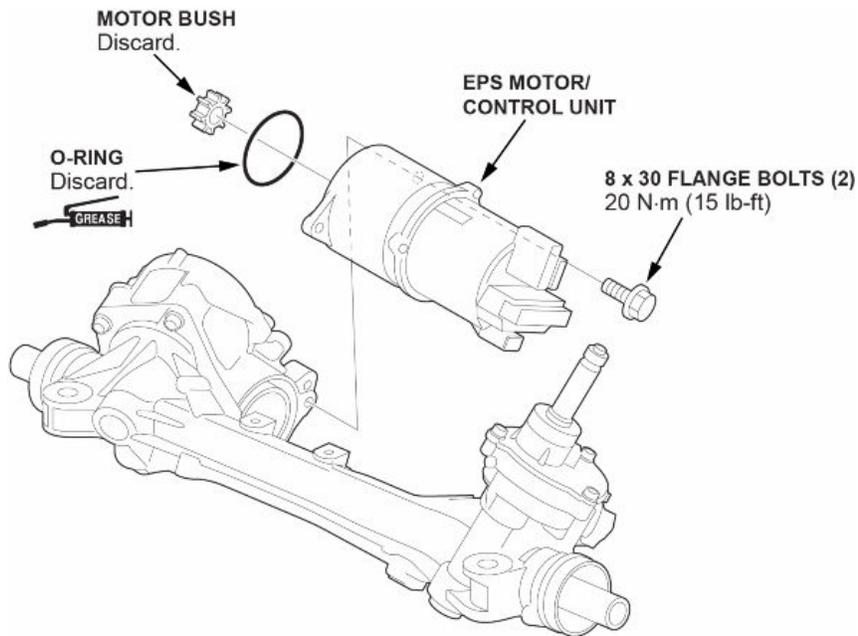
18. Remove the steering gearbox from the subframe.

19. Separate the EPS motor/control unit from the removed rack and retain for installation on the new gearbox.

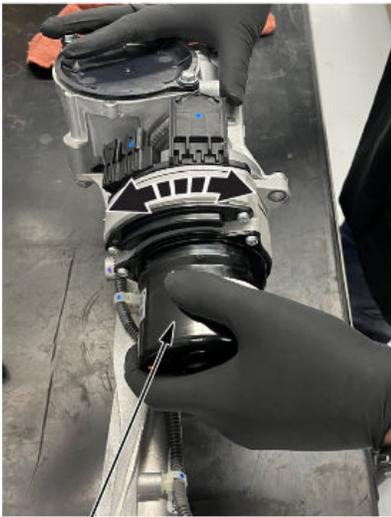
21. Install the EPS motor/control unit with the label facing up, but do not install the mounting bolts.

**EPS MOTOR CONTROL UNIT**  
Turn unit two or three times to the right and left (about 45 degrees).

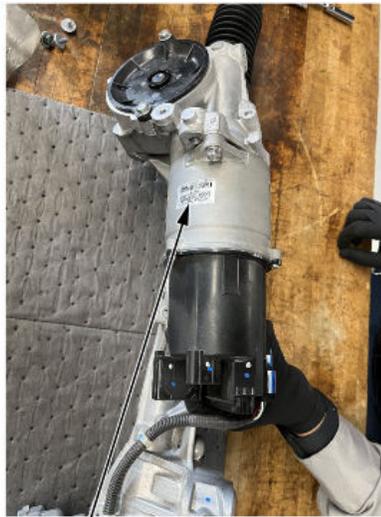
**BARCODE**  
Install with barcode facing up.

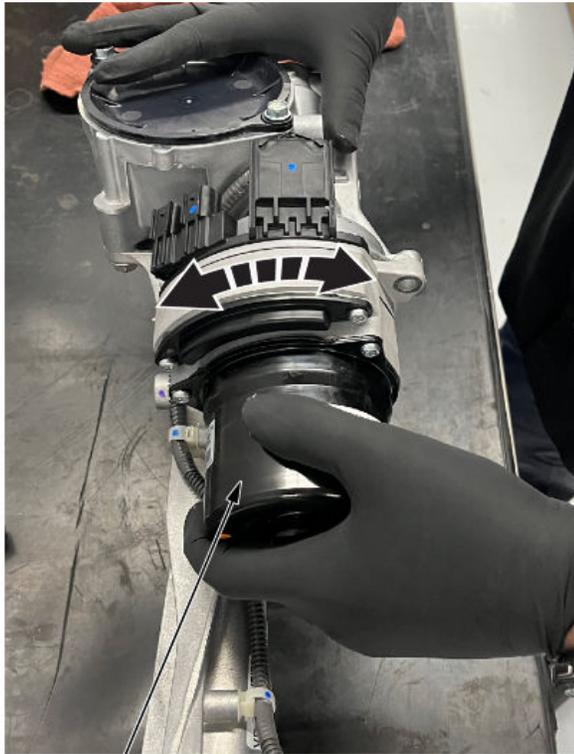
22. Turn the EPS motor/control unit **two or three times** to both the **left and right** in a **45° arc**.

**EPS MOTOR CONTROL UNIT**  
Turn unit two or three times to the right and left (about 45 degrees).

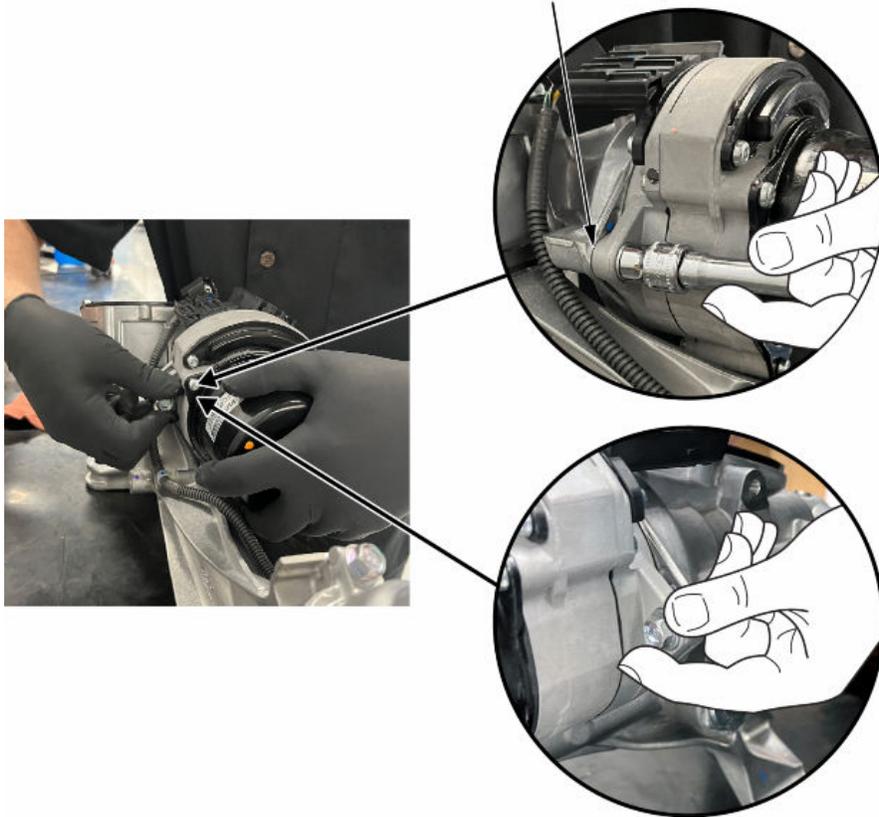
23. Loosely install the EPS motor/control unit mounting bolts by hand but do not fully torque them yet.

- To prevent damaging the motor and/or gearbox, **DO NOT** use power tools to install or tighten the bolts.
- Make sure the EPS motor/control unit is evenly seated on the P/S gearbox.

**EPS MOTOR/CONTROL UNIT**  
Make sure unit is evenly seated.

24. Torque the EPS motor/control unit mounting bolts to **20 N·m (15 lb-ft)**.

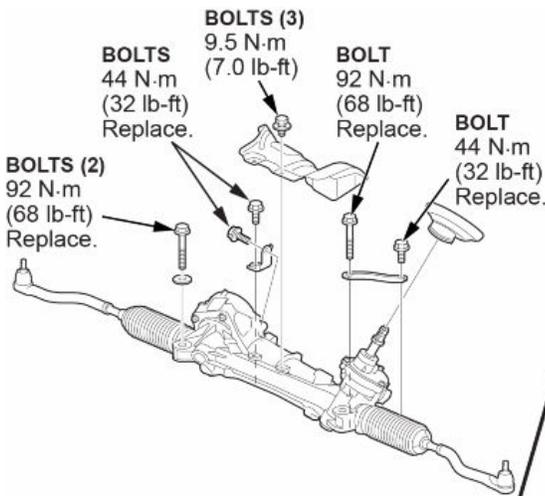
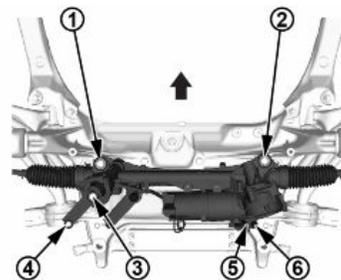
25. Install the EPS rack to the subframe and torque to spec as shown.

Position	Direction
a	Front

Step	Operation	Object	Specification
1	Temporarily Tighten	All Bolts	-
2	Tighten	All Bolts	①→②→③→④→⑤→⑥

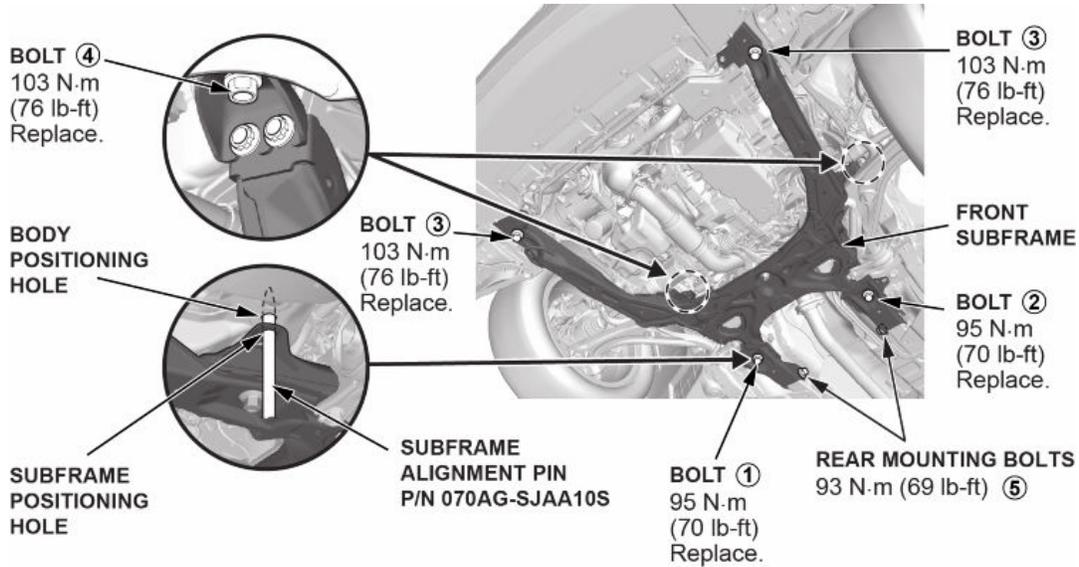
26. Raise a transmission jack and line up the slots in the sub frame adapter arms with the bolt holes on the transmission jack base. Loosely install the four bolts sub frame mounting bolts and the front subframe rear stay mounting bolts. Torque the front sub frame bolts **103 N·m (76 lb-ft), 95 N·m (70 lb-ft), 93 N·m (69 LB-ft)**.

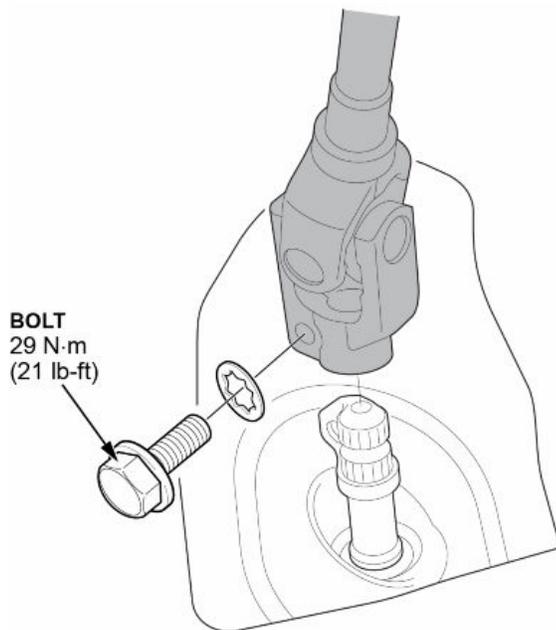
27. Install the pinion shaft to the steering joint **29 N·m (21 lb-ft)**.
