INSTRUCTION TO SERVICE

ITS60844		19-Oct-2023
SECTION:	219-Engine and Transmission	
WRITTEN BY:	Mike Pearson	
SUBJECT:	Retorque Transmission Yoke as per Allison Document SIL 20-WT-23	
ISSUE:	<i>This is to inform you that your vehicle may be non-compliant with the requirements of the Motor Vehicle Safety Regulations and that the non-compliance could affect the safety of a person.</i> Allison Transmission has observed a potential concern that affects the output shaft yoke/flange retaining bolt	
SUMMARY:	As a Customer Satisfaction Initiative, Allison will support increasing the output shaft yoke/flange retaining bolt torque specification for B3400 R xFE™ and B400 R Series transmissions.

Ref. NHTSA Recall No.	Ref. Transport Canada Recall No.
23V722	TC 2023-575

SUBJECT: Output Shaft Yoke/Flange Retaining Bolt Torque Specification Increase

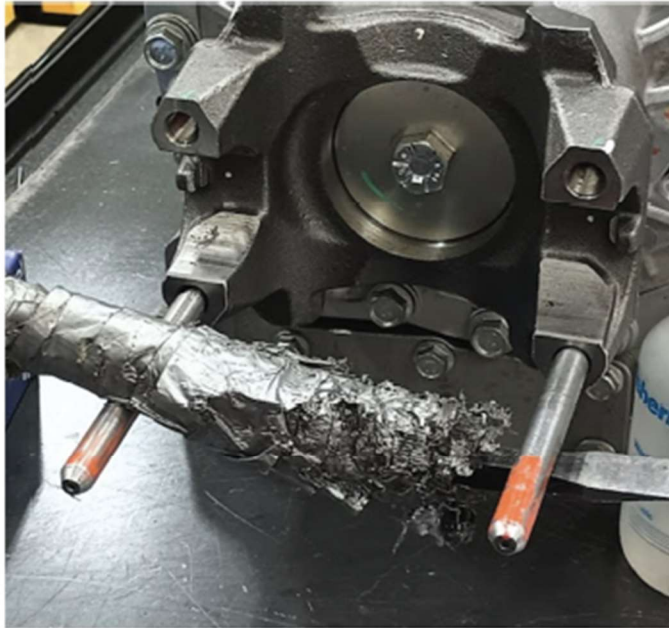
Figure 1.

4. Using a pry bar or yoke holding fixture, secure the yoke so it will not rotate.
 - Make sure not to damage yoke u-joint cavity or other machined surfaces (refer to [Figure 1](#)).

5. Torque output shaft yoke/flange retaining bolt P/N 29535219 to new specification; 130 N-m (95 lb ft).
6. Clean original paint mark and reapply paint mark to the output retaining plate and output yoke bolt with one continuous mark.

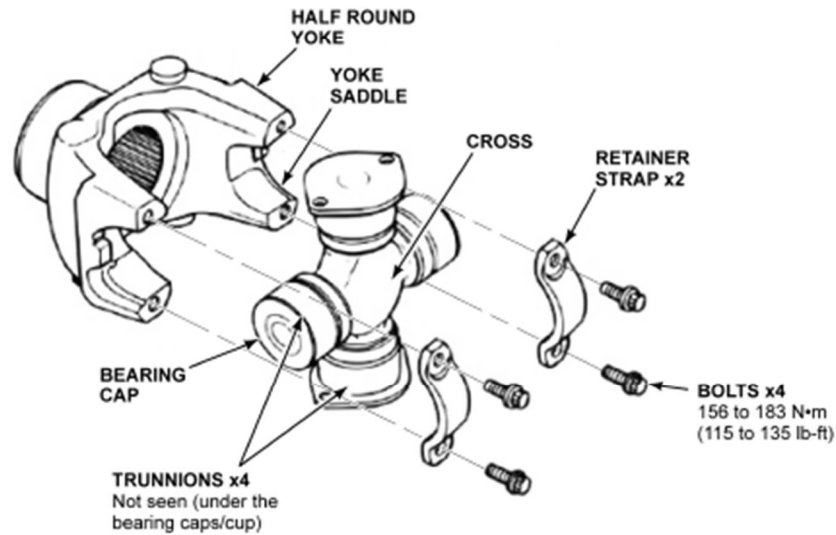
Figure 2.

7. Reinstall driveline and secure u-joint to transmission output yoke with new straps and bolts from hardware kit.
- Follow manufacturer's torque procedure and specifications. Refer to [Figure 2](#).
 - Prior to lowering bus from lift, mark transmission nameplate with paint pen to indicate output shaft yoke/flange retaining bolt torque has been verified.
