CR262 – Passenger Backrest Inspection

XDiavel Model Year 2016-2023 (all versions)

Safety Recall Campaign SRV-RCL-23-005

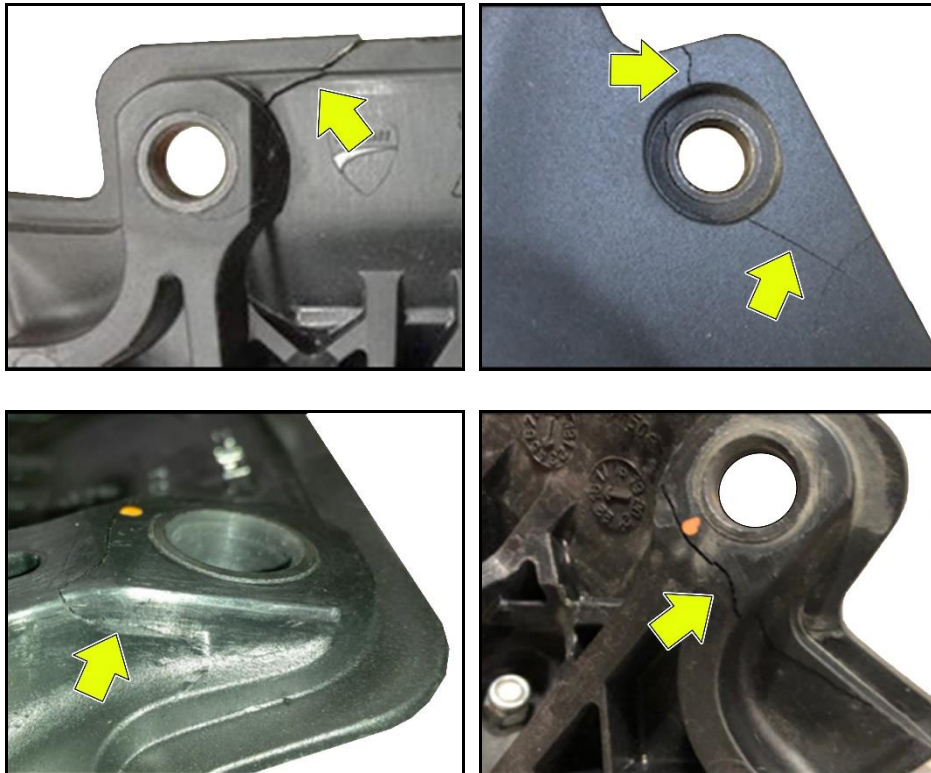
2. Remove passenger seat.
3. Remove the passenger backrest by first removing the 2 lower fixing screws and then the 2 upper fixing screws.
4. Carry out a visual check of the backrest, focusing particularly on the areas adjacent to the 4 fixing holes (see photo with examples of possible cracks)

- a. If the passenger backrest is undamaged (no cracks and/or breaks), the backrest can be reinstalled.
- b. If the backrest shows cracks and/or breaks, the passenger backrest must be replaced with a new one ordered from the spare parts warehouse.

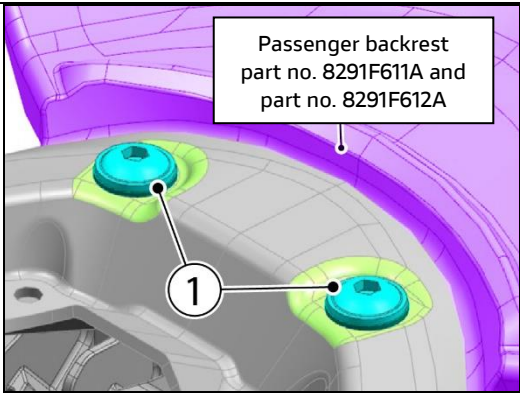
<p>Passenger backrest part no. 8291F611A and part no. 8291F612A</p>

Check for the presence of the **2 flat washers 8.2x17x1 part no. 85213101A** where provided (see table below).

UP TO frame serial number: ZDMGA00AAKB010234	From frame number: ZDMGA00AAKB010235
For passenger backrest part numbers 8291F611A and 8291F612A	For passenger backrest part no. 8291F613A
DO NOT install the washers	Install (if not already fitted) 2 flat washers 8.2x17x1 part no. 85213101A to fix the upper M8x14 screws

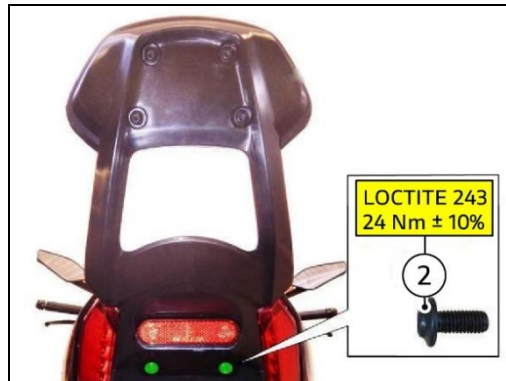
5.3 Then start the **2 lower M8x18 screws (2)**, applying **LOCTITE 243** to the threads of the screws.

5.4 Tighten first the **2 lower M8x18 screws (2)** to a torque of **24 Nm ± 10%**.

5.5 Then tighten the **2 upper M8x14 screws (1)** to a torque of **20 Nm ± 10%**

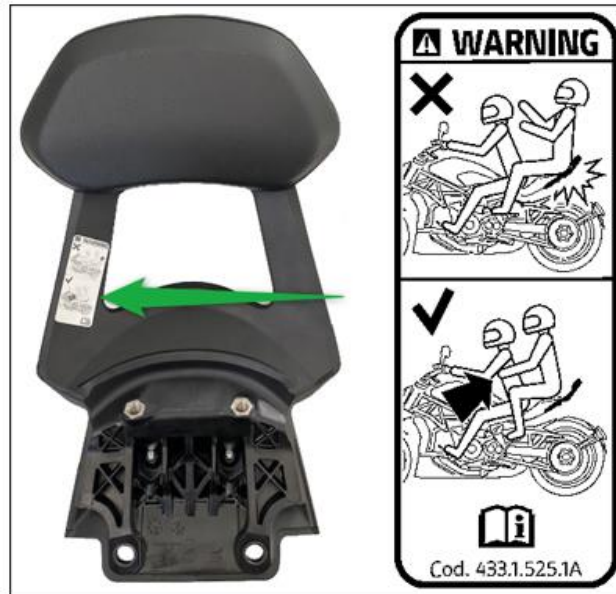
6. Thoroughly clean the surface of the backrest and apply the **warning sticker** part no. **43315251A** exactly at the point indicated in the figure.

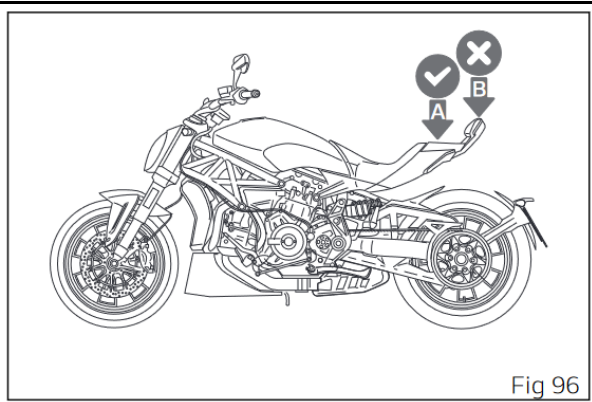
⚠ Attention
Never sit on the bike rear back (B, Fig 96). It is only a bearing surface, not a seat extension, therefore, it cannot support the passenger weight. It is important that the passenger weight remains always on the passenger seat (A; Fig 96) and not on the bike rear back (B, Fig 96).
