TECHNICAL INSTRUCTIONS

SAFETY RECALL 23TA16

PASSENGER AIRBAG MAY NOT DEPLOY AS DESIGNED

CERTAIN 2022-2023 COROLLA CROSS

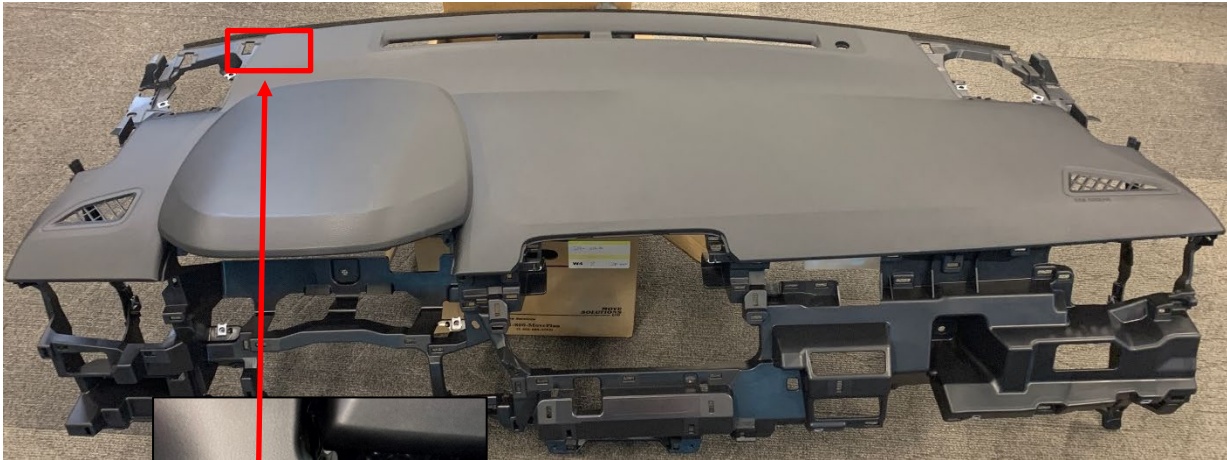
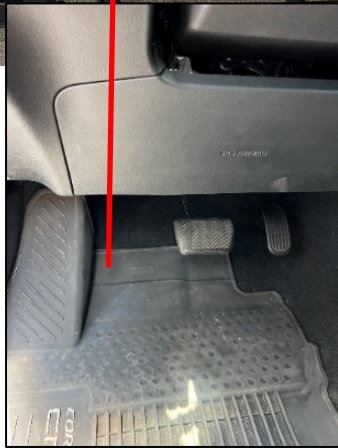
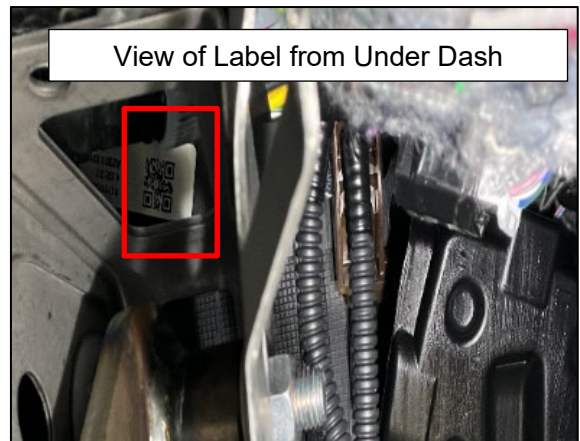
2. LOCATE THE QR CODE

- a) Locate the QR code on the underside of the dash by looking at the area shown below. The label is close to a brown clip.

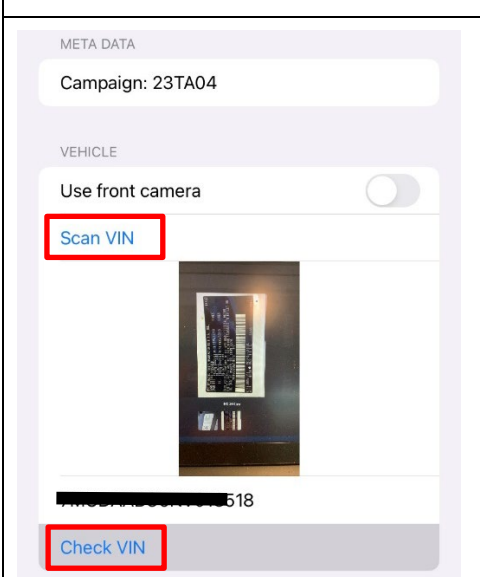
- d) Select "Scan VIN" in the app and using app scan the vin number on cert label.

- e) Once scanned press "Check VIN" in app to confirm applicability to recall.
