IMPORTANT SAFETY RECALL

NHTSA RECALL NO. 24E002

Villa International has decided that certain Jayco motor-homes equipped with Villa driver and passenger seating fail to conform to Federal Motor Vehicle Safety Standard NO. 207, "seating systems".

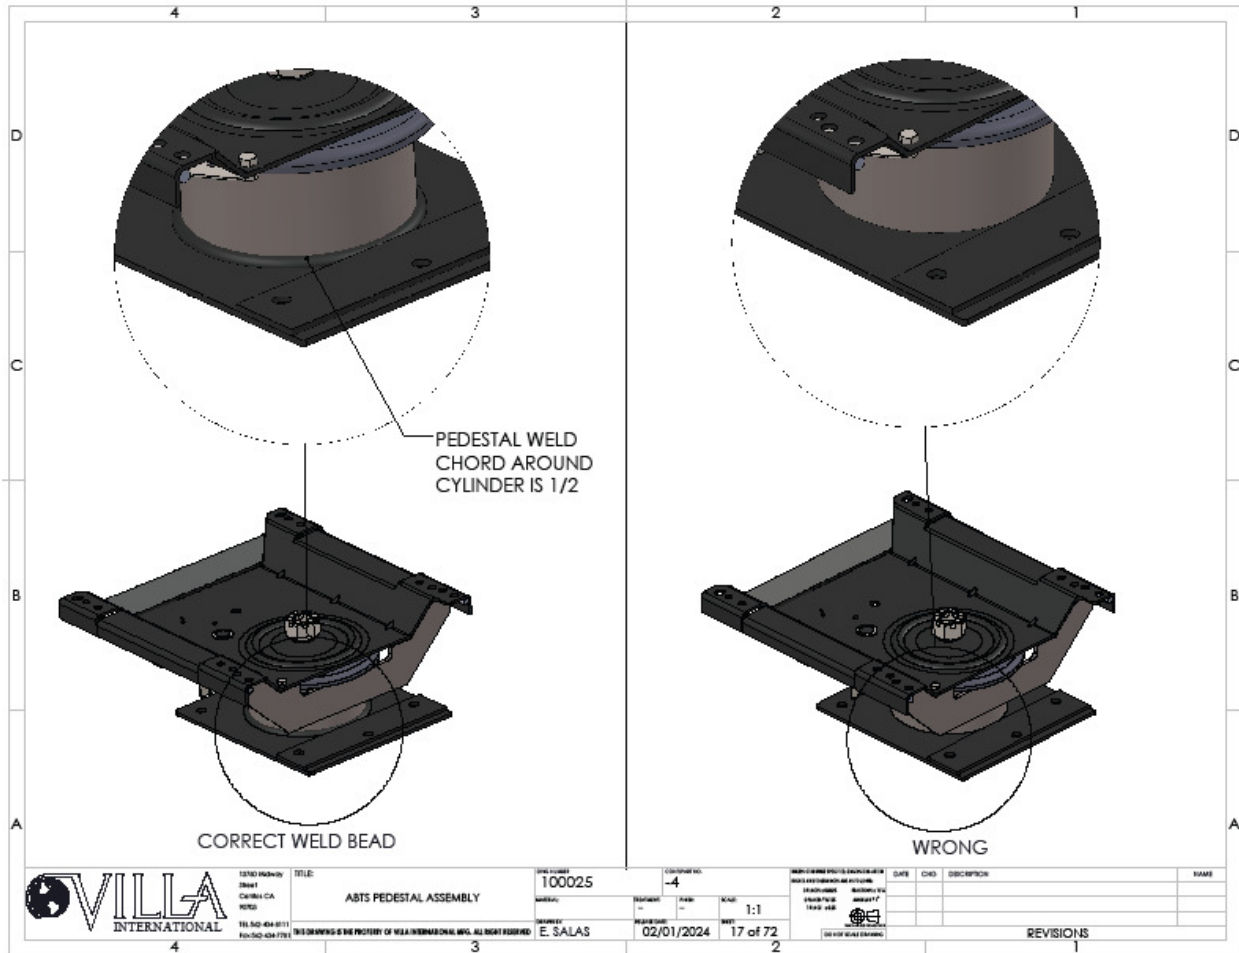
The defect concerns the seat pedestal that mounts to the vehicle floor. The attached drawing #100025 shows the defective pedestal without the weld bead and the correct pedestal with the weld bead. The pedestal incorrectly welded could fail in the event of a crash increasing the risk of injury.

The recall remedy is to inspect for the incorrect pedestal weld of the can to the mounting plate among the vehicles determined to be affected. The repair of vehicle seats found to have the defective pedestal will be to replace the defective pedestal with a new one.

Please contact your Jayco dealer as soon as possible to arrange an inspection date for your vehicle. Inspection photos of the pedestal weld areas per the attached drawings can also be sent to Villa to determine if the recall repair will be required. The pedestal inspection photos can be sent to jim@villainternational.com.
