Safety Recall – 2024 CX-90 - Steering Gear Safety Recall

A. VEHICLE INSPECTION PROCEDURE – AND PREPERATION FOR REPAIR

B. REPAIR PROCEDURE

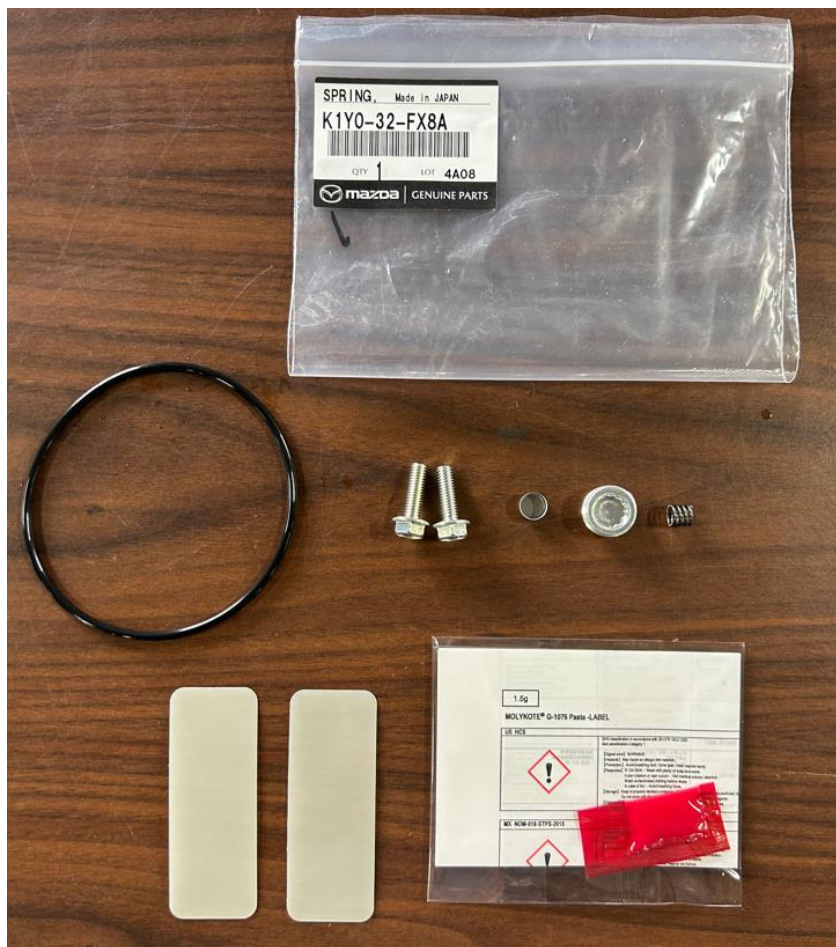
Parts Kit Contents: K1Y0-32-FX8A

1. O-ring
2. 2 new 10mm bolts
3. Outer Cap
4. Plastic strips (2)
 - a. 1 strip to be used for repair
 - b. 1 extra strip included if first strip is lost/misplaced/becomes dirty prior to use.
5. Pink grease for new nut, spring and cap only **** DO NOT INSTALL IN LARGE WORM GEAR**
6. Inner Cap
7. Spring (All Black in Color)

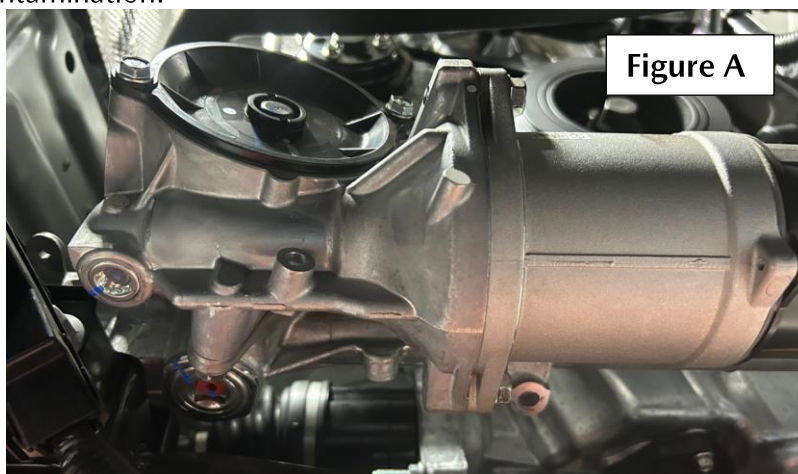
1. In order to prevent contamination later in the procedure, (step 4), wash away with water, any slush, snow, sand, mud, etc. around the steering gear and dry the entire area with an air gun (Figure A). Use Parts Cleaner if needed to completely clean the area to avoid any contamination.

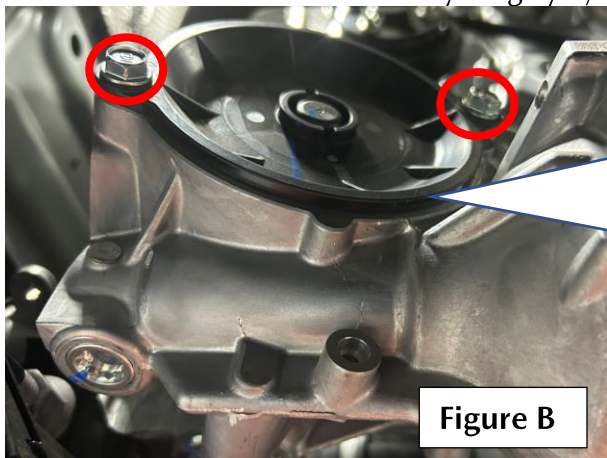
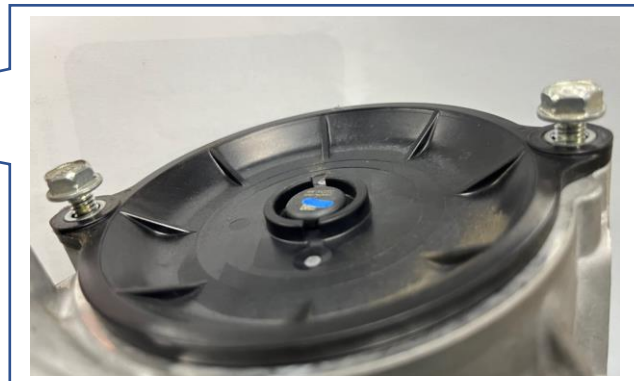
2. Loosen the two bolts for the black cover (Figure B) on the top of the steering motor to the point where the threads are visible by roughly 1/8" (3 mm).

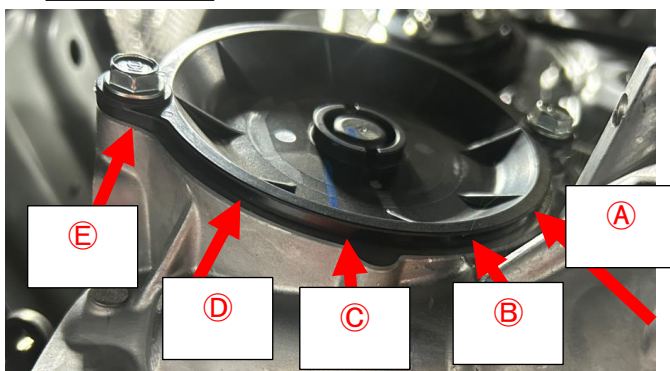
Figure C

3. Gently use a plastic door trim tool to remove the black cover so that it slowly pops up and rests against the loosened bolts (Figure C). You will need to gently insert the pry tool several times rocking the piece slowly up left-to-right (A), (B), (C), (D), and (E). Do not use any excessive force. (Figure D). There is an O-Ring on this cover that makes it difficult to remove by hand. [PLEASE CLICK HERE TO WATCH THE VIDEO OF THIS PROCEDURE STEP. \(Right Hand drive vehicle shown, but repair is the same\)](#)

Do not use a metal pry tool or flathead screwdriver, as this will cause damage/deform the aluminum case. Deformation or cracking of the black cover will allow moisture to enter the worm gear breaking down the grease resulting in rusted parts. Costs to replace damage to these components caused by incorrect tool use/improper repair will be absorbed by the Mazda dealer causing customer frustration and delay of repairs.

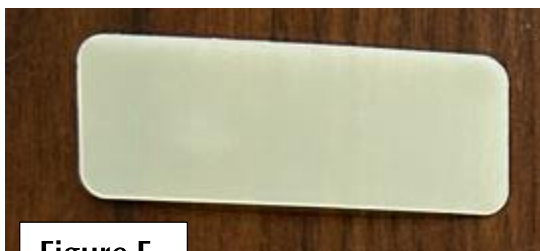
Figure E

4. Once the cover has been loosened and is against the bolts, remove both bolts and remove the cover by hand. It does not take much force with the tool to pop up the cover.
5. **WASH YOUR HANDS COMPLETELY AND DRY THEM.** Take out one plastic strip in the replacement parts kit and place it on a clean cloth (Figure E). Use a clean Neoprene glove. **If the first strip is lost or has debris from the shop environment, use the second strip.**

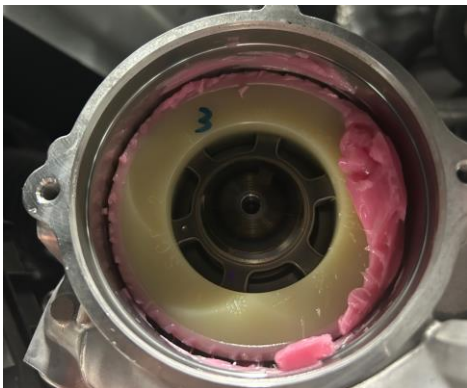
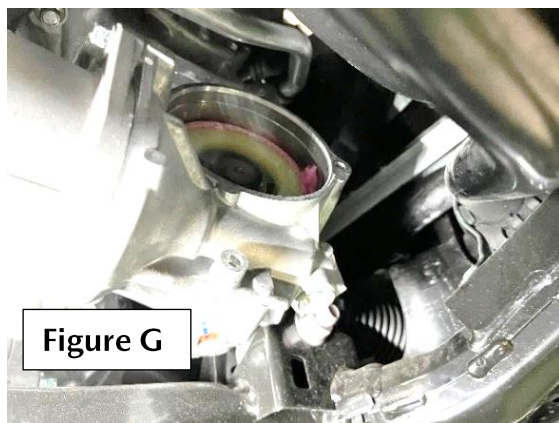
Figure G

6. Using your gloved finger, press the grease into the gap between the aluminum case and the worm gear insert around the worm gear Figure G, which adheres to the area of the blue frame in Figure H. Note G is showing a Right Hand Drive Steering Rack.

BEFORE

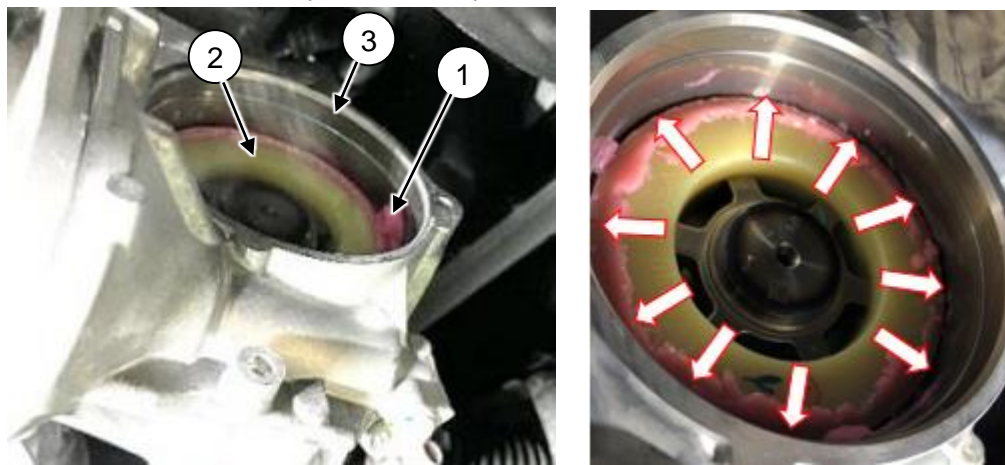
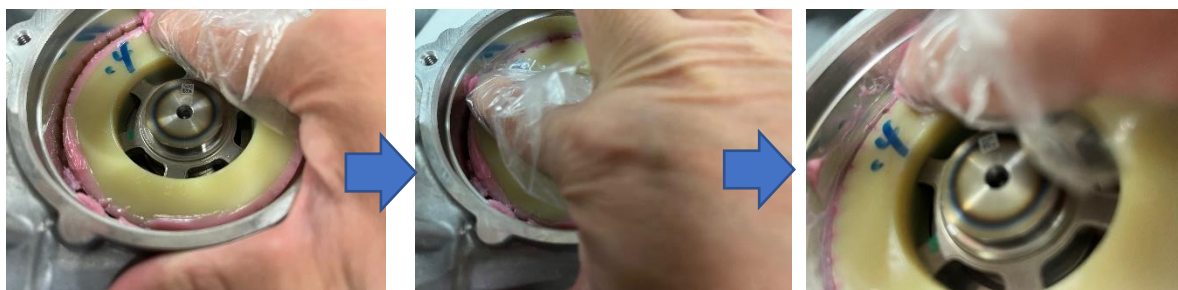
a. Flow of pushing grease into the gap is below

Push the protruded grease (pink) (1) into the gap between the worm wheel (2) and the housing (3) with a finger covered with the new glove as per the following image.

NOTE: There are variations in the amount of the grease attached to the worm wheel. Even if the amount is small, perform this procedure.

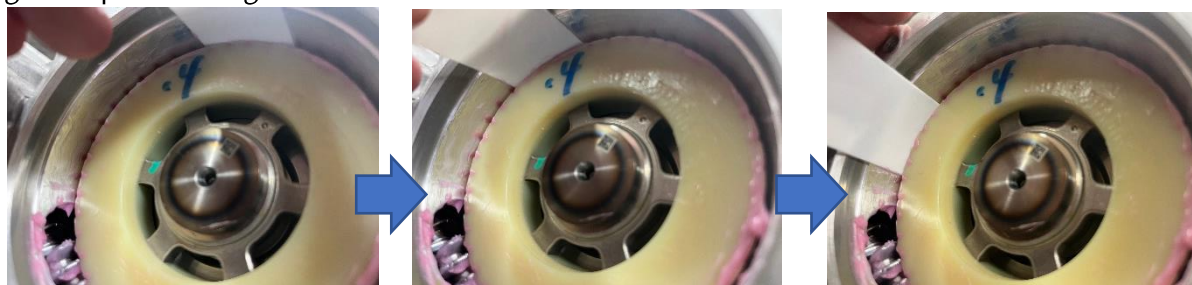
7. Place the plastic strip between the aluminum case and the worm gear, align the range of the blue frame in the figure below twice on the left and right, and press the pink grease on the groove part of the gear.

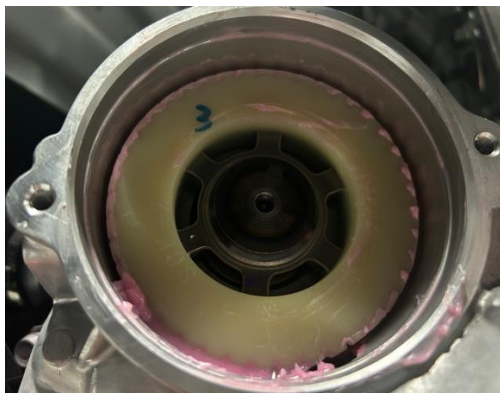
AFTER PRESSING GREASE IN

When you are done this is what this looks like. You can see that the plastic strip has pushed the grease into the teeth of the gear.

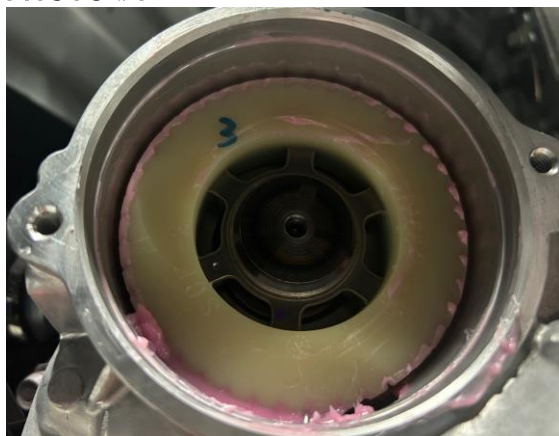
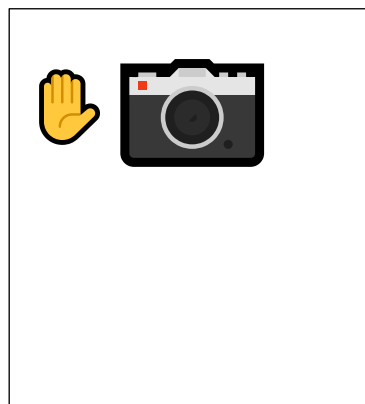
PHOTO #1

8. PHOTO REQUIREMENT #1 and 2: Write the RO# on the Steering Gear Case. Take two photos, one with pink grease blended into the gear teeth and the other with the RO in the photo and RO on the gear case. The photos must be taken properly, or the warranty claim will not be approved. Make sure it is clear like the below as this will be 100% reviewed. 100% **NOTE: Paperless dealers: RO in 2nd photo is NOT Required to save printing costs but write the RO on the steering gear.**

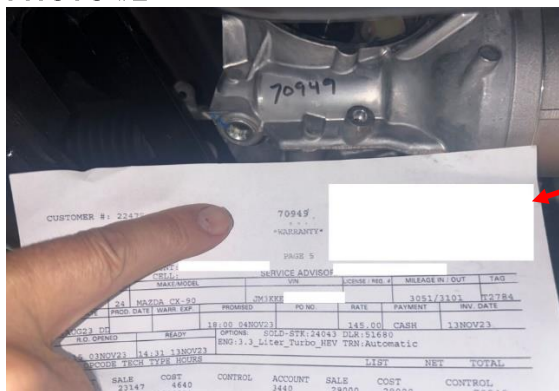
PHOTO #2

NOTE: Paperless dealers: RO in second photo is NOT Required to save printing costs, but write the RO# on the steering gear.

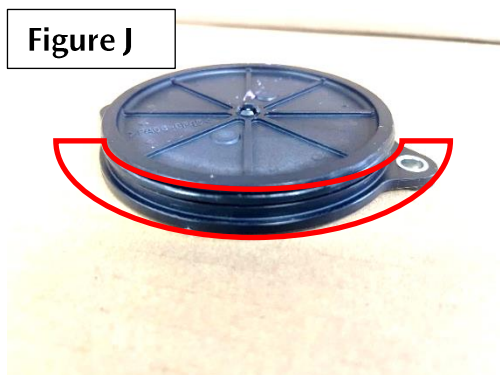
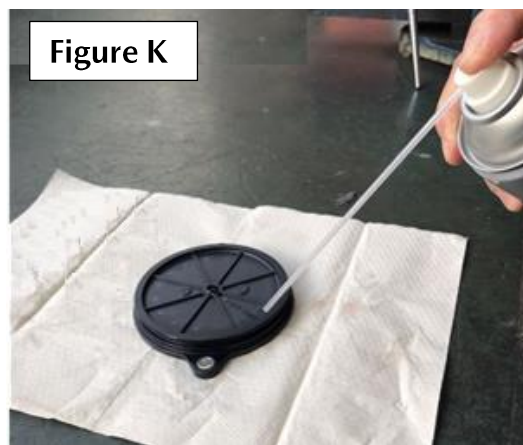
- a. Figure J. Remove the O-ring in Figure J on the outer periphery of the black cover and discard the O-ring.
- b. Figure K. Place the black cover on a clean cloth and clean the housing contact surface of the aluminum case with a non-corrosive parts cleaner that does not degrade plastic or metal.
- c. Figure L. Thoroughly remove dirt from the O-ring groove with a parts cleaner. Install the new O-ring in the parts kit.

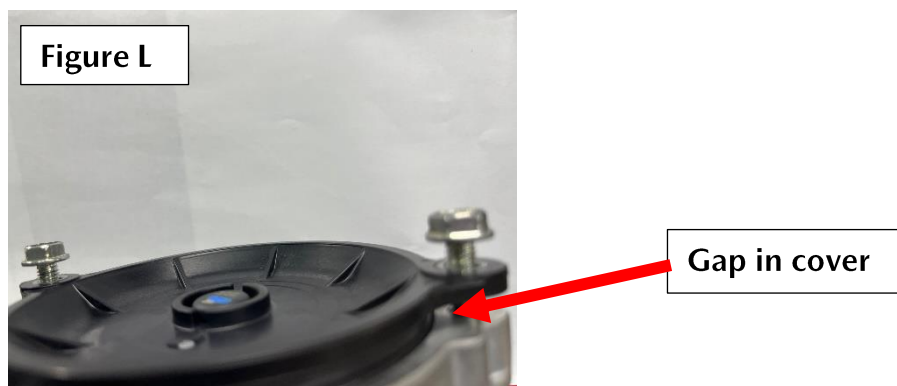
11. Install the black cover, but do not push down completely. Leave a gap and insert the bolts a few turns holding the black cover in place. Refer to Figure L.

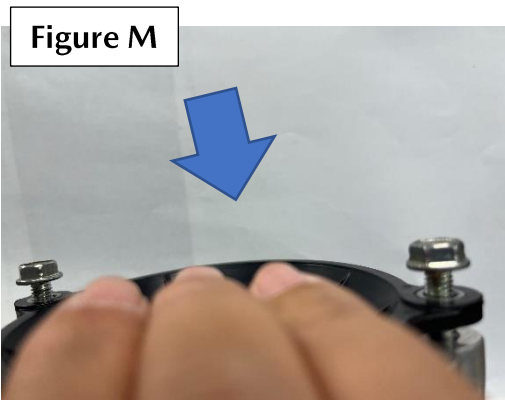
12. Gently push the black cover into the aluminum case housing surface (Figure M) and tighten the bolts with the specification below (Figure N).

Black cover bolts	Tightening torque
A	6-7lbf-ft (8 – 10) N·m

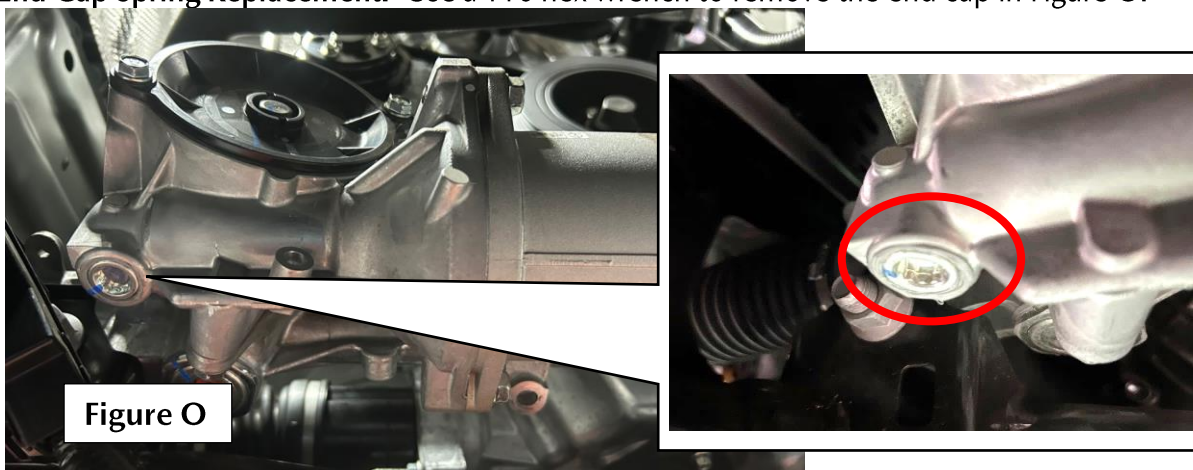
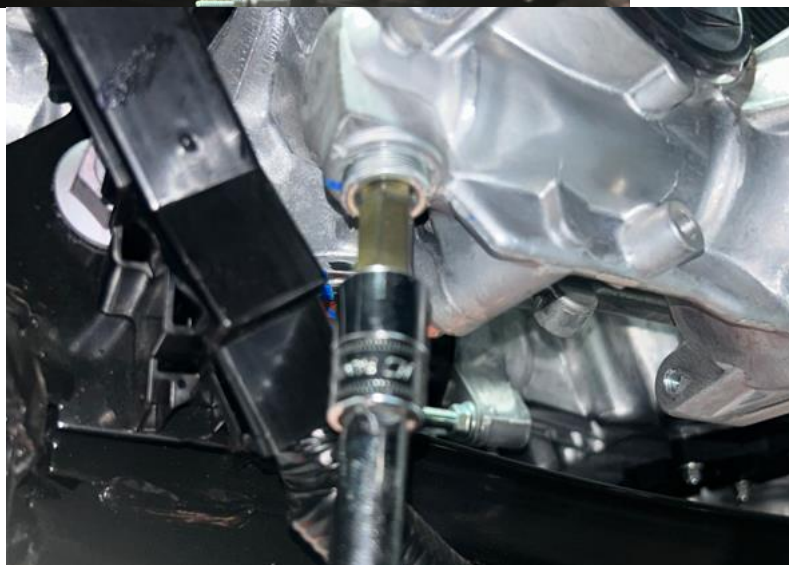
13. **End Cap Spring Replacement:** Use a T10 hex wrench to remove the end cap in Figure O.

14. Clean off a medium or long needle nose pliers and remove the spring and/or cap inside if needed. The tool must be cleaned to prevent any contamination. Visually inspect the inside and make sure that there are no springs and caps.

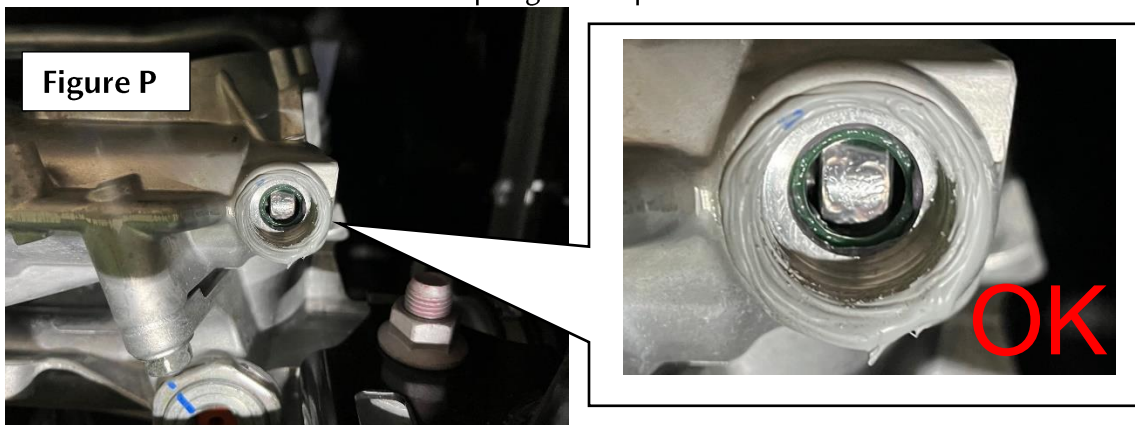
Correct - Normal condition: After spring and cap are removed.

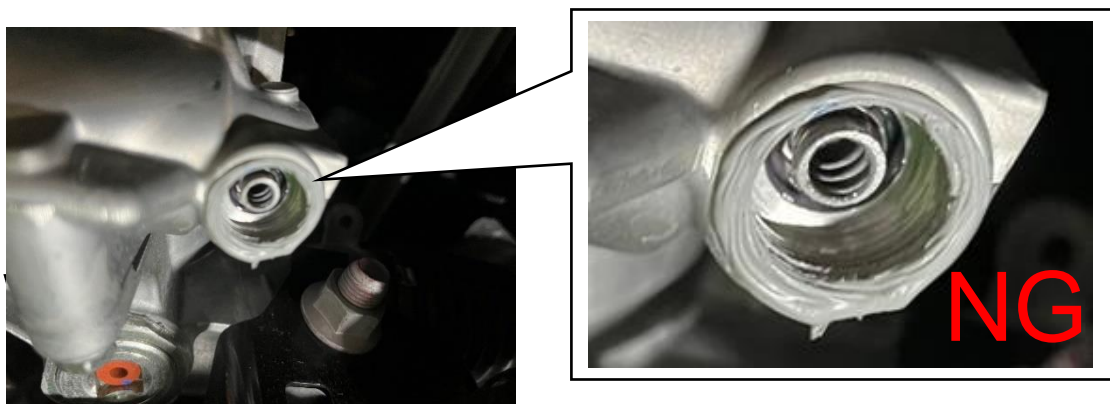
NO GOOD – Incorrect condition: Spring is not removed

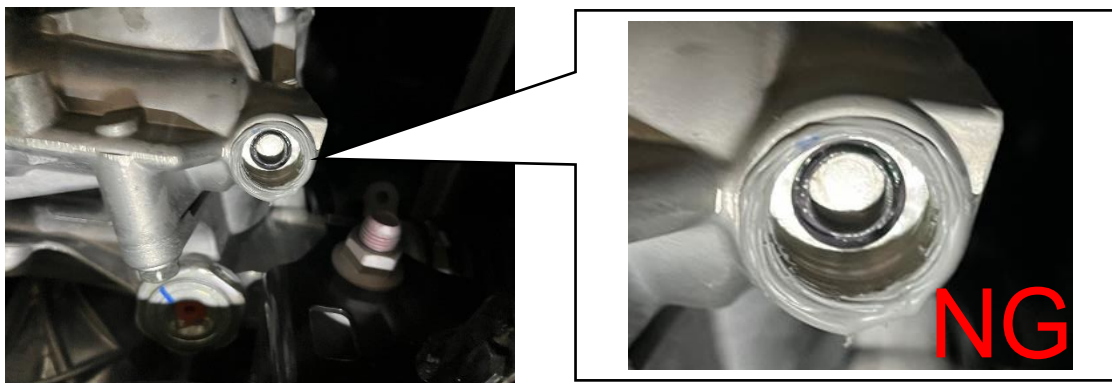
NO GOOD (NG) – Incorrect condition: Cap is not removed

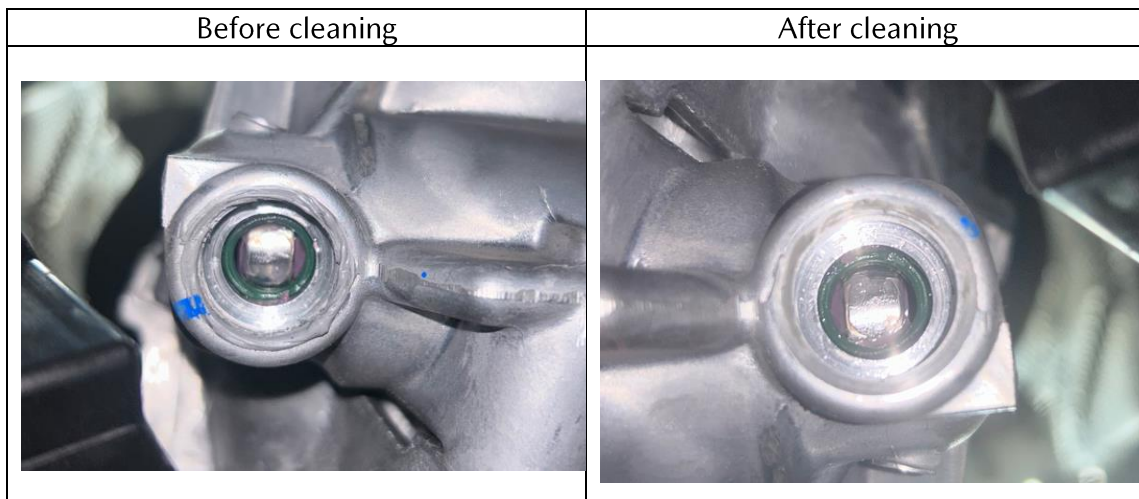
15. Remove all of the sealer on the end cap mounting surface. Use a new clean glove to

remove the gray sealer applied to the threaded part of the end cap mounting surface. Remove any remaining sealer, with a clean rag and parts cleaner as necessary. by inserting it into the end cap attachment part and removing the sealant from right to left.

CAUTION: Do not rotate to the right. If you rotate it to the right, the sealer might get pushed into the housing.

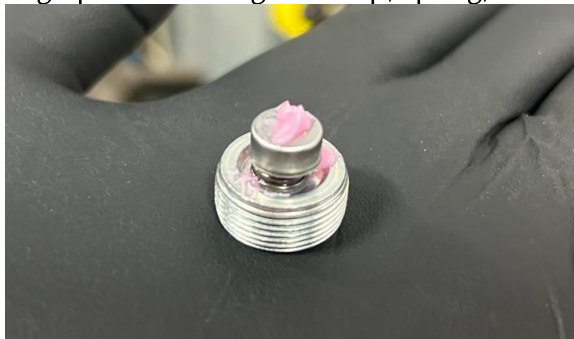
Photograph of the integrated cap, spring, end cap

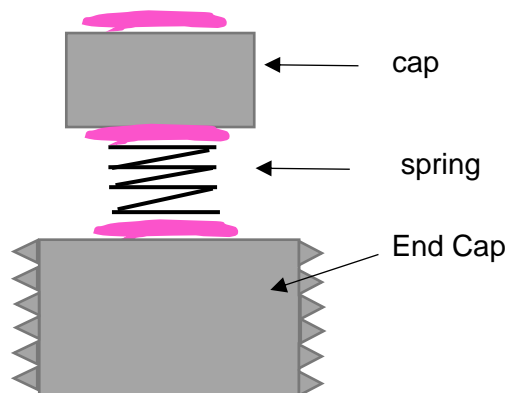
Where to place Grease

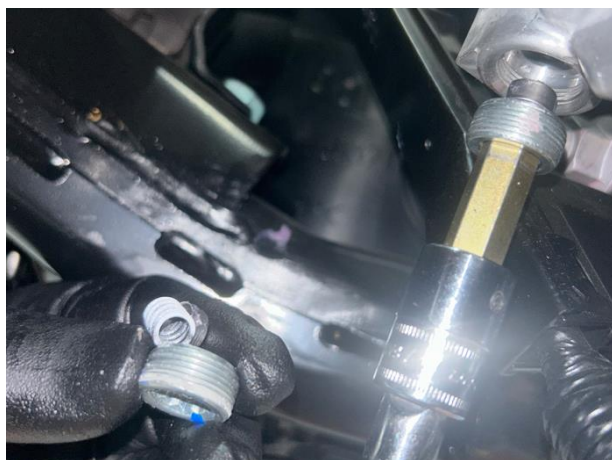
17. PHOTO REQUIREMENT #3: Take a photo for the warranty claim.

With the RO# in the photo, take a photo so that the integrated cap, spring, end cap, and old spring, which are replacement parts, are in the photo. (Note, this photo is a little low and you do not see the RO# on the rack. Make sure the RO# is present in the photo like #4

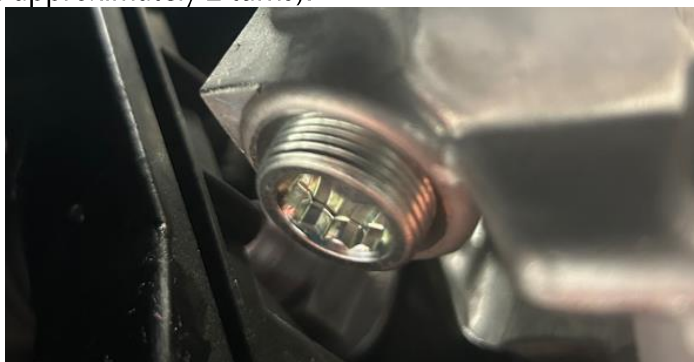
18. After taking photo #3, start the threads of the integrated cap, spring, and end cap (should be approximately 2 turns).

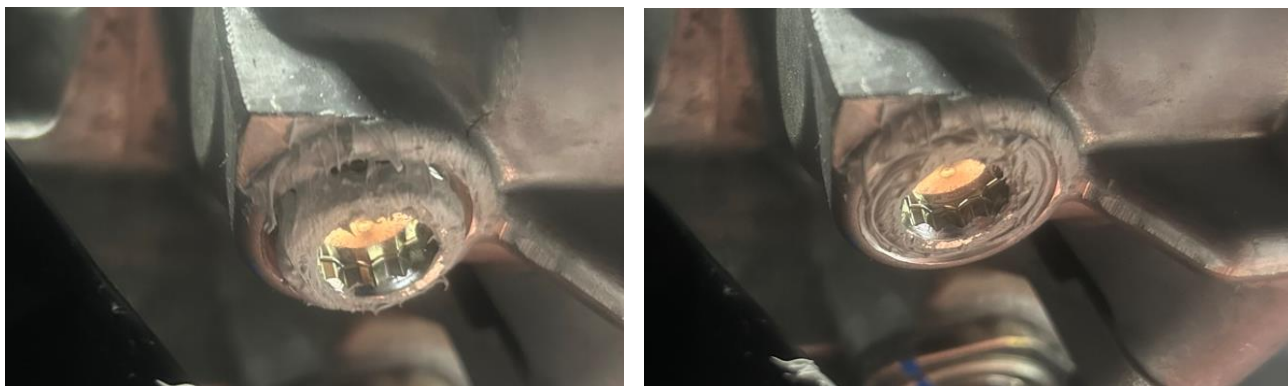
19. Apply a silicone liquid gasket (0000-77-1217-ES Mazda required sealant) to the thread of the end cap and tighten it. This tube will repair at least 25 vehicles. [PLEASE CLICK HERE TO WATCH THE VIDEO OF THE PROCEDURE. \(Right Hand drive vehicle is shown, but repair is the same\)](#) **NOTE: THE SEALANT IS GRAY IN COLOR FROM PN# 0000-77-1217-ES)**

Tightening torque: 9-12 lbf-ft (12-16 N-m)

BEFORE TORQUE WITH GREASE

AFTER TORQUE

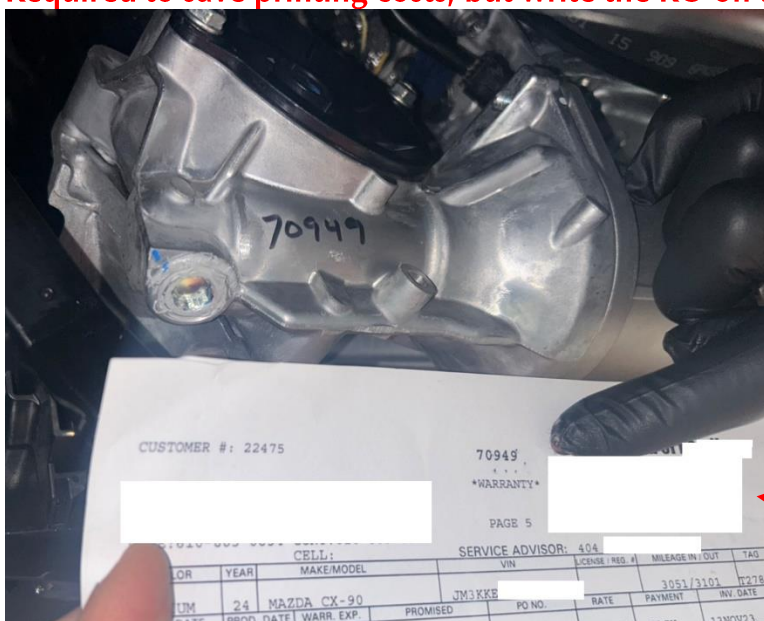
20. PHOTO REQUIREMENT #4. Take a photo for a warranty claim.
Take a photo so that the black cover and end cap are visible.

NOTE: THE RO ON THE CASE MUST MATCH THE RO IN THE PHOTO, THIS WILL BE CHECKED. NOTE: Paperless dealers: RO in 4th photo is NOT Required to save printing costs, but write the RO on the steering gear.

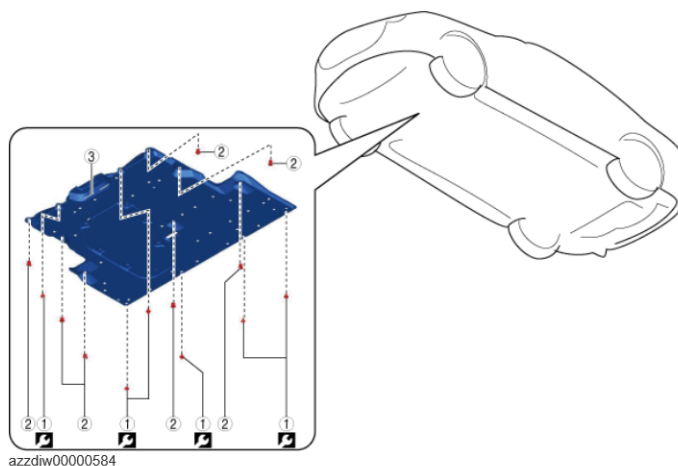
21. Reinstall the #3 Under Cover. Refer to MGSS online ([FRONT UNDER COVER # 3 REMOVAL / INSTALLATION](#))

Step	Part name	Applicable condition	Tightening torque
1	Bolt	All models	11 N·m {110 kgf·cm, 95 in·lbf}
2	Fastener	All models	—
3	Front undercover No.3	All models	—
