TECHNICAL INSTRUCTIONS

SAFETY RECALL HLD

DRIVER OR FRONT PASSENGER AIRBAG ASSEMBLY

**CERTAIN 2006 LX 470
CERTAIN 2008-2013 LX 570**

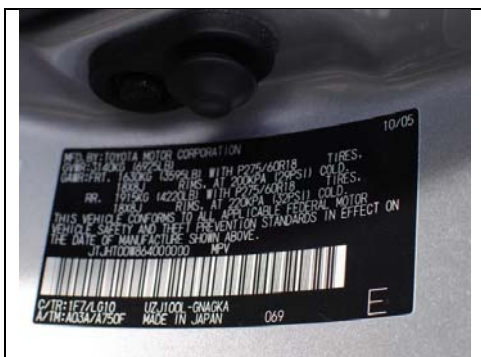
1. REQUEST REPLACEMENT PART

- Locate the FMVSS Certification Label inside the driver's door.
- Verify that the VIN number listed is an affected vehicle by this Safety Recall (Section II, page 2).
- Take a clear photo of the label so that the VIN number can be read.
- Consult your parts department and follow the directions in Section III. A. to order the needed part.

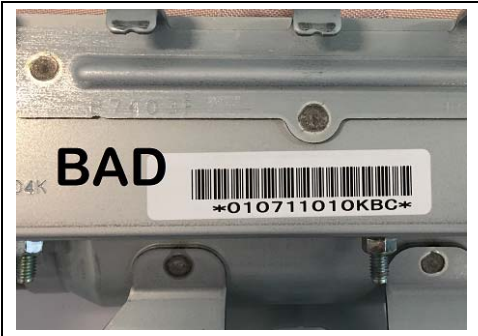
5. PHOTO OF ORIGINAL AIRBAG SERIAL NUMBER

A photo of the ORIGINAL airbag serial number will also be required to be attached to the Warranty Claim Submission.

- a. Using a black permanent marker, write “BAD” next to the serial number on the airbag.
- b. Take a clear photo of the airbag serial number to include the handwritten “BAD”.
