01466 Version 4

## Safety Recall: SRS Unit

Year	Model	VIN Range
2003	MDX	Check the iN VIN status for eligibility

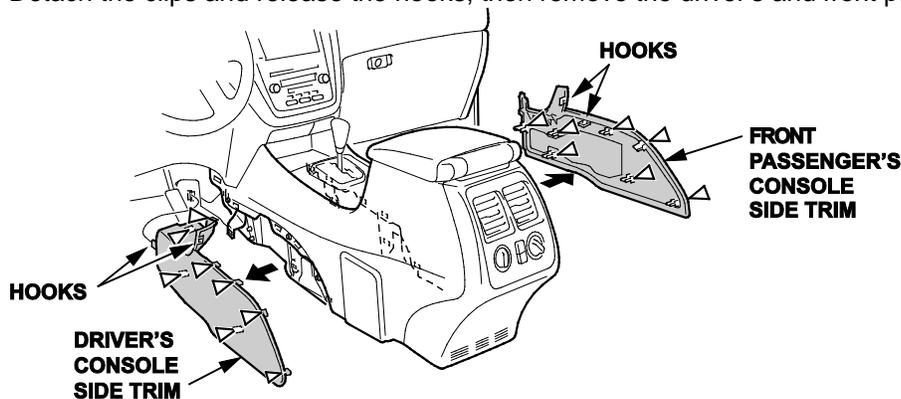
5. Disconnect the negative battery cable and wait at least 3 minutes before beginning work.
  6. Detach the clips and release the hooks, then remove the driver's and front passenger's console side trim.

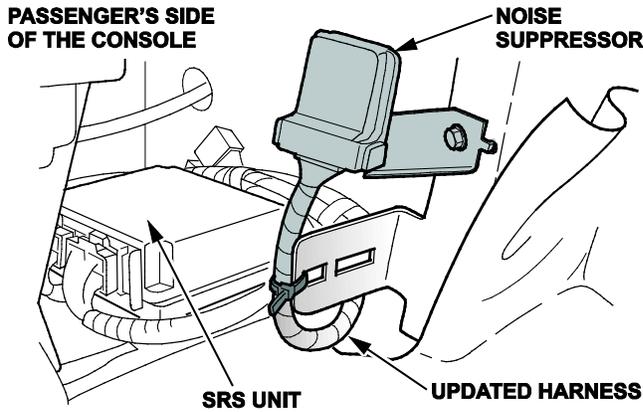
**UPDATED SRS SUBHARNESS WITH NOISE SUPPRESSOR**

- The original subharness is installed in the vehicle.
- There is an updated subharness connected to the noise suppressor.
- There is an updated subharness that has been taped up as shown and the noise suppressor has been removed.

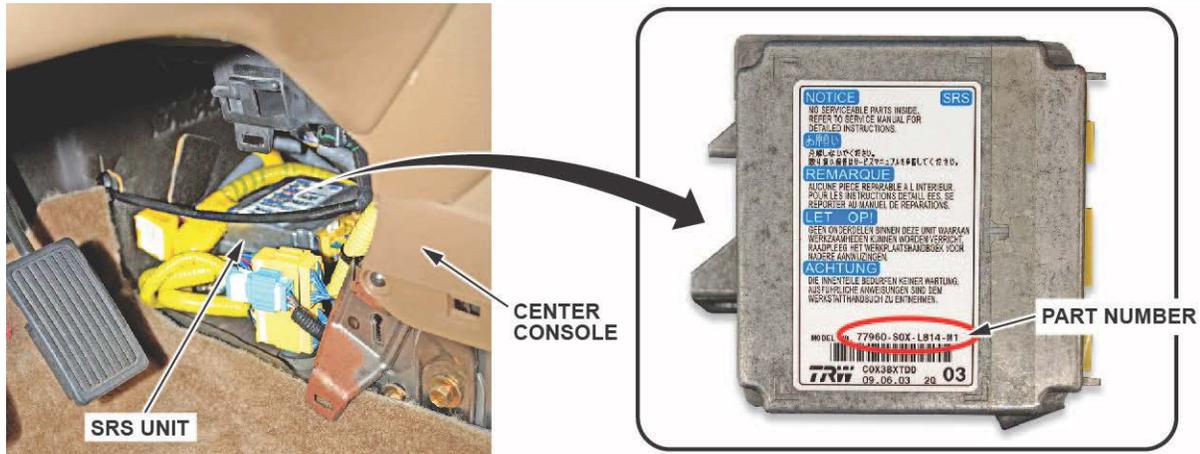
- Write down the SRS unit P/N on the RO.

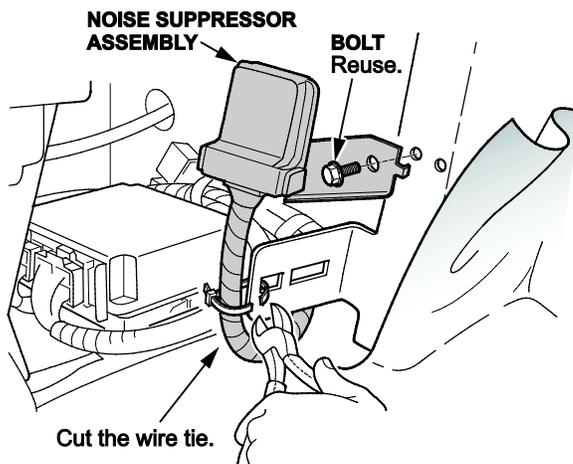
### PASSENGER'S SIDE

- Cut the wire tie and unbolt the suppressor bracket.

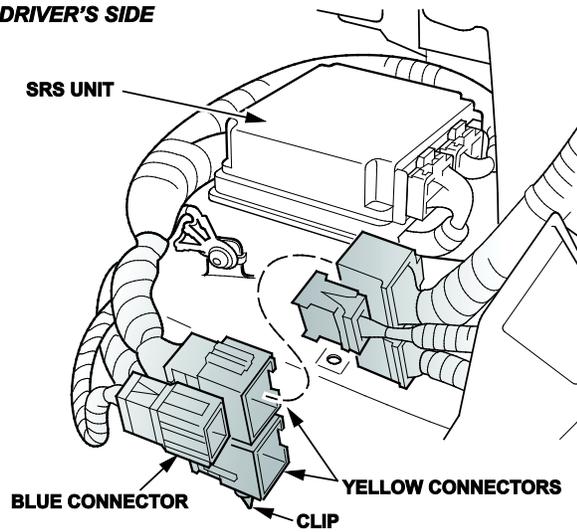
**DRIVER'S SIDE**

2. On the driver's side, disconnect the clip, then disconnect the two yellow connectors and the blue connector.

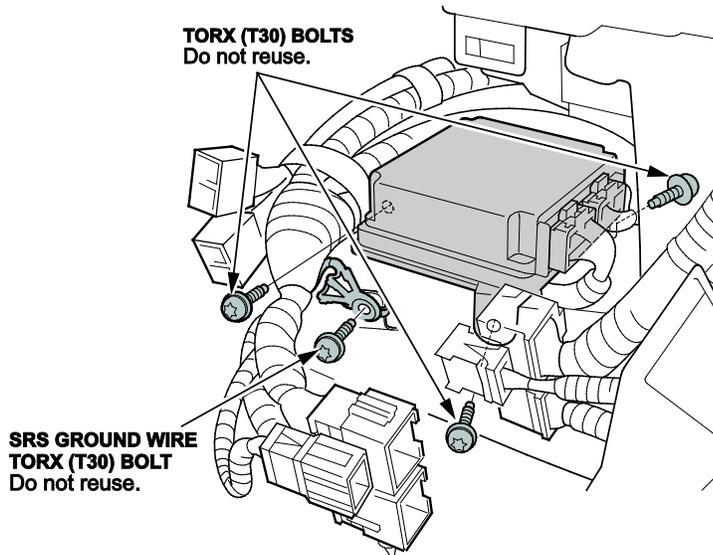
3. Remove the SRS ground wire Torx (T30) bolt.

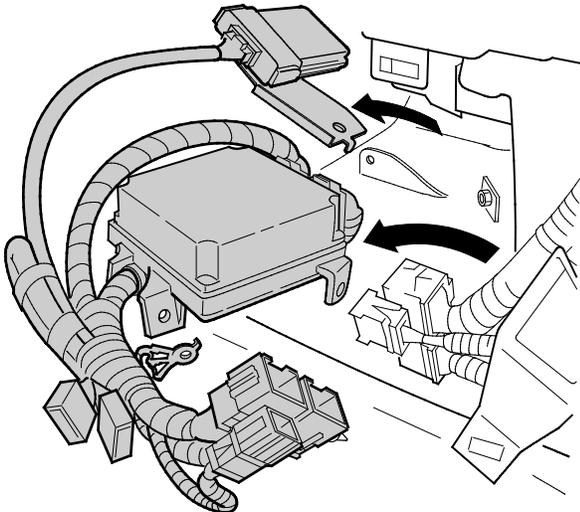
4. Remove the SRS unit by removing the three Torx (T30) mounting bolts.  
NOTE: Two of the bolts are accessible from the driver's side, and one is accessible from the front passenger's side.
5. Remove the SRS unit and the subharness from the vehicle.

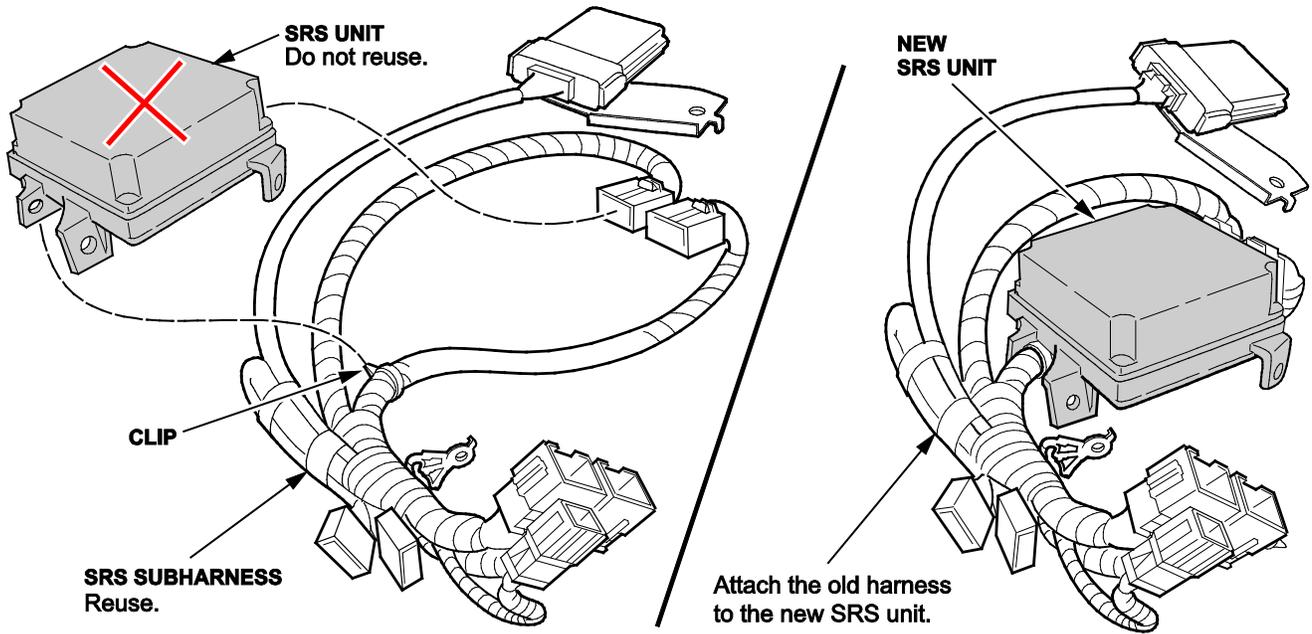
6. Remove the subharness clip from the underside of the SRS unit, then disconnect the subharness from the old SRS unit.

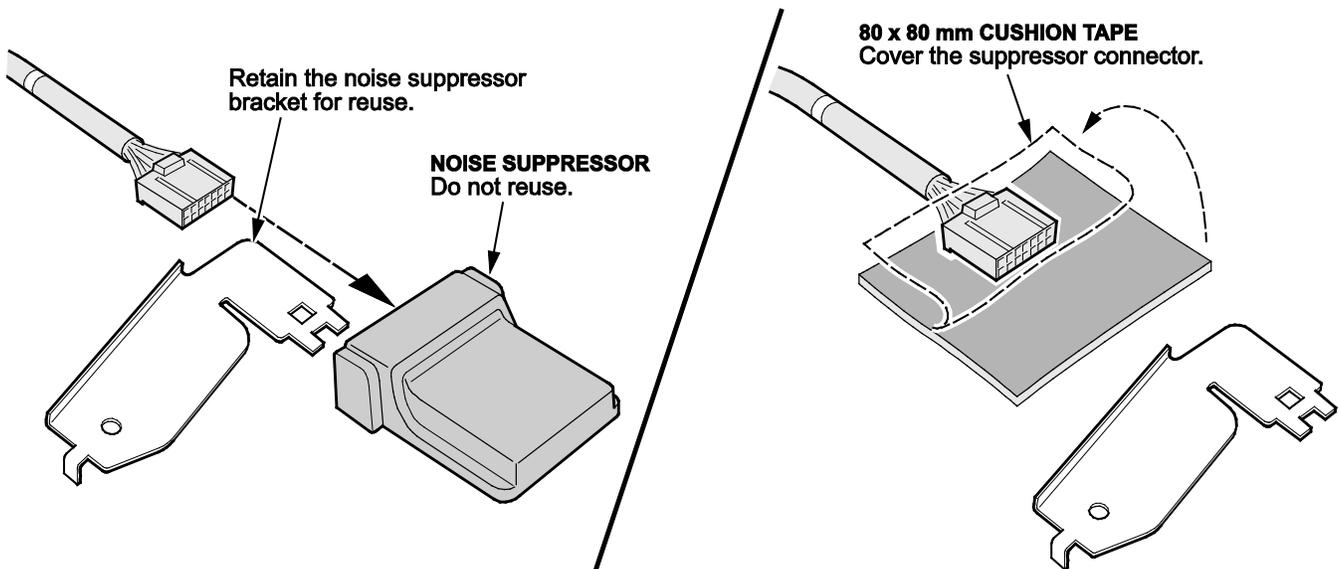
7. Connect the subharness to the new SRS unit P/N 77960-S3V-307.  
8. Remove the bracket from the suppressor because you will reuse the bracket. Do not reuse the noise suppressor.

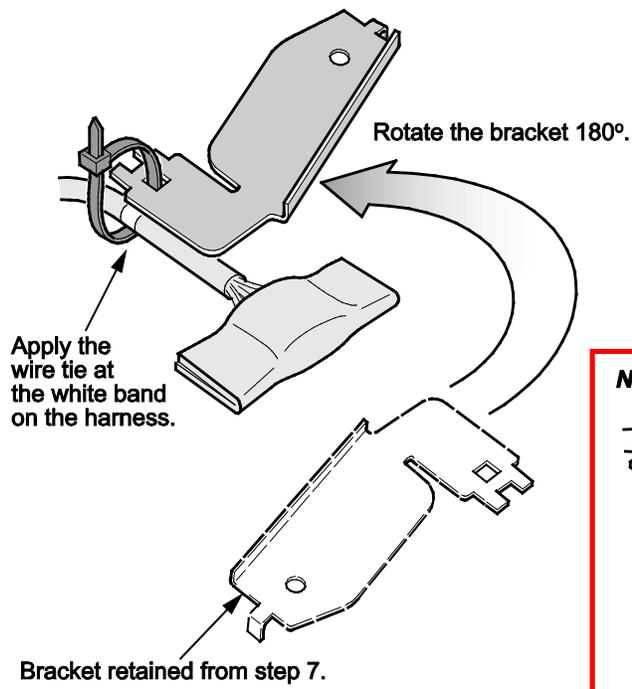
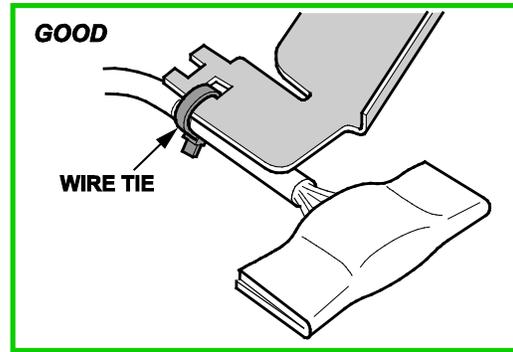
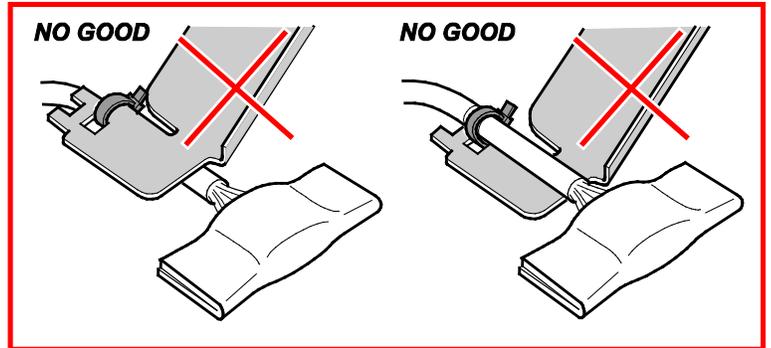
9. Apply a piece of 80 mm x 80 mm cushion tape over the noise suppressor connector as shown.

10. Using a wire tie, secure the old bracket to the harness as shown. In a later step this will hold the harness with the connector pointing down.

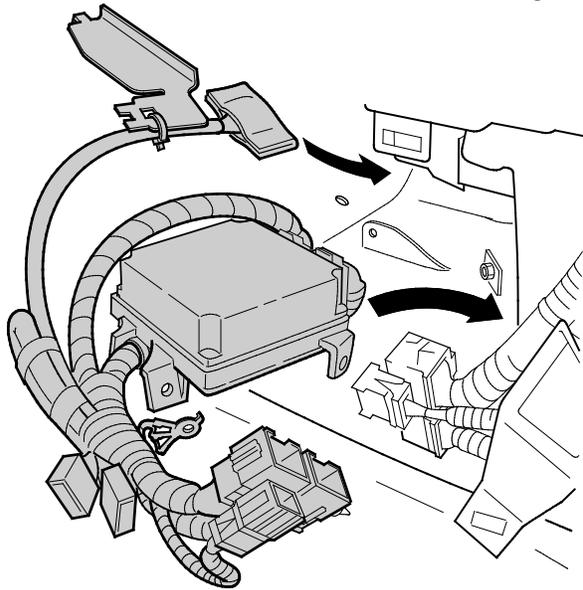
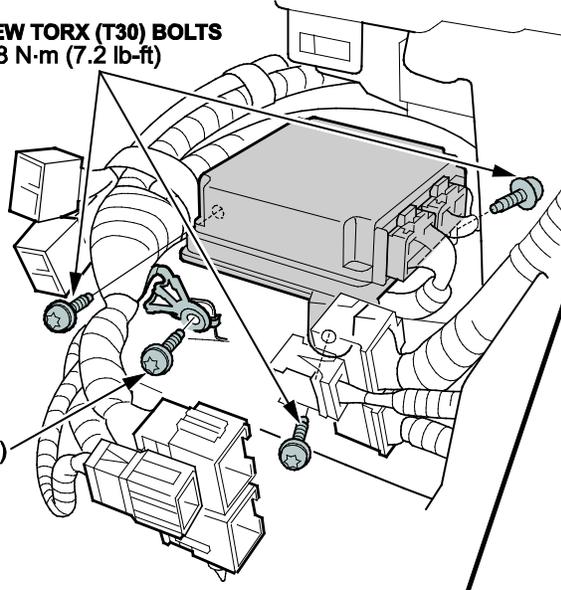
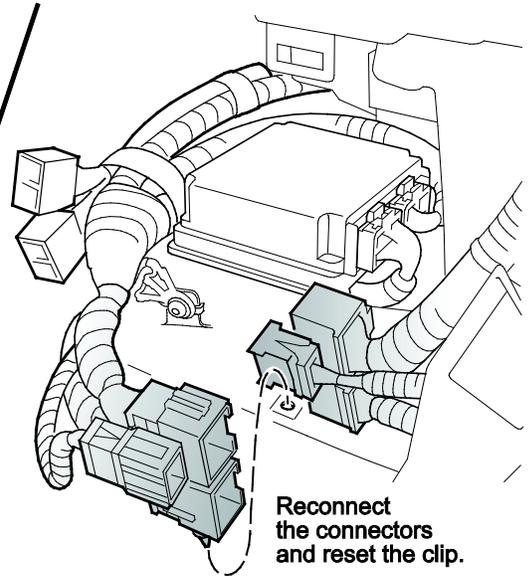
- Make sure the SRS unit is squarely against its bracket and install the three new Torx bolts. Torque them to **9.8 N•m (7.2 lb-ft)**.
- Install the fourth new Torx bolt to secure the ground wire and torque it to **9.8 N•m (7.2 lb-ft)**.

**NEW TORX (T30) BOLTS**  
9.8 N•m (7.2 lb-ft)

**NEW SRS  
GROUND WIRE  
TORX (T30) BOLT**  
9.8 N•m (7.2 lb-ft)

**Reconnect  
the connectors  
and reset the clip.**

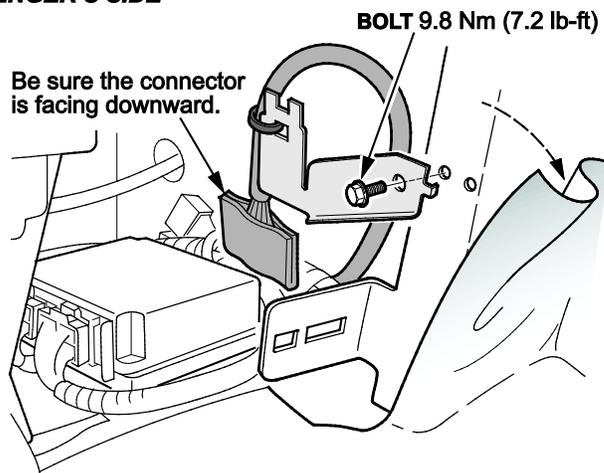
**PASSENGER'S SIDE**

12. Reinstall the bracket using the original bolt as shown. Make sure the connector is pointing downward.

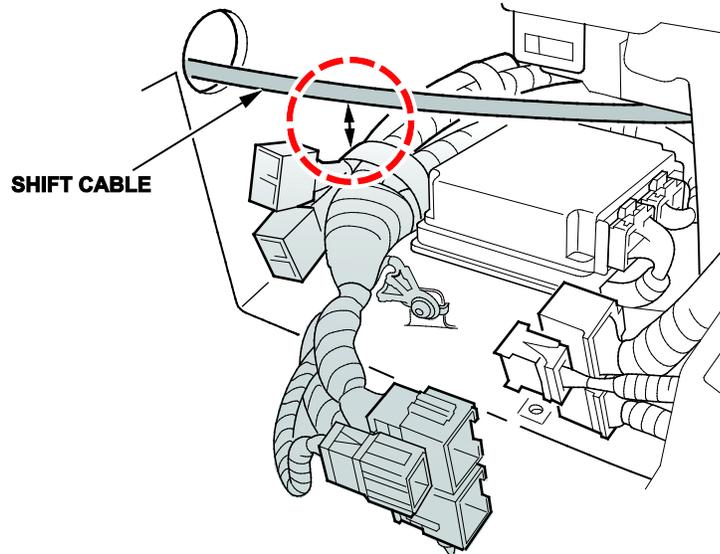
13. Make sure the SRS subharness does not interfere with or rub against the shift cable.

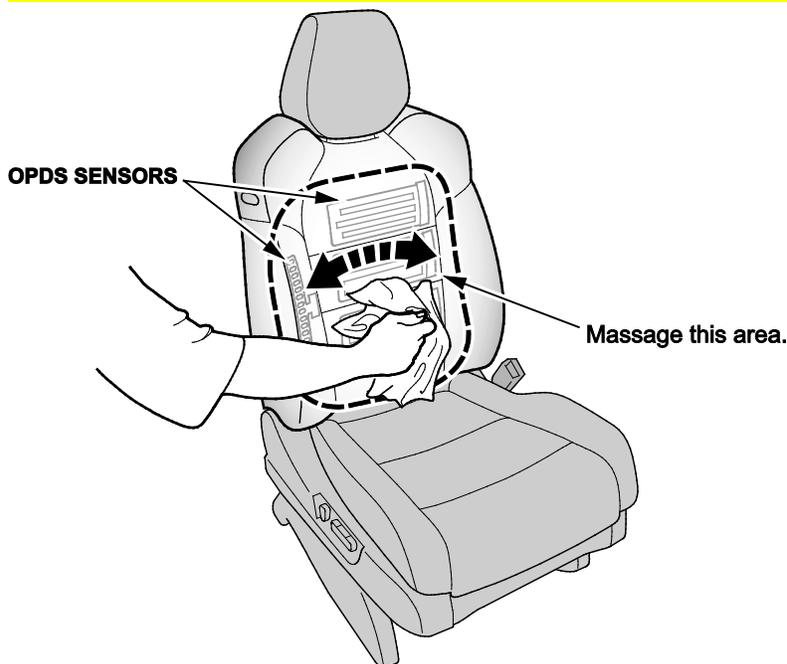
- If the OPDS is initialized (the indicator light is off) and it passed all the inspection items (INSPECTION PROCEDURE steps 1-3), go to step 19.
- If the SRS indicator remains on and the SIDE AIRBAG OFF indicator is flashing, the leather passenger seat back material around the OPDS may be causing an issue. Massage the leather to make sure there are no tight areas where the leather is stretched across the seat for about 1 minute and then repeat step 17-18.

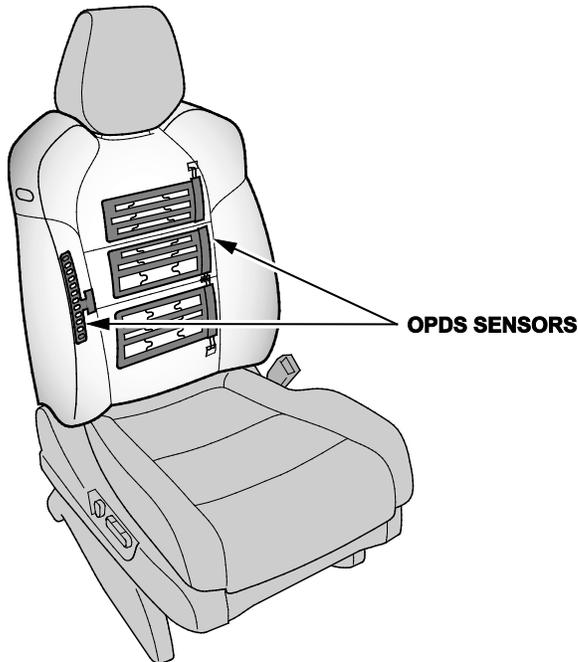
- If the SRS indicator remains on and the SIDE AIRBAG OFF indicator is flashing, use the HDS to initialize the OPDS from the SRS menu.

**NOTE:** If the SRS indicator is on and the SIDE AIRBAG OFF indicator is flashing, do not initialize the SWS (seat weight sensor).

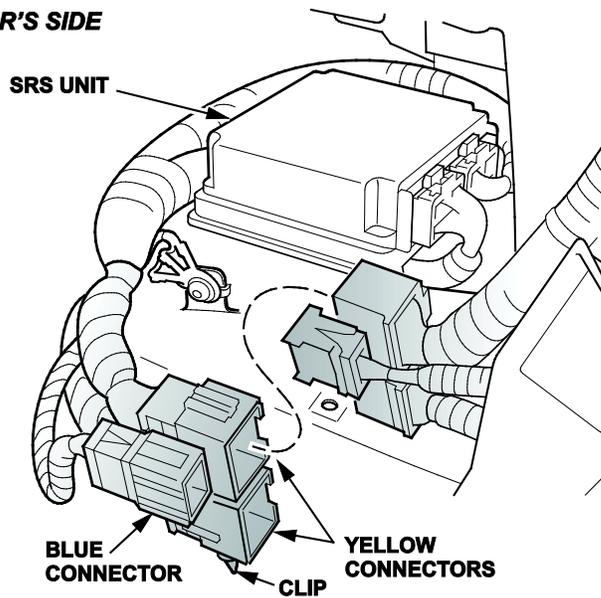
### DRIVER'S SIDE

1. Disconnect the two yellow connectors and remove the clip from the floor.

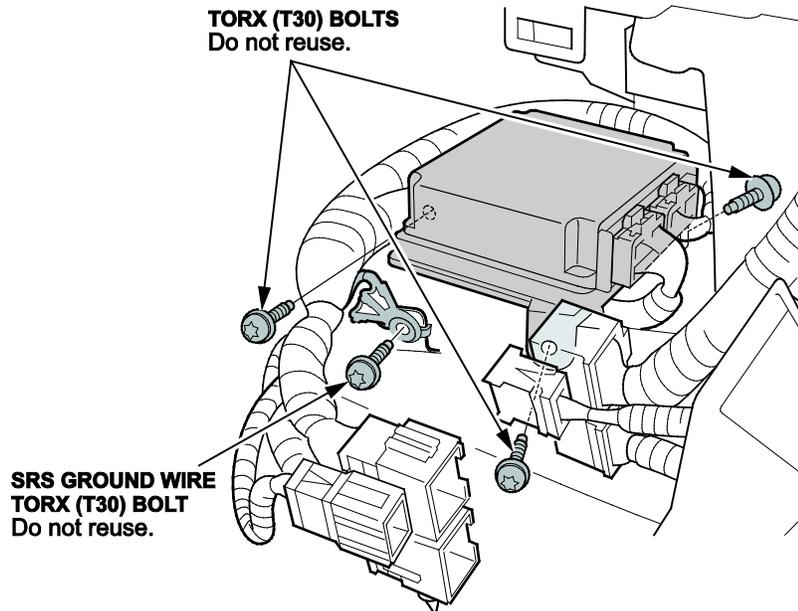
2. Remove the SRS unit by removing the three Torx bolts.

NOTE: Two of the bolts are accessible from the driver's side and one is accessible from the front passenger's side.

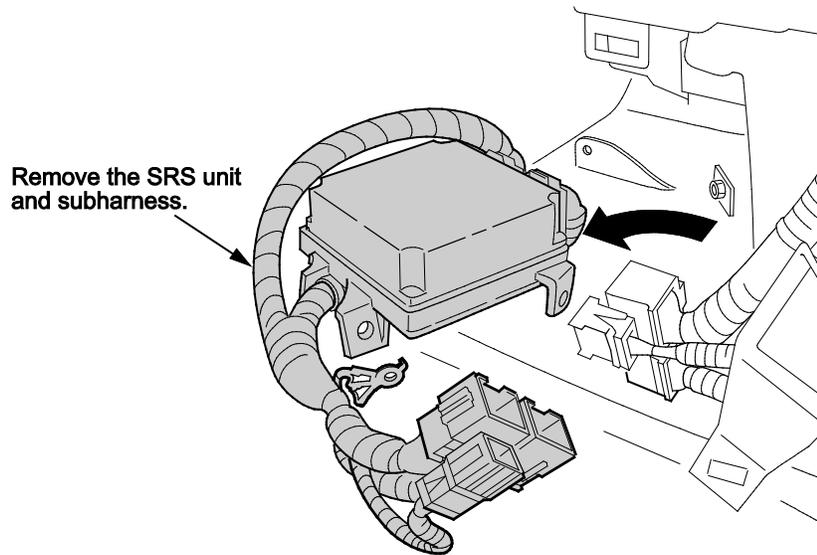
3. Remove the ground wire by removing the Torx bolt.
4. Remove the SRS unit and the subharness from the vehicle.

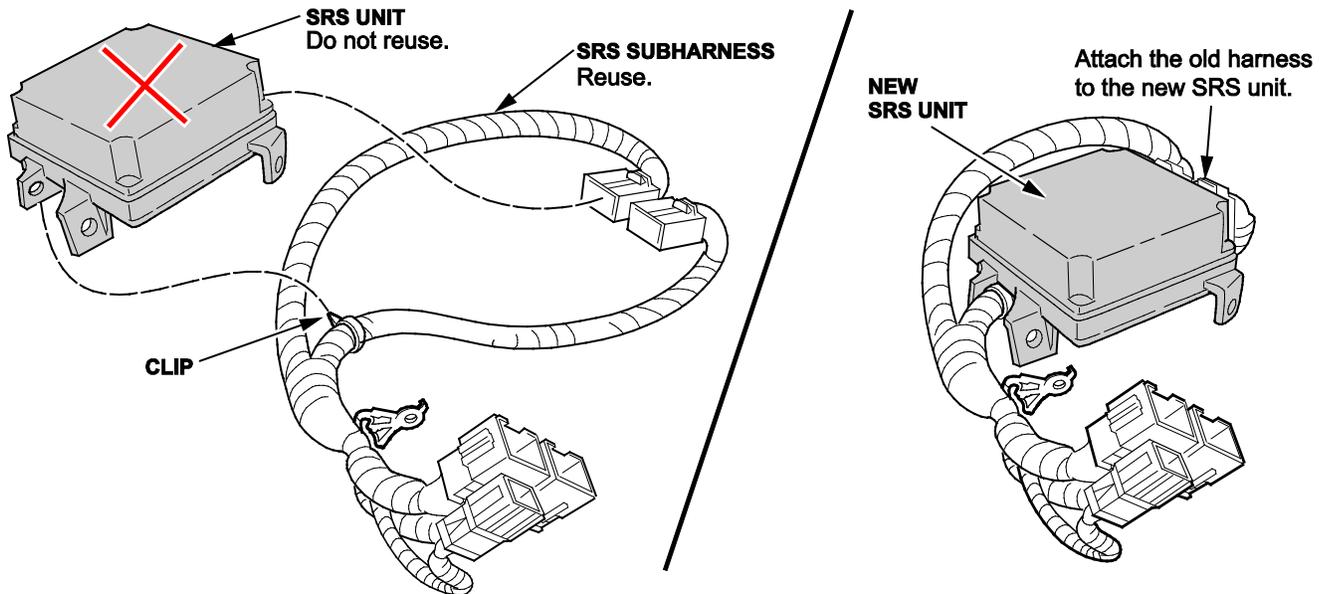
5. Remove the subharness clip from the underside of the SRS unit, then disconnect the subharness from the unit.

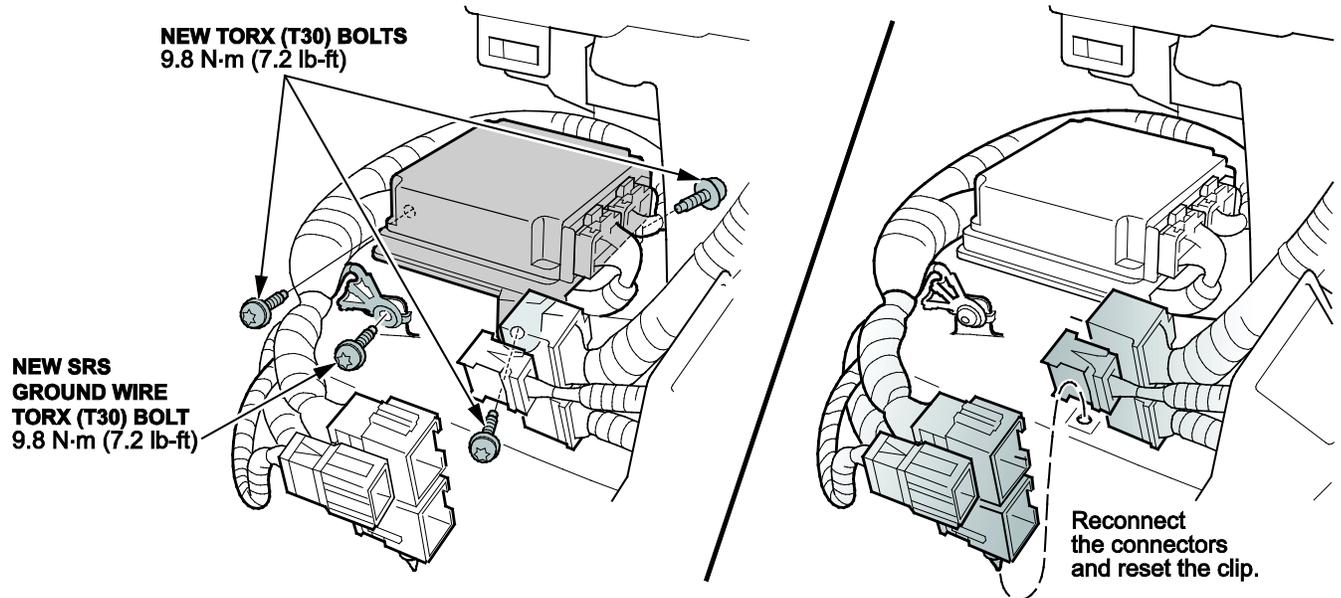
6. Install a new subharness clip onto the original subharness, then connect the subharness to the new SRS unit P/N 77960-S3V-307.

7. Reinstall the new SRS unit and existing SRS subharness into the vehicle with three new Torx bolts and torque them to **9.8 N-m (7.2 lb-ft)**.

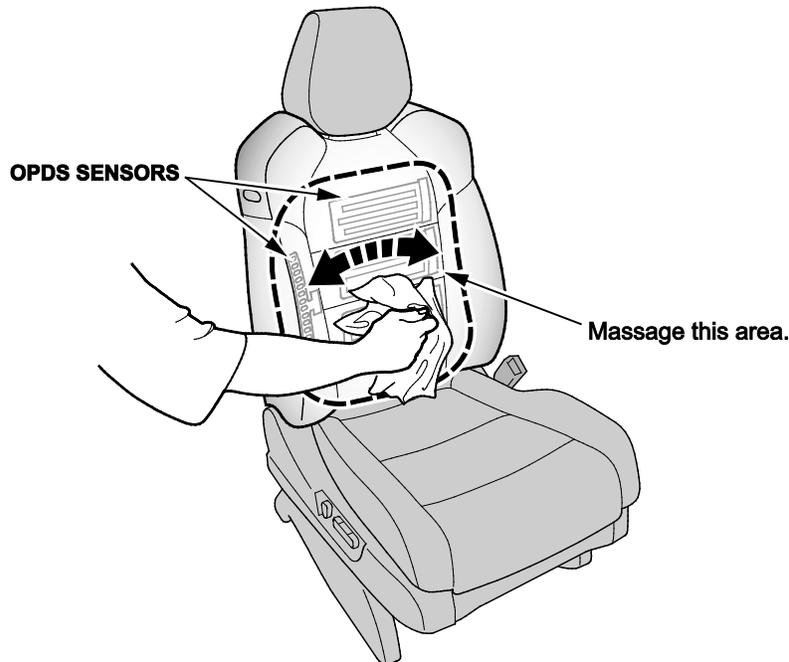
- If the OPDS is initialized (the indicator light is off) and it passed all the inspection items (INSPECTION PROCEDURE steps 1-3), go to step 14.
- If the SRS indicator remains on and the SIDE AIRBAG OFF indicator is flashing, the leather passenger seat back material around the OPDS may be causing an issue. Massage the leather to make sure there are no tight areas where the leather is stretched across the seat for about 1 minute and then repeat step 12-13.

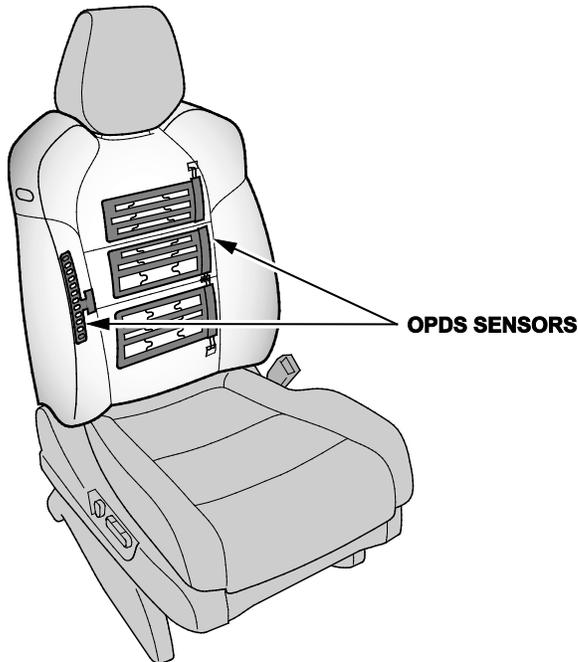
- If the SRS indicator remains on and the SIDE AIRBAG OFF indicator is flashing, use the HDS to initialize the OPDS from the SRS menu.

**NOTE:** If the SRS indicator is on and the SIDE AIRBAG OFF indicator is flashing, do not initialize the SWS (seat weight sensor).
