June 23, 2015

02096 Version 1

Safety Recall: 2016 Pilot Third Row Seat Belt Inspection

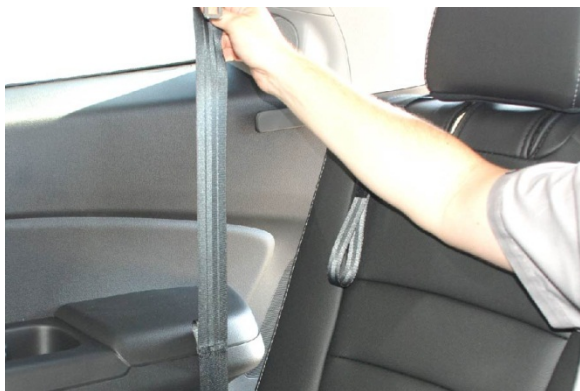
1. Make sure the third row seats are in the upright position. If the third row seat belts are buckled, unbuckle them, and pull them straight up making sure they are fully retracted.

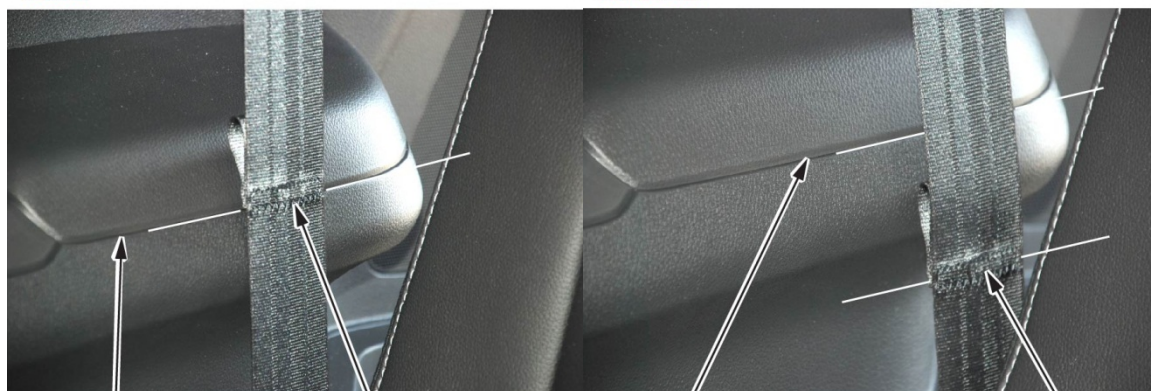
2. Compare the stitching on the seat belt with the edge of the third row side panel arm rest.
 - If the seat belt stitching lines up with the edge of the third row arm rest as shown, the seat belt is Good.
 - If the seat belt stitching DOES NOT line up with the edge of the third row arm rest, go to step REPAIR PROCEDURE.

GOOD

NO GOOD

SEAM ON
INTERIOR TRIM

STITCHING ON
SEAT BELT

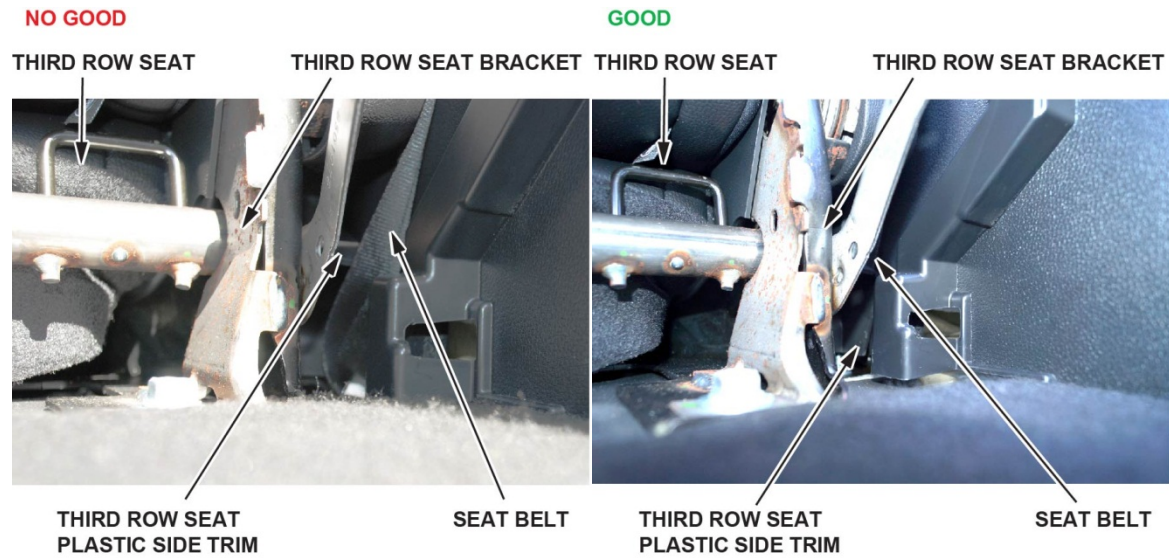
The third row seat belts are trapped under the third row seat trim.

4. While pulling up on the seat belt, maneuver the seat belt from beneath the third row seat side trim to release the belt.
