**November 3, 2017**

07667 Version 1

## Safety Recall: Right-Side (Passenger) Driveshaft

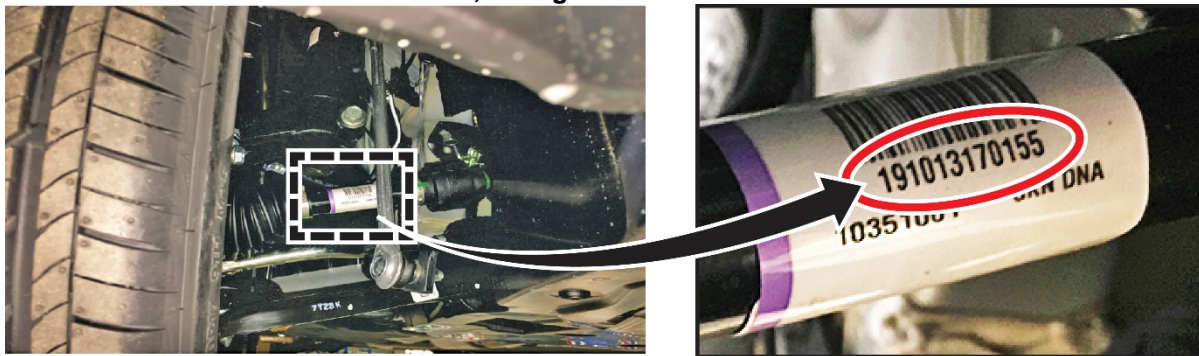
1. Raise the vehicle on a lift.
2. Locate the right (passenger) side driveline label and write down the 12 numbers below the BAR code.

- You will need the serial number to determine if the driveline needs to be replaced, and the warranty clerk will need the serial number to file a claim.
- If you can not read the label or if the label is missing, take a photo of the label or where the label would be and attach it to the RO, then go to the REPAIR PROCEDURE.

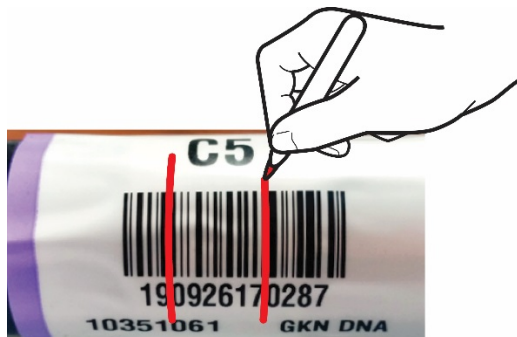
3. Using a permanent marker, divide the serial number as shown below.

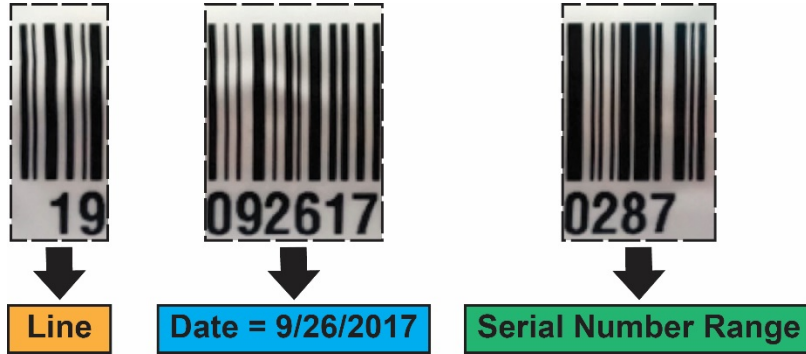
The 12 numbers are broken up into three categories as shown below. The date and serial number range will determine if the driveline needs to be replaced or not.

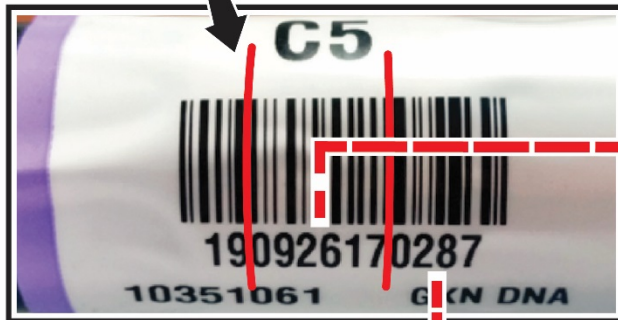
The example below shows how to use the chart to determine if the driveline needs to be replaced.

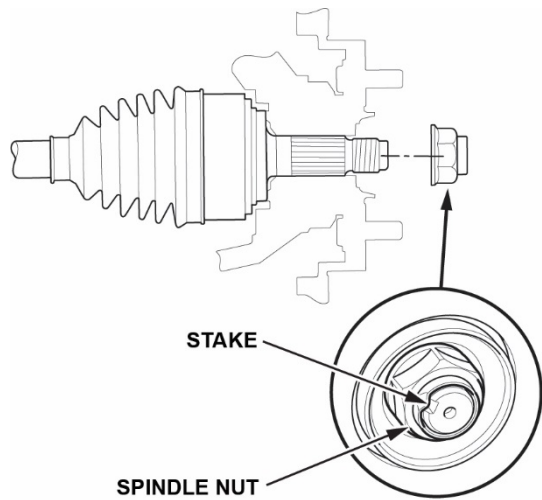
1. Lift the vehicle.
2. Remove the right front wheel.
3. Pry up the stake on the spindle nut, then remove the nut.

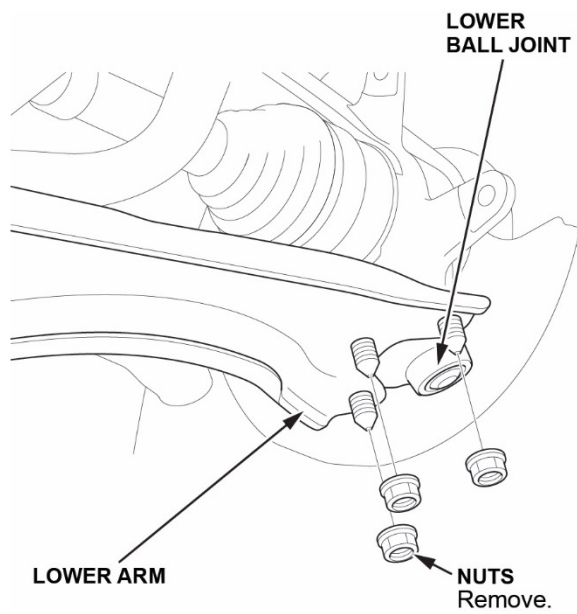
4. Remove the nuts and disconnect the lower ball joint from the lower arm.

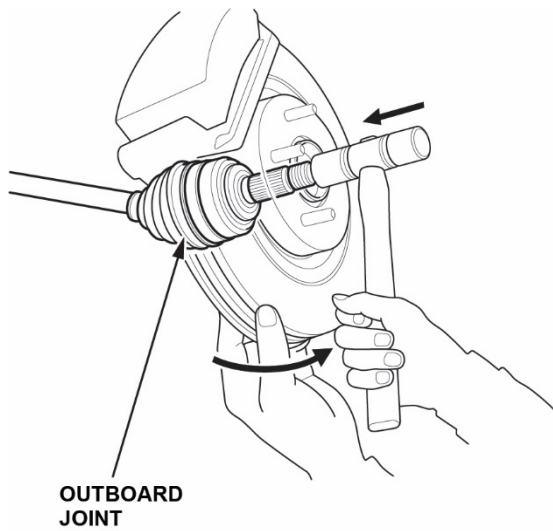
5. Disconnect the outboard joint.

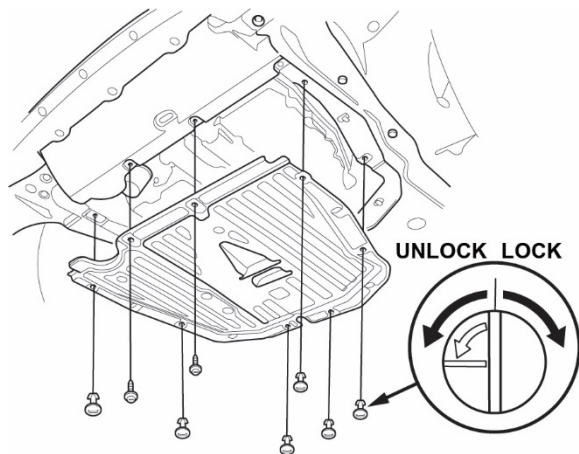
6. Remove the engine undercover plate.

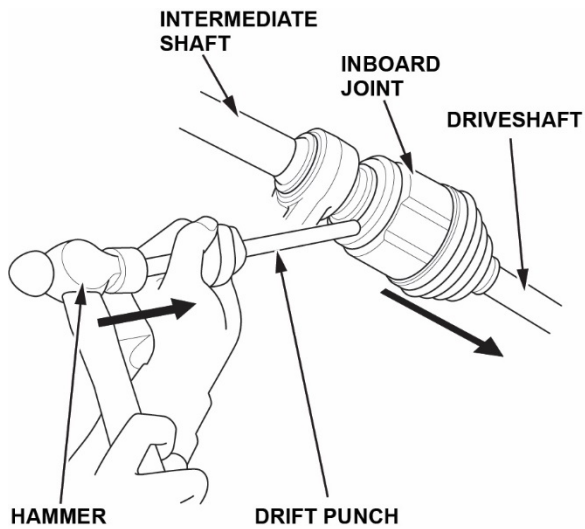
7. Remove the inboard joint off of the intermediate shaft using a drift punch and a hammer.

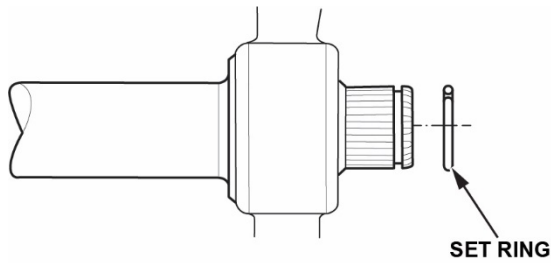
8. Remove the set ring on the intermediate shaft and replace it with a new set ring.

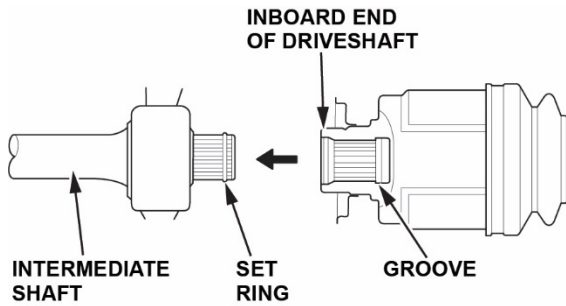
9. Insert the inboard end of the new driveshaft into the intermediate shaft until the set ring locks in the groove.

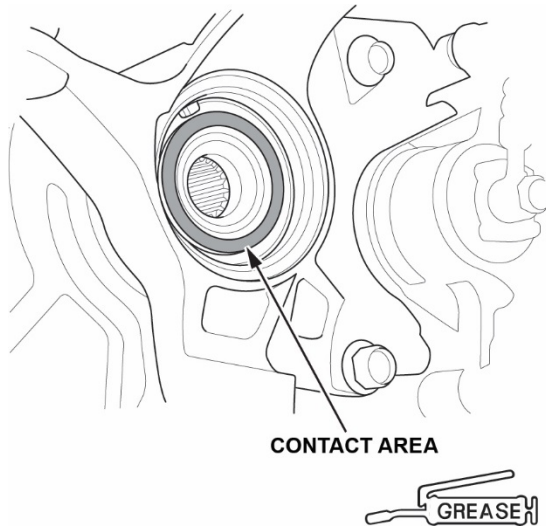
10. Apply about 3 g (0.11 oz) of molly 77 paste (P/N 08798-9010) to the contact area of the outboard joint and front wheel bearing. Then install the outer joint into the hub.

NOTE: The paste helps prevent noise and vibration.

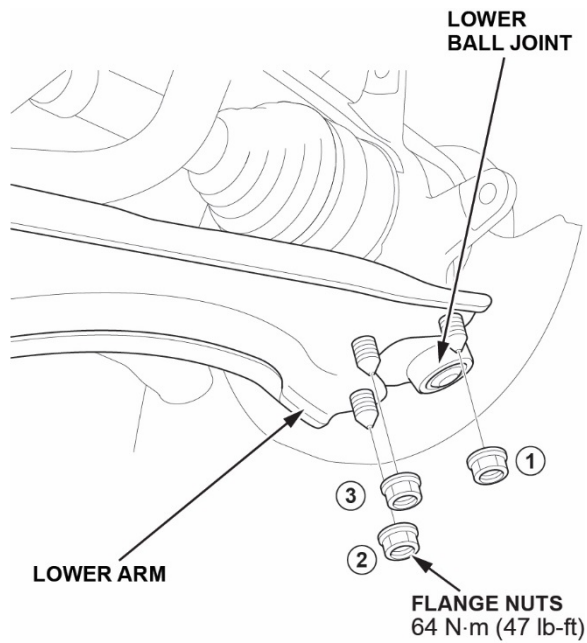
11. Install the lower ball joint to the lower arm with new flange nuts and torque in the sequence shown.

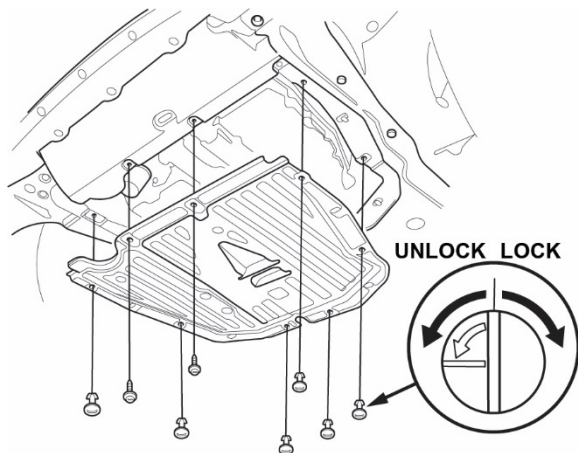
12. Install the engine undercover plate.

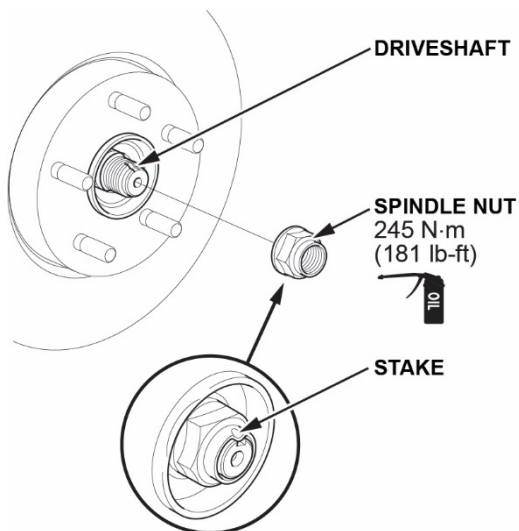
13. Install a new spindle nut and torque it to **245 N·m (181 lbf-ft)**. Use a drift to stake the spindle nut shoulder against the driveshaft.

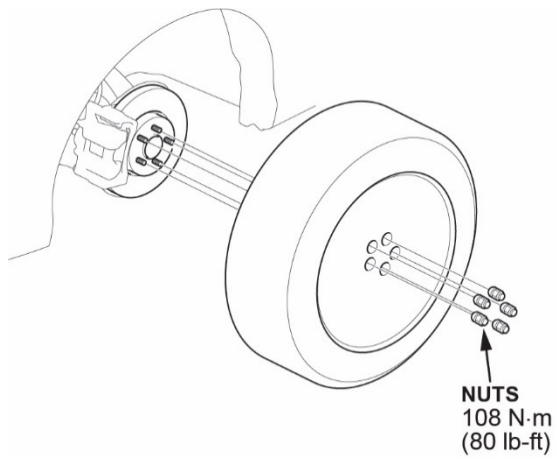
14. Install the right front wheel.
