April 19, 2017

06292 Version 1

Noncompliance Recall: 2017 CR-V Certification Label

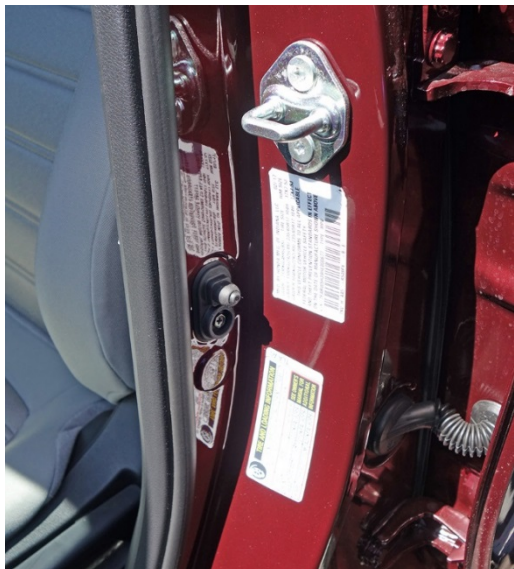
1. Open the driver's door, and locate the certification label.

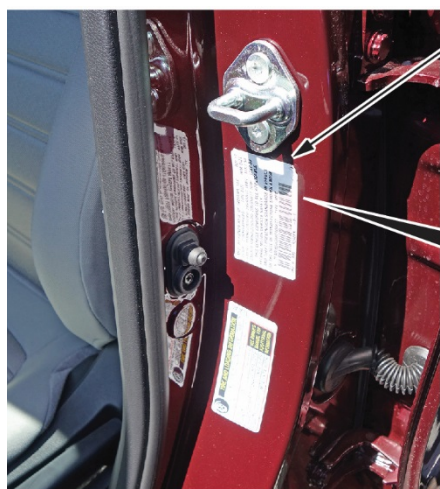
The certification label is located on the driver's side doorjam below the striker.

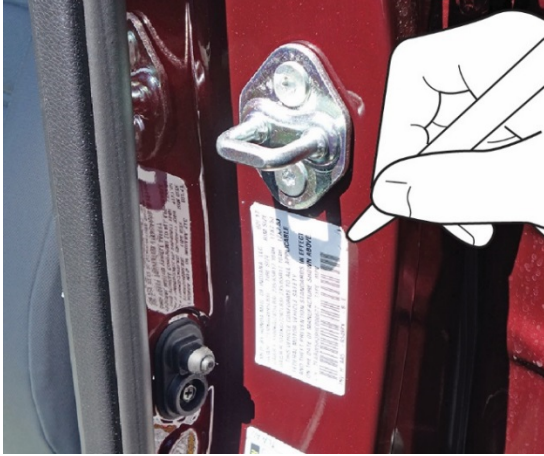
3. Use a plastic tool to remove the label. Be careful not to scratch or damage the paint.

NOTE: Applying heat with a heat gun may make the label easier to remove.

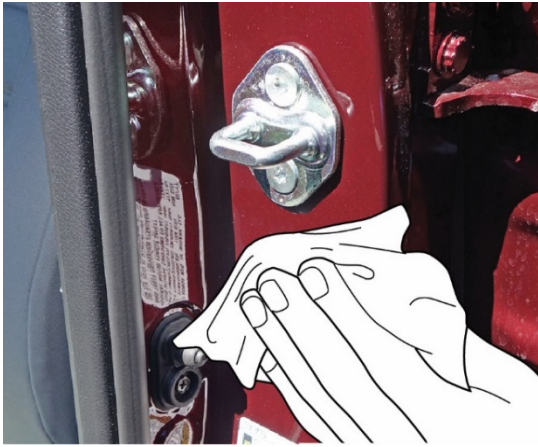
4. After the label is removed, using isopropyl alcohol on a lint free cloth, thoroughly clean the area where the new label will be attached. Make sure there is no residue from the old label, and allow the alcohol to dry.

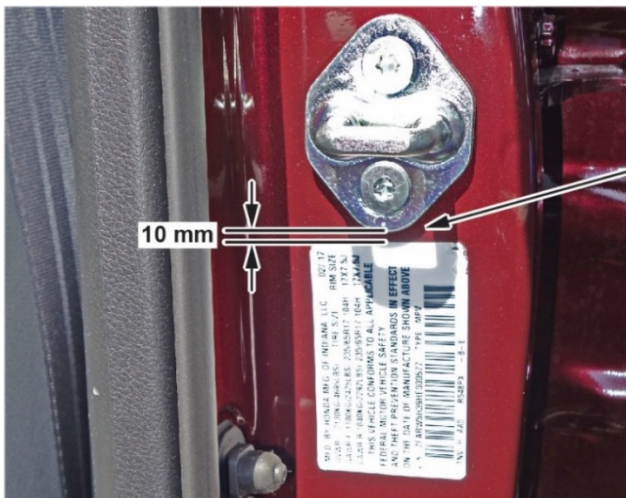
5. Apply the new certification label 10 mm below the striker. Make sure the label is applied in the same orientation as the removed label.

NOTE: Make sure the label is properly applied to the body, and make sure there are no wrinkles, tears, or bubbles on the new label.

Mount the new label
10 mm below the striker.
