June 23, 2017

06923 Version 1

## Non-Compliance Recall: 2018 Odyssey 3<sup>rd</sup> Row Center Seatbelt Tongue

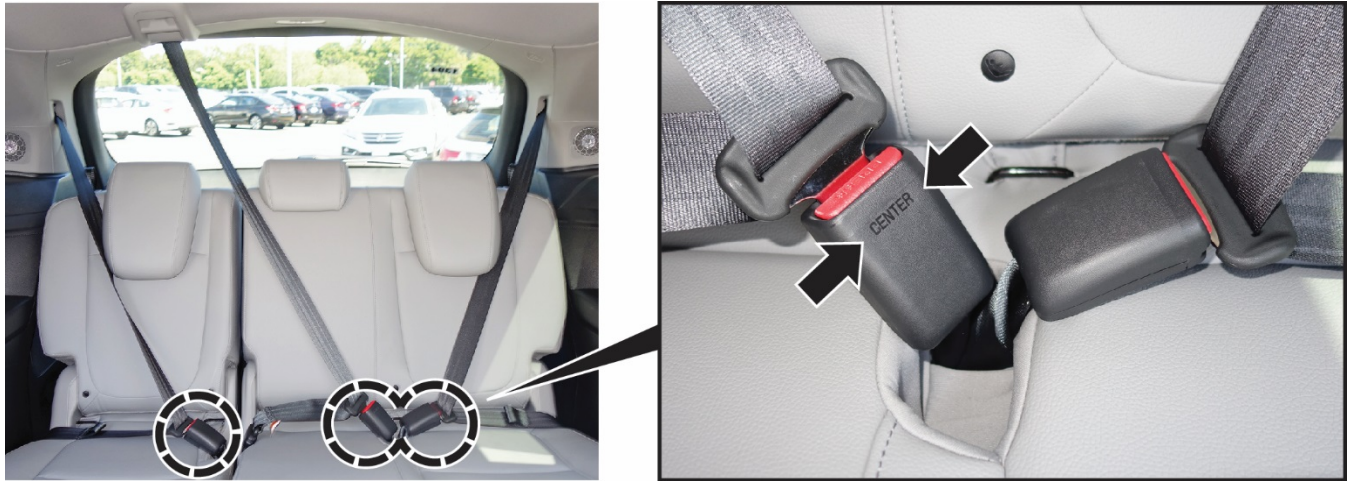
1. Latch all three 3<sup>rd</sup> row seatbelts and confirm they all buckle or latch into their corresponding buckles.

NOTE: The center seat belt buckle is labeled "CENTER".

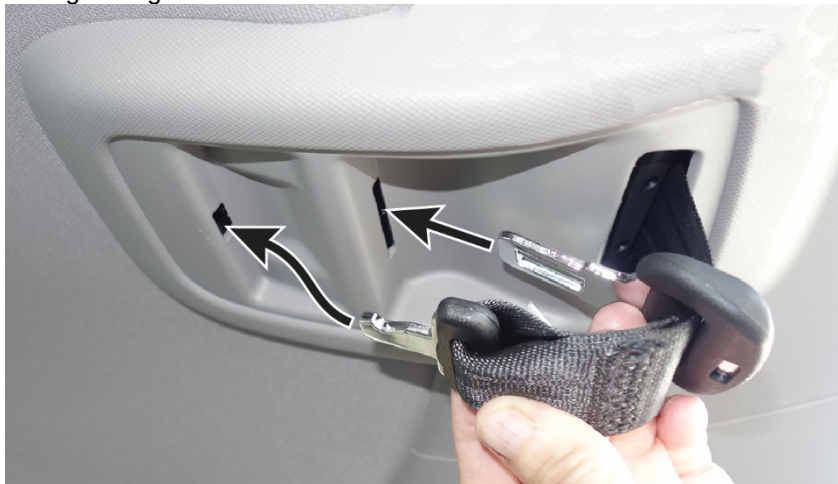
- If the center seatbelt did not latch, go to REPAIR PROCEDURE.
- If all 3 seatbelts latched securely, the vehicle is OK. Unlatch the seatbelts and reinstall the center seatbelt in the ceiling storage slots.

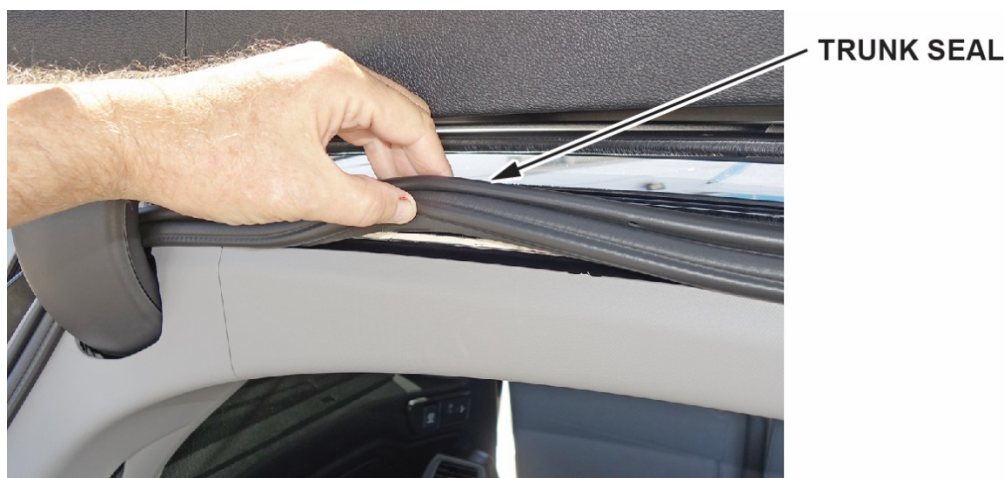
1. Partially remove the trunk seal above the rear hatch opening.

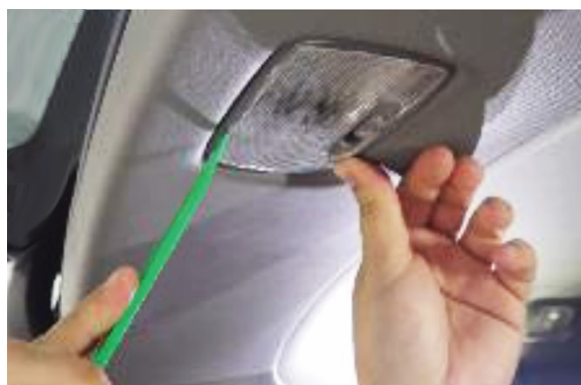
2. Remove the cargo light lens.

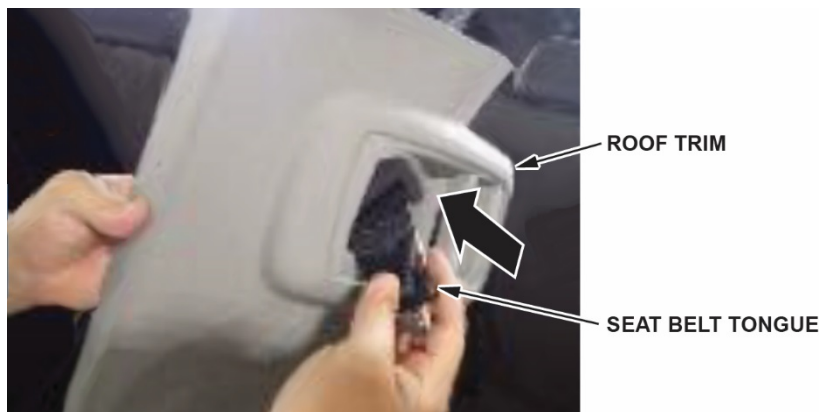
5. Push the tongue and anchor through the roof trim.

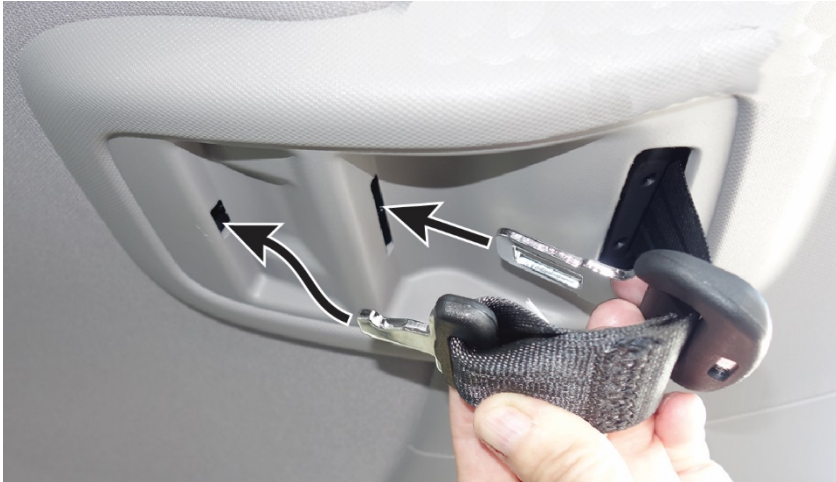
8. Remove the seatbelt retractor.
9. Install a new seatbelt retractor, torque the bolts to **39 N·m (29 lb-ft)**.
10. Confirm the center seatbelt securely latches into the center buckle.
11. Install all removed parts in reverse order of removal.
12. Unlatch the seatbelts and reinstall the center seatbelt in the ceiling storage slots.
