To All Lamborghini Dealers and Licensed Service Point
From Customer Service Department
Subject CCB Fasteners Replacement.
Group 6.15.00
Date 04th/10/2013
Pages 17

CCB Fasteners Replacement.

All Lamborghini Murcièlago Coupe; Roadster and Reventon MY06,07,08,09 and 10 from VIN 6LA01713 to ALA04099.

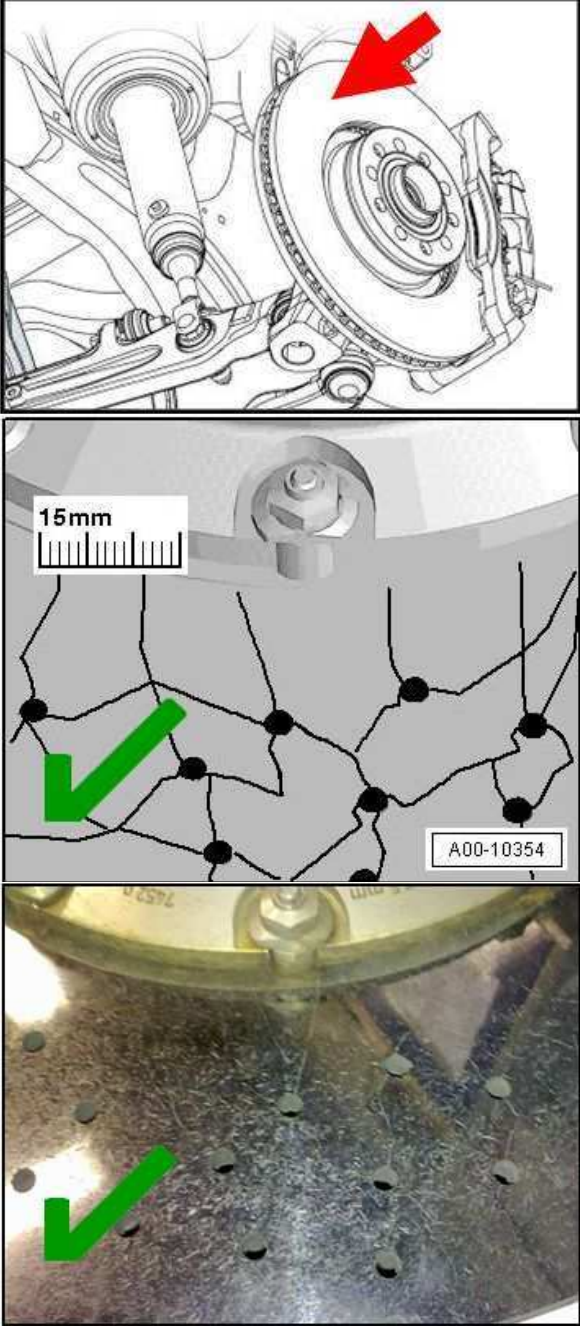
Outside surface of brake disc

<p>3</p>	<p>Due to the production process, relaxation cracks already exist on the friction surface of the brake disc when it is new. These cracks can vary in size and can occur on both sides of the disc.</p> <p>

</p> <p>Relaxation cracks on a ceramic brake disc do not constitute a technical problem.</p>

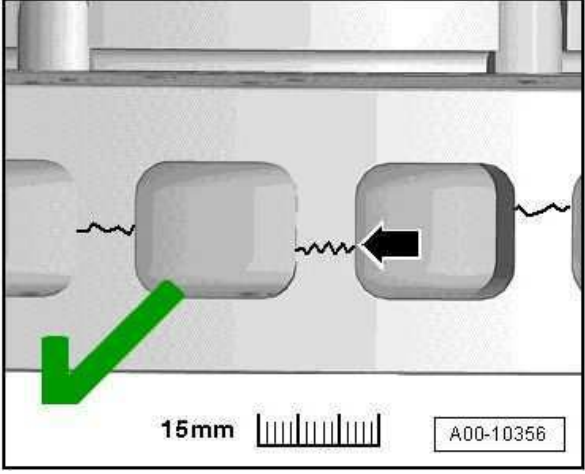
<p>4</p>	<p>Cracks in the cooling channel lands -arrow- are caused during manufacture.</p> <p>

</p> <p>Cracks in the cooling channel lands do not constitute a technical problem.</p>

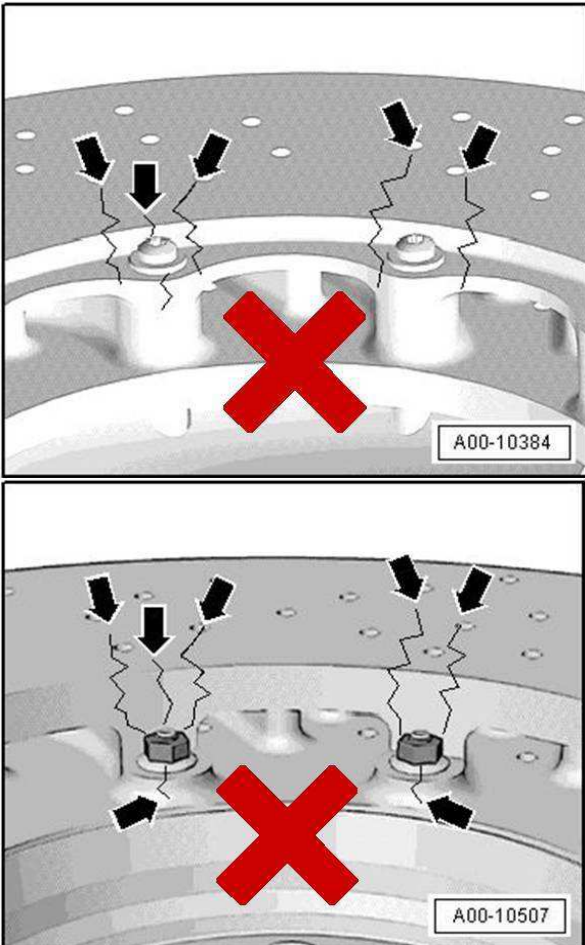
A. Inside surface of brake disc:

<p>5</p>	<p>Ceramic brake discs must be replaced if there are cracks in the vicinity of the bolted connection on the inside of the brake disc hub extending into the friction surface of the disc (arrows).</p> <p>Ceramic brake discs must be replaced if there are radial cracks in the area of the bolted connection on the brake disc hub.</p>

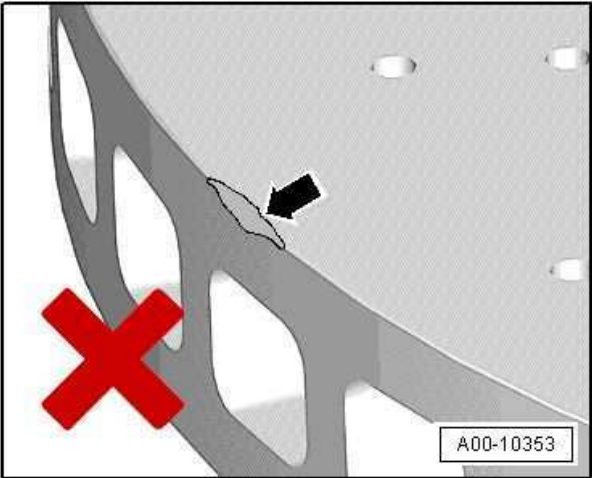
<p>6</p>	<p>Edge fractures -arrow- are caused by mechanical damage to the edges of the disc.</p> <p>Permissible damage:</p> <ul style="list-style-type: none"> • Max. width / depth = 2 mm • Max. length = 10 mm • Max. 3 edge fractures per brake disc <p>If any of the criteria listed above are exceeded, the brake disc must be replaced.</p> <p><u>File a Quick claim before replacing.</u></p>

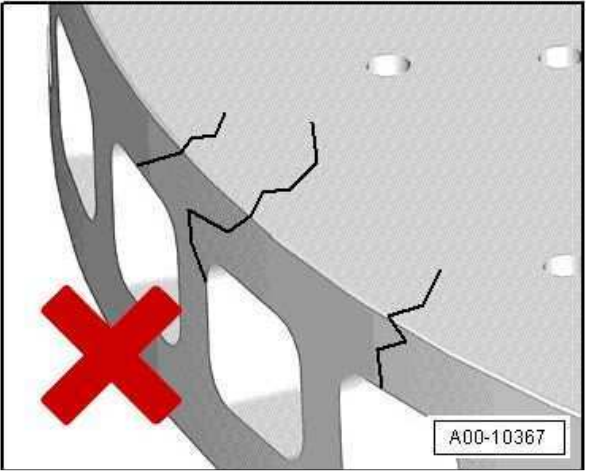
<p>7</p>	<p>Ceramic brake discs with cracking extending from the friction surface of the disc to the cooling channel or through the cooling channel must be replaced.</p> <p><u>File a Quick claim before replacing.</u></p>

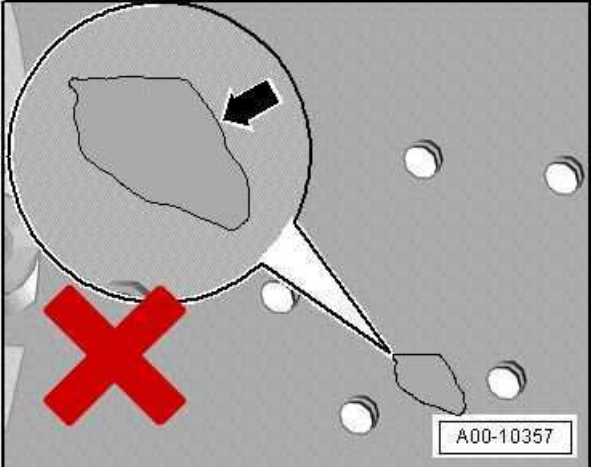
8	<p>Ceramic brake discs with chipping larger than 1 cm² at any one point -arrow- on the friction surface must be replaced.</p> <p><u>File a Quick claim before replacing.</u></p>

<p>The diagram shows a grey brake disc with several circular holes. A large red 'X' is overlaid on the disc. A magnifying glass is positioned over a large, irregular chip on the disc's surface. An arrow points to the chip. A small label in the bottom right corner of the magnified area reads 'A00-10357'.</p>
---	---	---

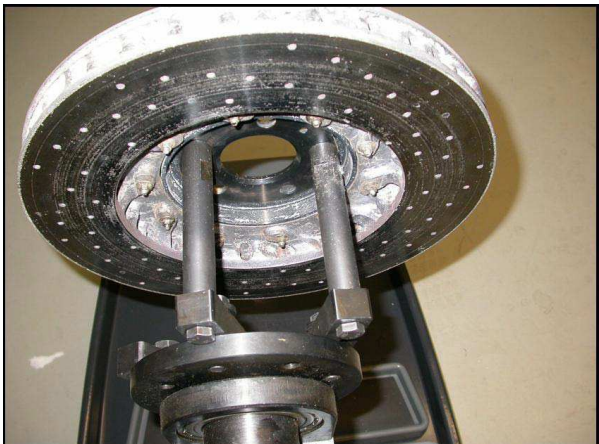
9	<p>After removal, attach the ceramic brake disc either directly to the engine and gearbox support (P/N 69195227) and universal adaptor (P/N 69195257).</p>

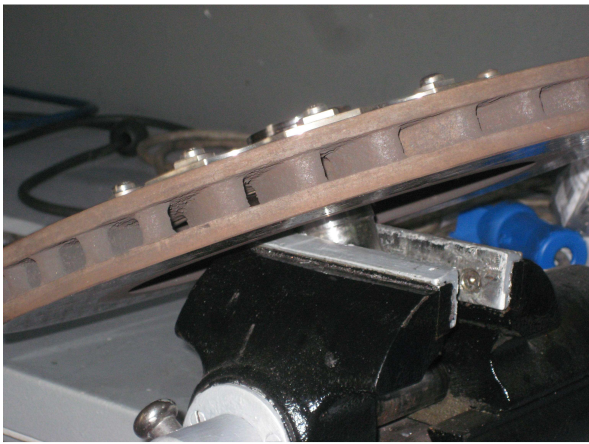
1	<p>After removal and inspection, attach the ceramic brake to the special tool (P/N 63153000044) as described in the 2 following steps.</p>

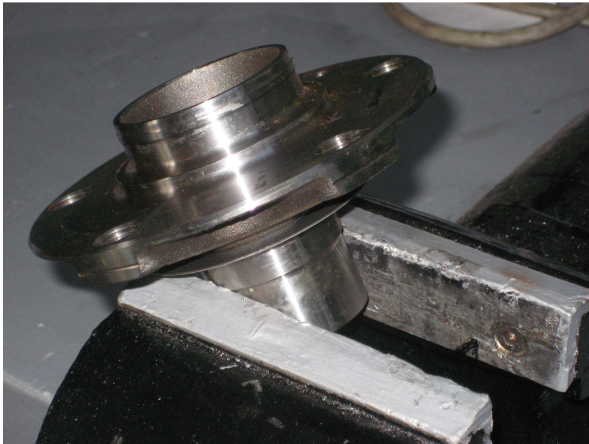
2	<p>Secure the special tool (P/N 63153000044) in a vice.</p>

<p>It is recommended to produce flats on the hub to improve stability in the vice jaws.</p>

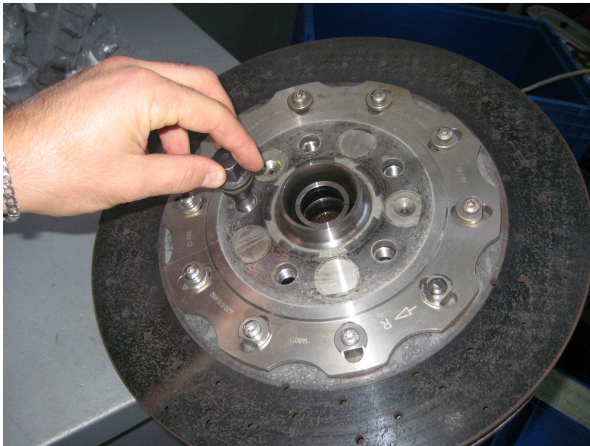
<p>3</p>	<p>Mount the disc onto the hub using bolts to lock the hub with bolt to enable the controlled tightening of the new fasteners.</p>

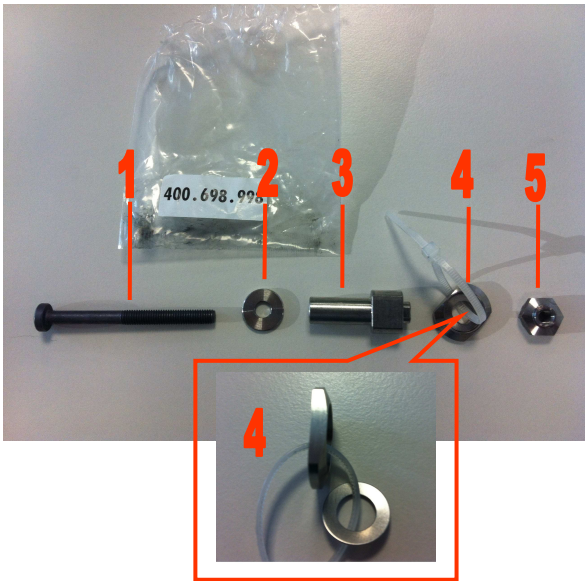
Front and rear axle

<p>10</p>	<ol style="list-style-type: none"> 1. Bolt 2. Washer 3. Sleeve 4. Retaining washer with dished pressure springs (held together with cable tie) 5. Nut. <div data-bbox="260 1205 333 1276" data-label="Image">

</div> <p>Do not open cable tie until parts have been fitted.</p>

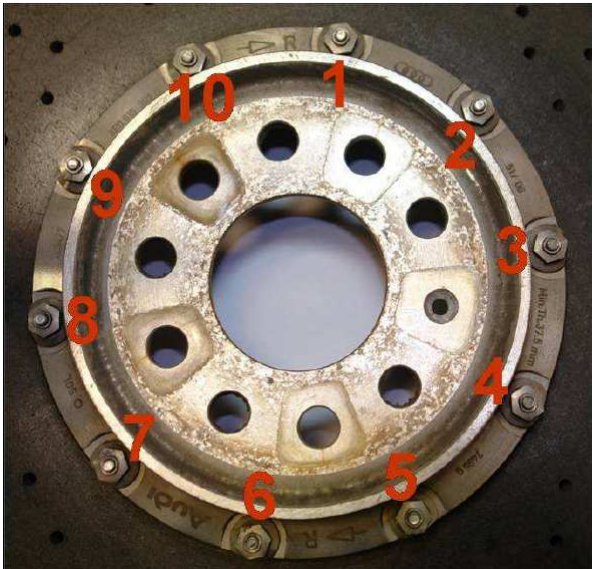
11	<p>Replace fasteners 1...10.</p> <p>

</p> <p>Replace the fasteners one after the other. <u>Do not loosen and replace more than one fastener at a time.</u></p>

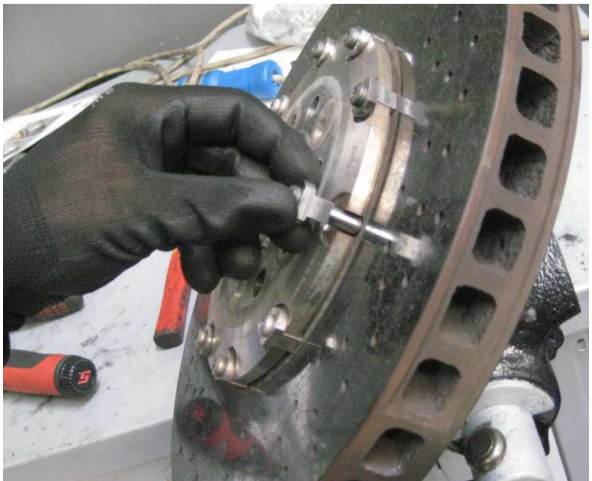
12	Remove one fastener.	
13	Fit sleeve (3) from outside.

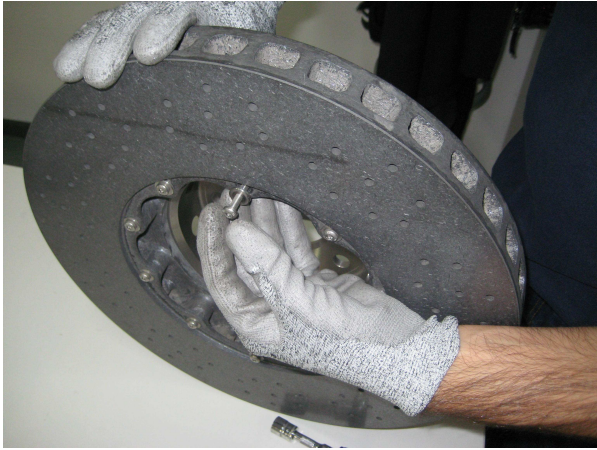
<p>14</p>	<p>Fit the Bolt (1) and Washer (2)</p>

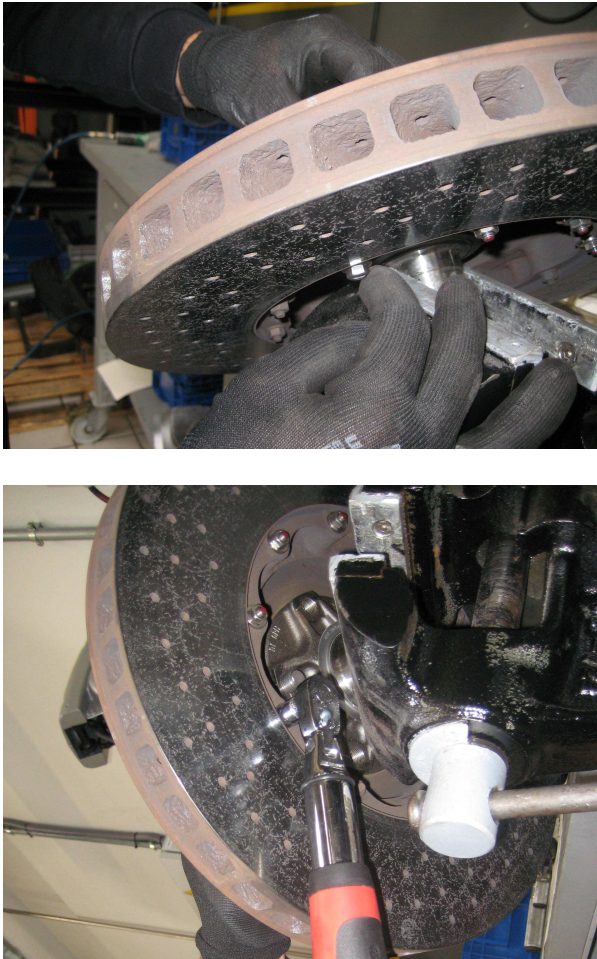
<p>15</p>	<p>Tighten bolt (1) with washer (2). Tightening torque: 4 Nm</p>

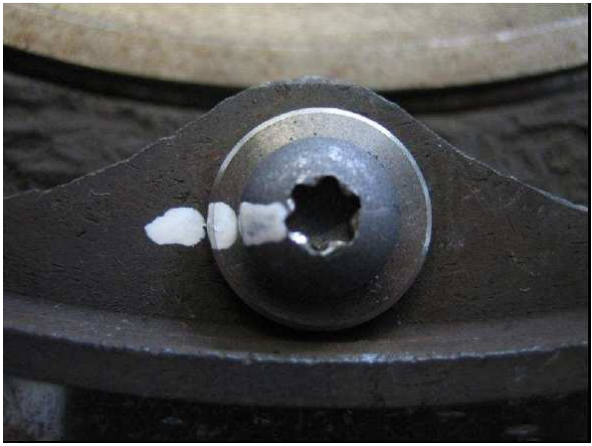
16	Mark bolt.

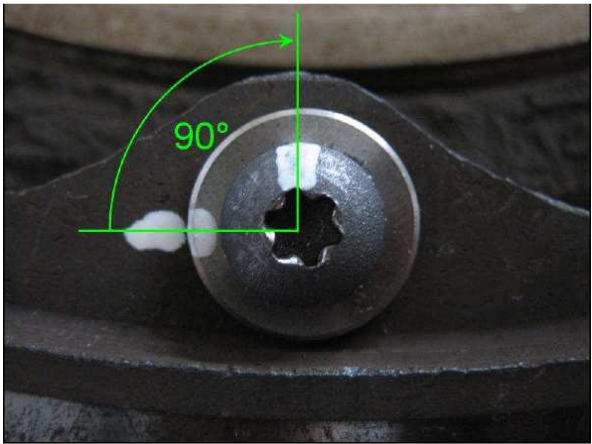
17	Turn bolt 90° further (1/4 turn) .

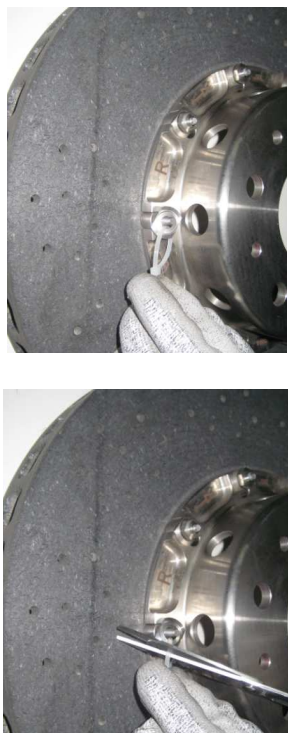
18	Fit the sleeve retaining washer with dished pressure springs (4) and then (but not before) cut open cable tie.

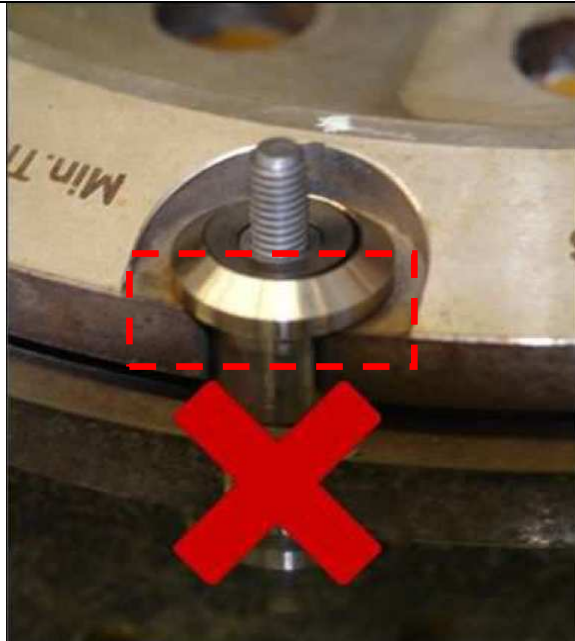
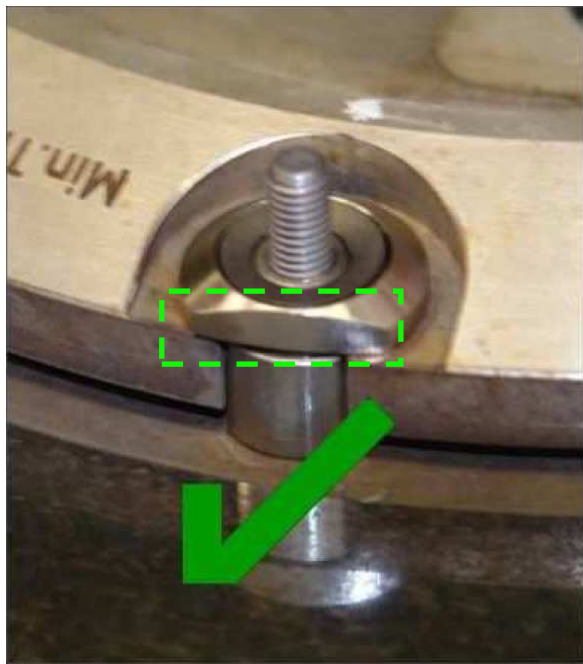
- 19** Make sure that the retaining washer is fitted in the correct position, as shown in illustration.

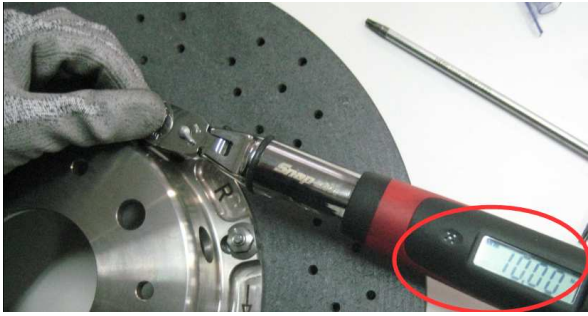
20	<p>Counterhold bolt (5) and tighten nut.</p> <p>Tightening torque: 10 Nm</p>

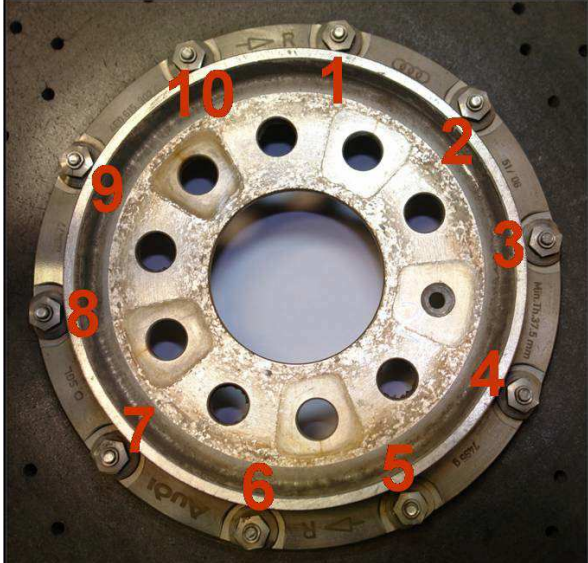
21	<p>

</p> <p>Replace the fasteners one after the other. Do not loosen and replace more than one fastener at a time!</p>
