16019 HVAC Module Temp Door

Reference Number: N16202805 Release Date: October 2016

Condition	Certain 2015-2016 model year Chevrolet Colorado and 2015-2016 model year GMC Canyon vehicles,
	may have a condition in which a crack in the heating and cooling module temperature door control shaft may form and result in inconsistent air discharge temperature control. If the shaft cracks, the air discharge temperature may be up to 33 degrees Fahrenheit (20 degrees Celsius) cooler than the requested values, depending on the HVAC mode selected.
Correction	Inspect the temperature valve control shaft for cracks. If the shaft is intact, install a reinforcing clamp around the temperature valve shaft to prevent the shaft from cracking. If more than one crack is present, replace the temperature control valve.

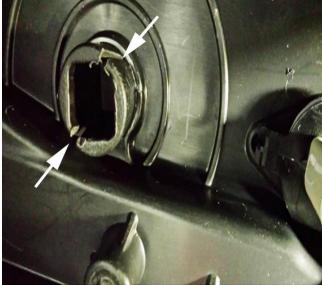
4585850

- 2. Inspect the temperature valve drive for cracks.
 - If the temperature valve does not have any damage or is cracked in only one place, proceed to steps 3-4 and 6.

• If the temperature valve is cracked in more than one place or has a piece missing, proceed to step 5.

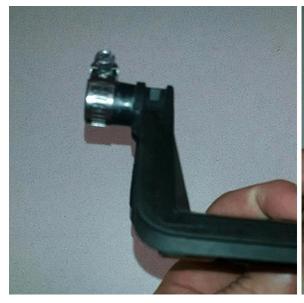
4585852

Note: It is not necessary to remove the temperature valve to add the clamp. Temperature valve removed for illustrative purposes only.

- 3. Install a #4 hose clamp over the temperature valve shaft as shown above.
- 4. Install the temperature valve actuator. Refer to Temperature Valve Actuator Replacement in SI.

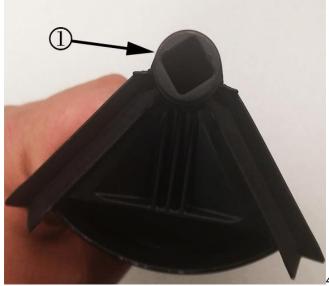
4585855

• If the replacement temperature valve has a square drive (1), a #4 clamp must be installed as shown in step 3 above to ensure this condition does not occur on the replacement temperature valve.

5. Replace the temperature valve. Refer to Temperature Valve Replacement in SI.

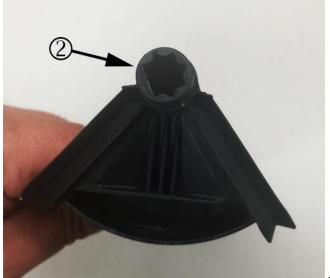
4585859

Note: A #4 hose clamp is NOT required with the star-D drive temperature valve.

• If the replacement temperature valve has a star D drive (2), the temperature valve actuator must also be replaced.
