SUBJECT: **Customer Satisfaction Program 19N06**
 Certain 2018-2019 Model Year F-150-F-550 Vehicles
 Door Latch Freezing Concerns

CERTAIN 2018-2019 MODEL YEAR F-150-F-550 VEHICLES — DOOR LATCH FREEZING CONCERNS

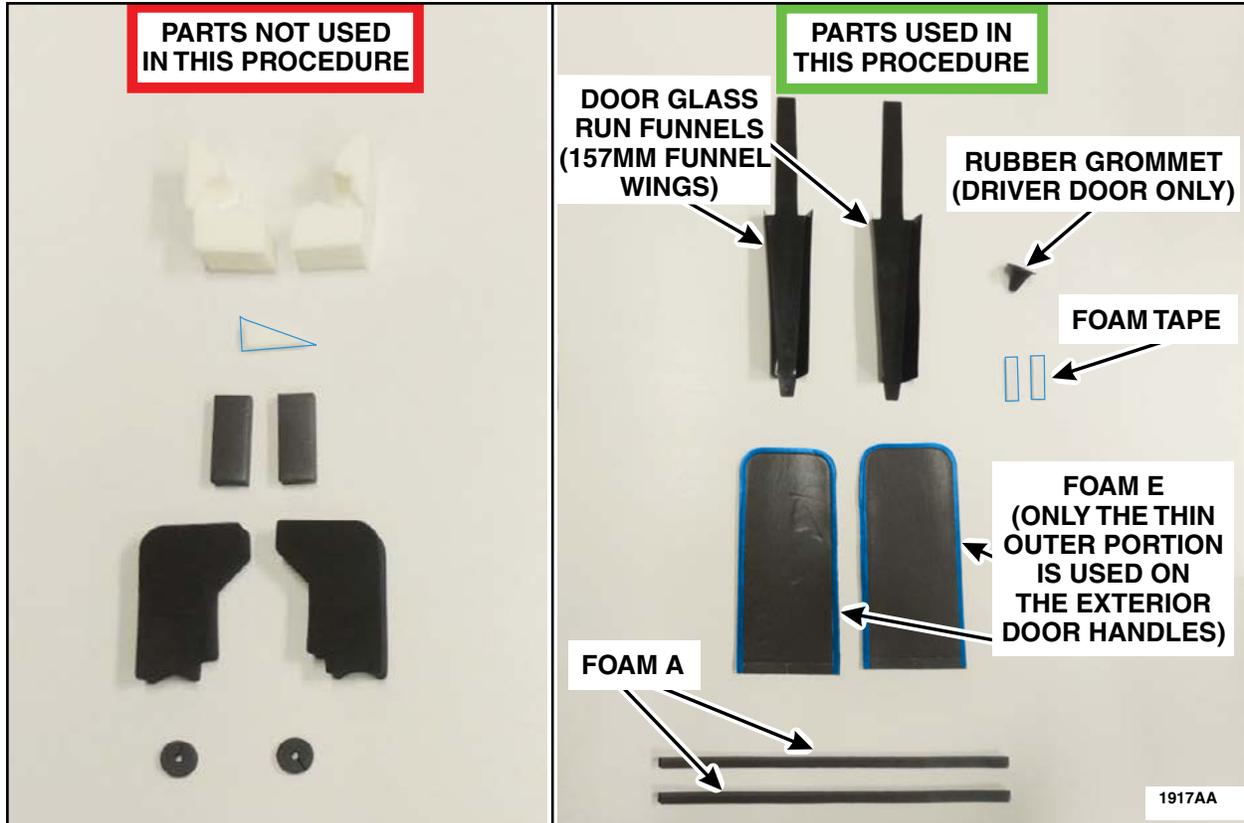
FIGURE 1

Complete Front Door Part Kit

NOTE: The parts being installed in this procedure are not labeled. Refer to Figure 1 for component identification.

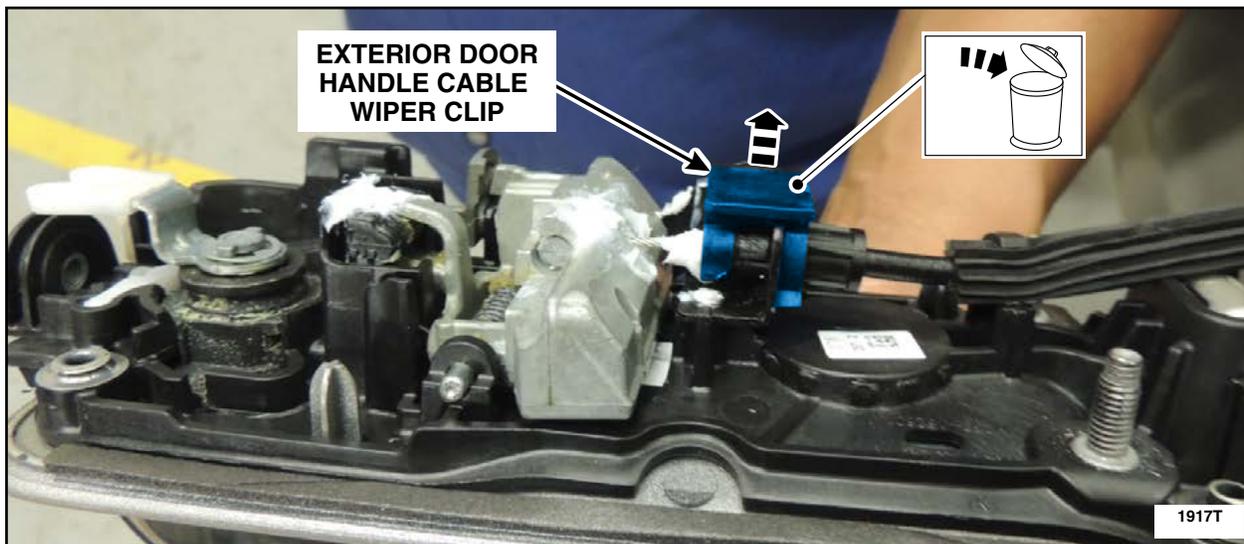
FIGURE 2

NOTE: Front passenger door shown, all doors similar.

2. If a cable wiper clip is present on the exterior door handle cable end, remove and discard the cable wiper clip. See Figure 2.

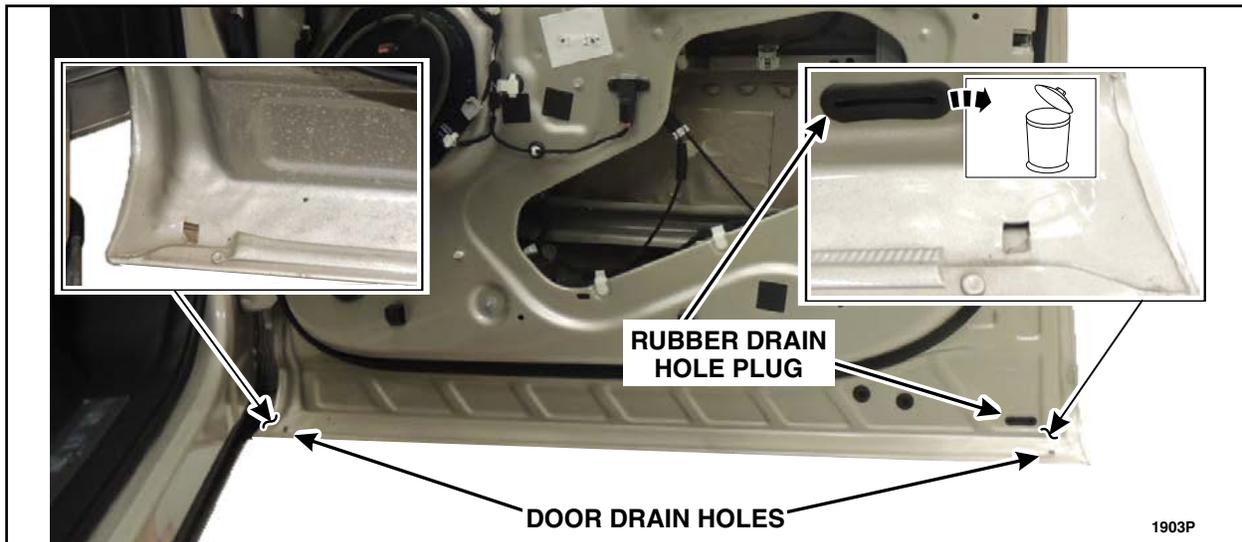
FIGURE 6

NOTE: Front passenger door shown, all doors similar.

6. Reassemble and reinstall the front door latch. Complete by reversing Step 4 (above). Please follow the WSM procedures in Section 501-14. Then proceed to Step 7.
7. Remove and discard the rubber drain plug and clean any obstructions, debris, foreign material and residual water from all of the door drain holes using compressed air and a tool such as a plastic trim tool or a zip tie. See Figure 6.

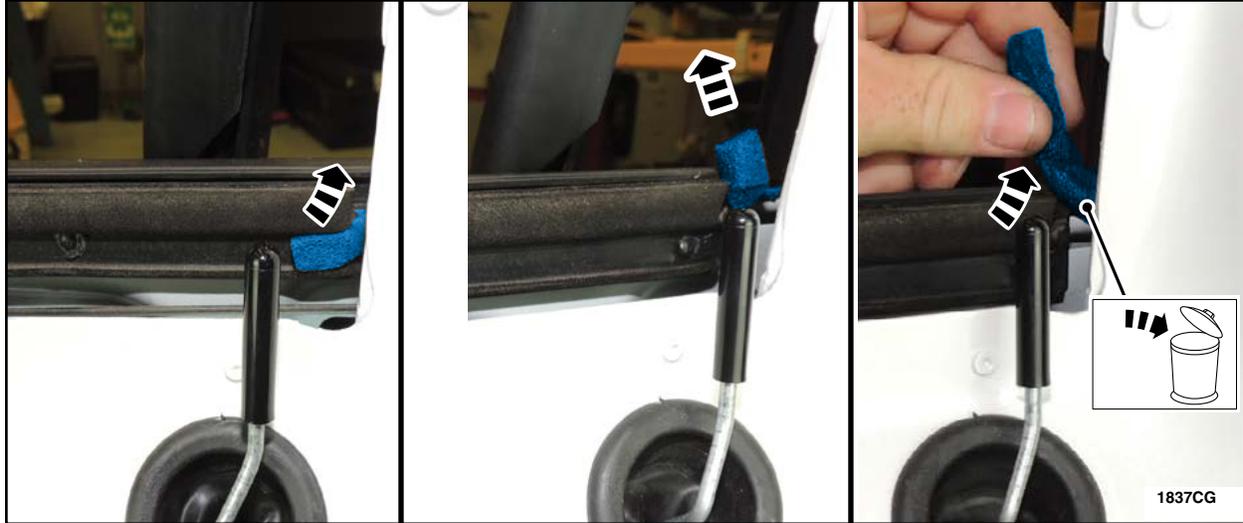
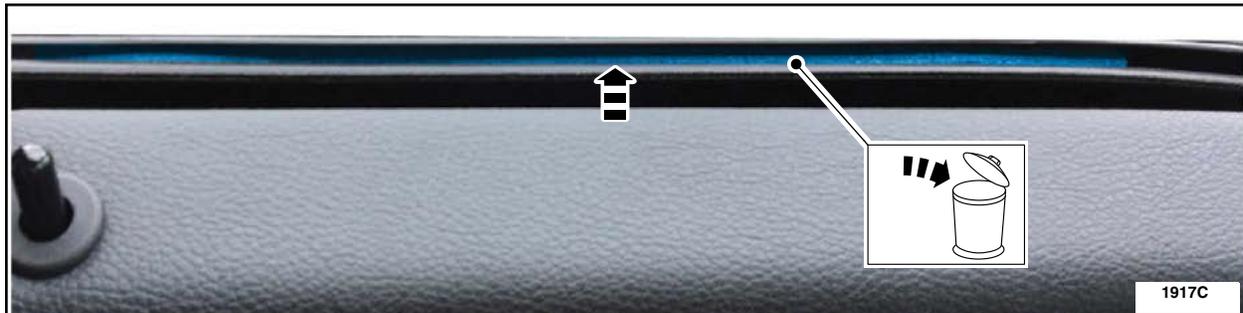
NOTE: Passenger door shown, driver door similar.

11. If present, remove and discard the two pieces of foam on the driver and passenger side outer belt moulding (also known as upper belt moulding) as shown in Figures 9 and 10.

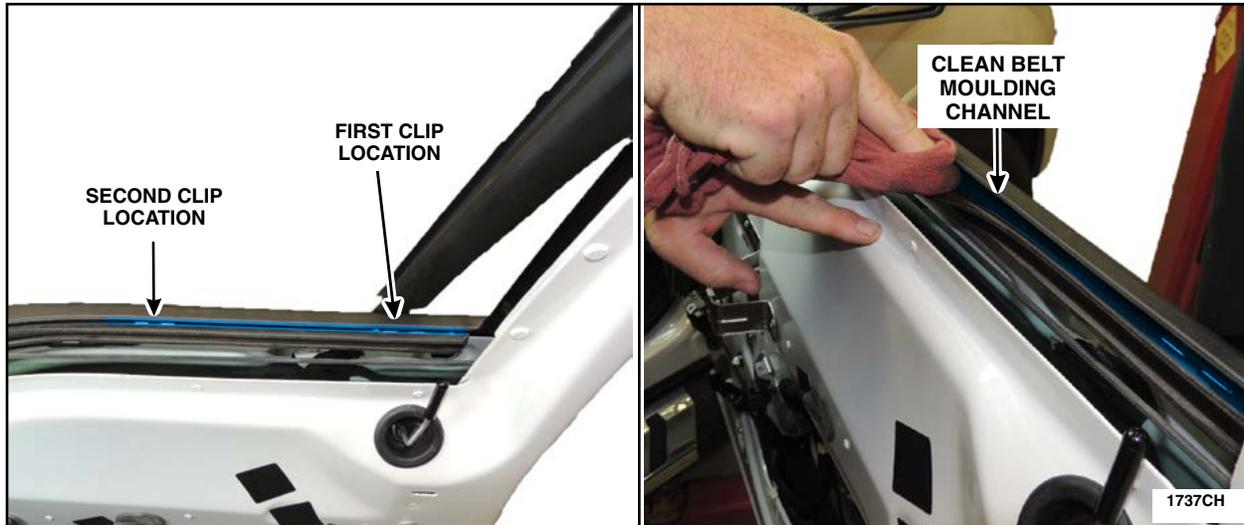
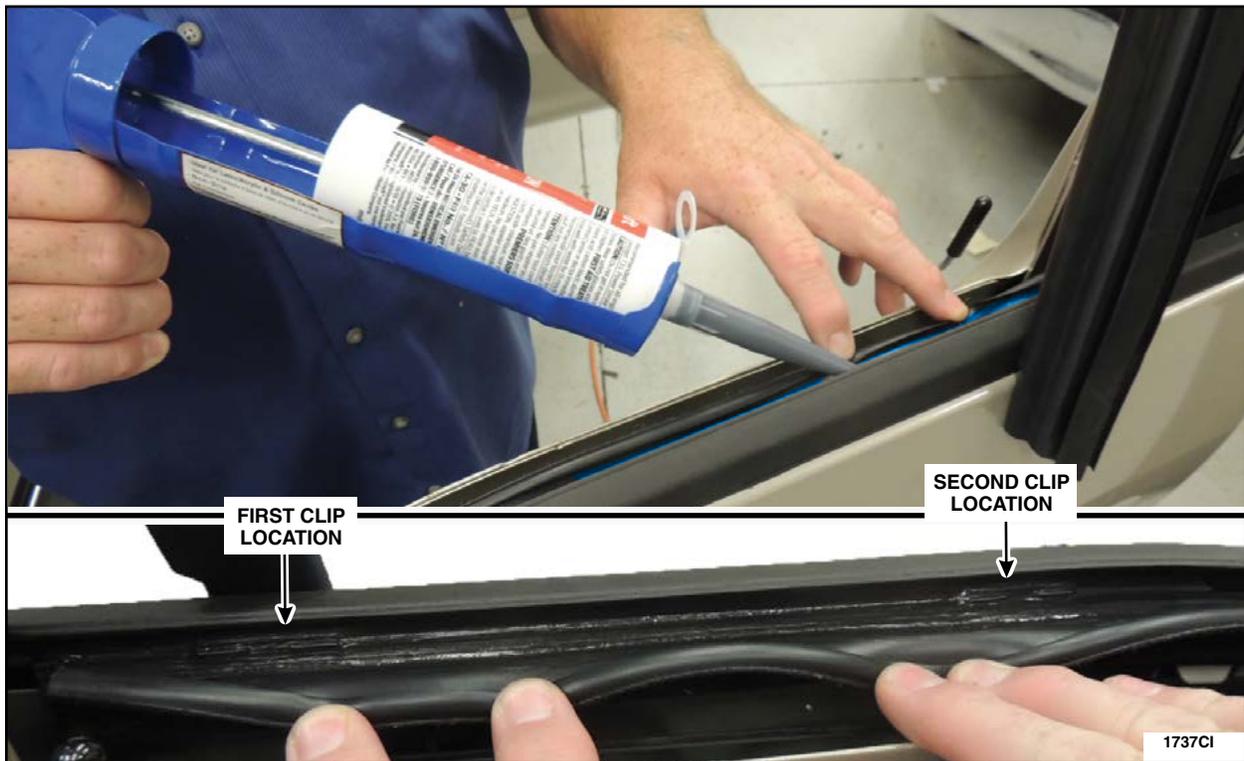
NOTE: A proper seal around the belt moulding clips shown in Figures 11 and 12 is crucial.

13. Apply a small bead of Motorcraft® TA-30 silicone sealant onto the highlighted area of the outer belt moulding, ensuring the two belt moulding clips shown in Figures 11 and 12 are completely covered. Using your finger, smooth out the sealant to establish an even surface. See Figure 12.

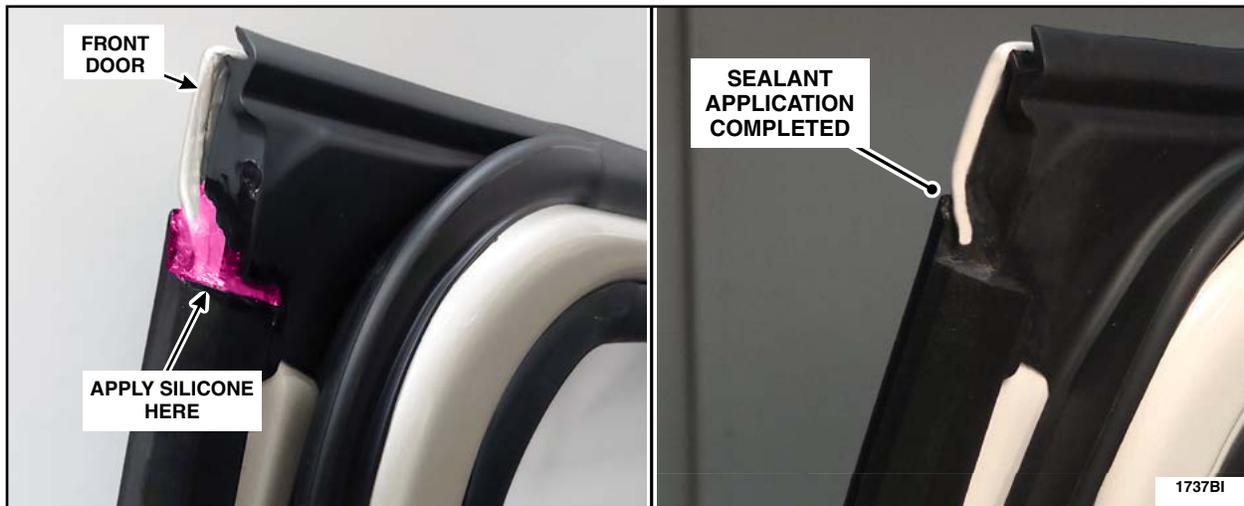
FIGURE 17

20. Using a clean shop towel and isopropyl alcohol clean the top portion of the door and neatly apply Motorcraft® TA-30 silicone sealant to the indicated/highlighted area in order to completely fill the gap as shown in Figure 17.

NOTE: Proper application of the sealant is crucial to properly water seal the door and also avoid appearance concerns.

NOTE: Top of driver front door shown, passenger front door similar.

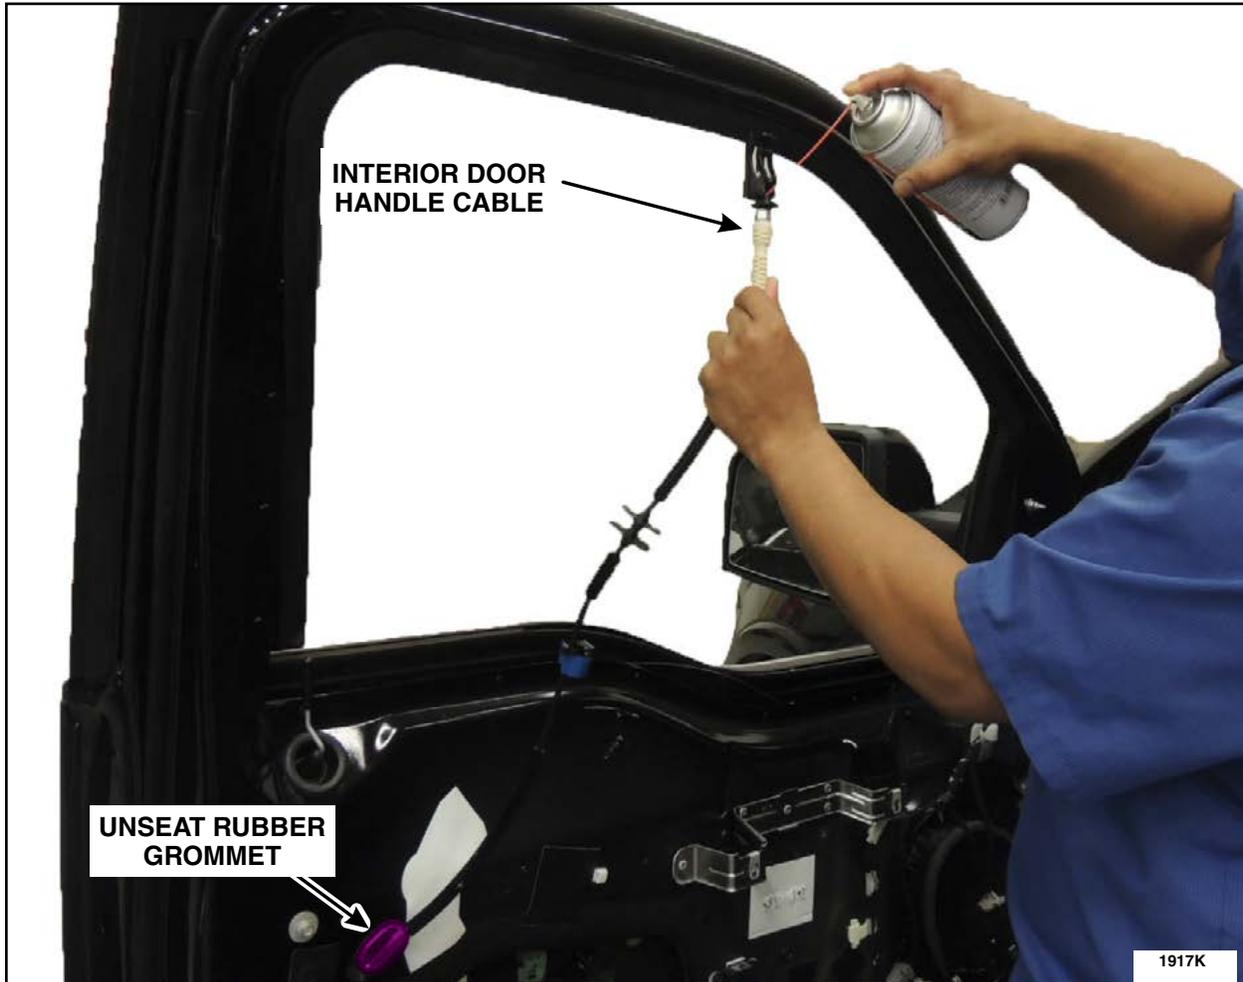
FIGURE 19

NOTE: If the Motorcraft® XL-6 lubricant container is not equipped with an applicator nozzle that can accommodate a straw, swap the applicator nozzle from another Motorcraft® chemical such as: XL-5 Multi-Purpose Grease Spray, XL-5-A Multi-Purpose Grease Spray or ZC-30-A Silicone Gasket Remover so a straw can be used. Spray a small amount to clear the applicator nozzle and straw prior to spraying the cable.

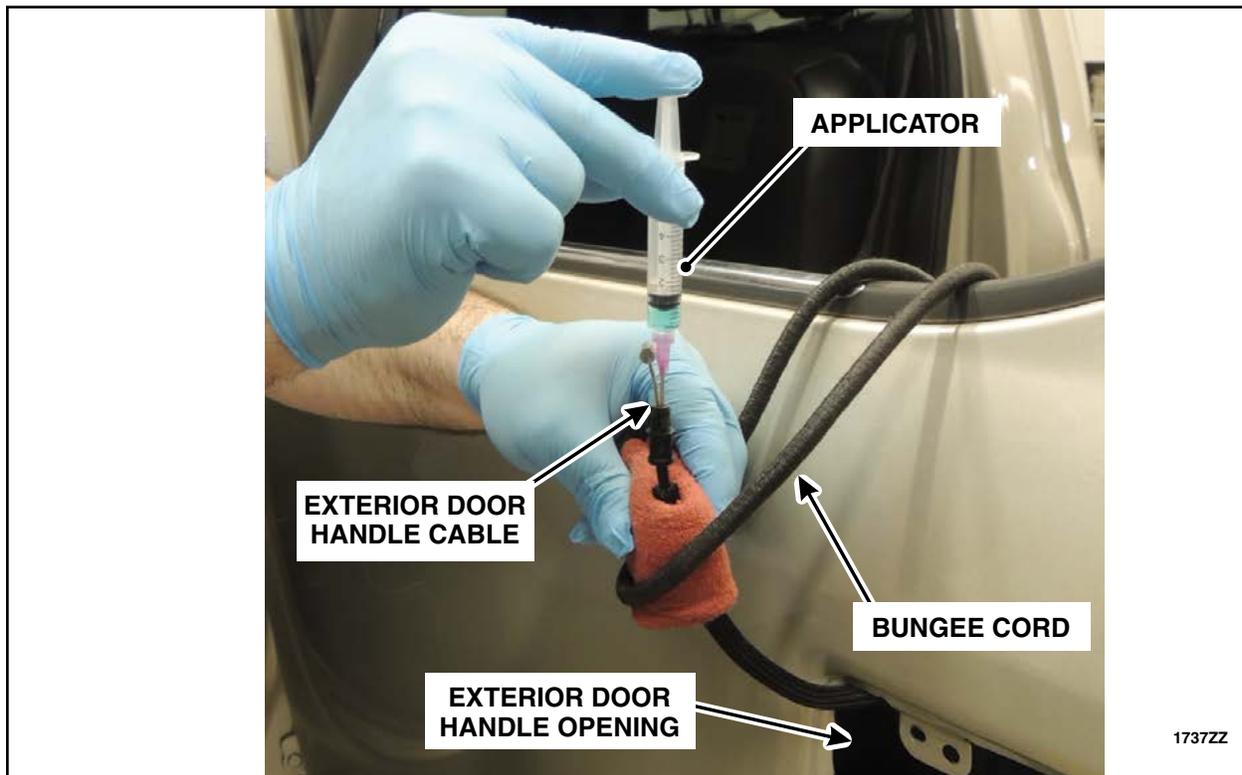
FIGURE 21

NOTE: Rear door shown, front door similar.

25. Towel dry the exterior door handle cable to absorb any residual moisture. Using a bungee cord or other similar device secure the exterior door handle cable to the door in an upward position as shown in Figure 21, to allow the undiluted Motorcraft® Premium Windshield Wash Concentrate (ZC-32-B2) or a 99 percent methyl hydrate (methanol) product time to run down into the cable, until the exterior door handle cable is reinstalled later in this procedure.

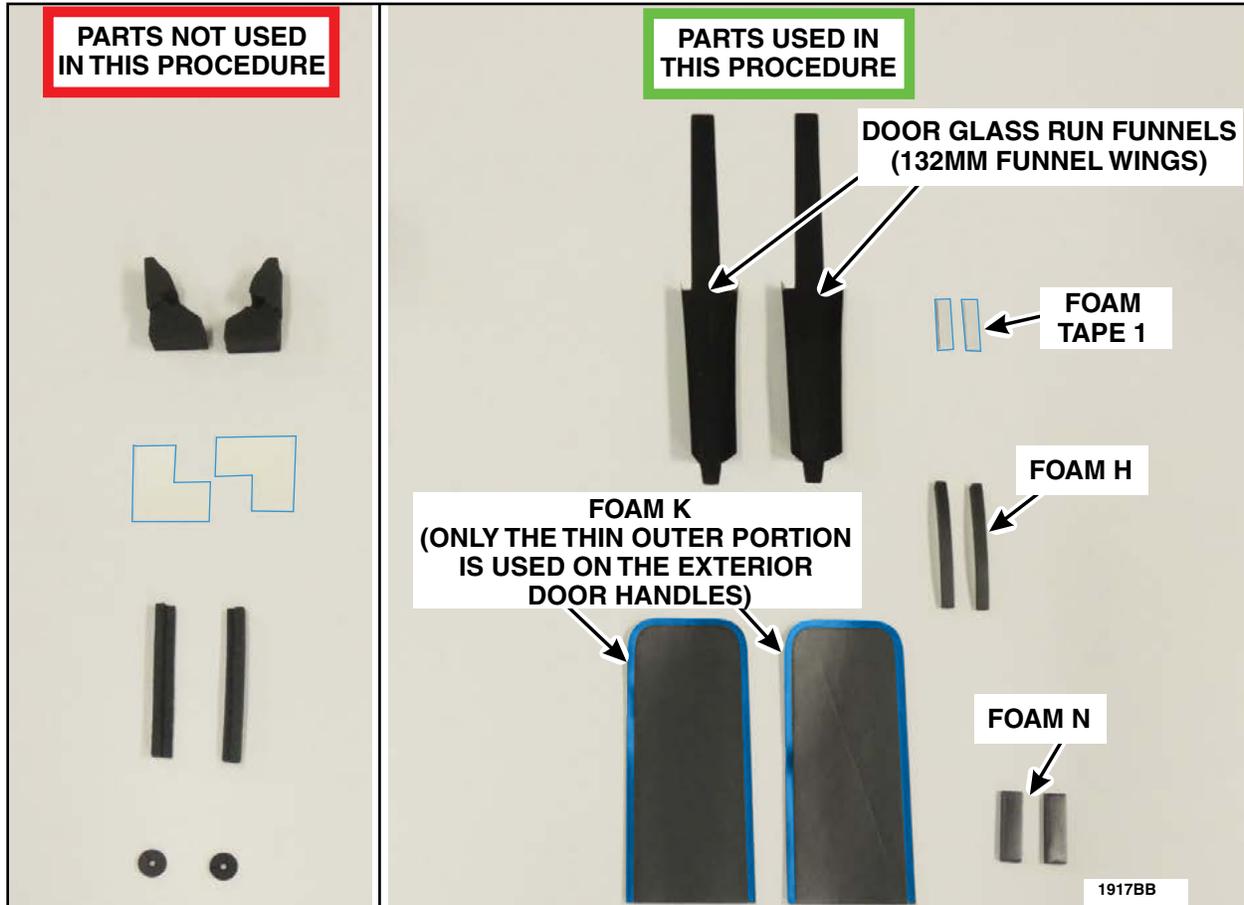
FIGURE 32

Complete Rear Door Part Kit

NOTE: Not all the parts in the kit will be used

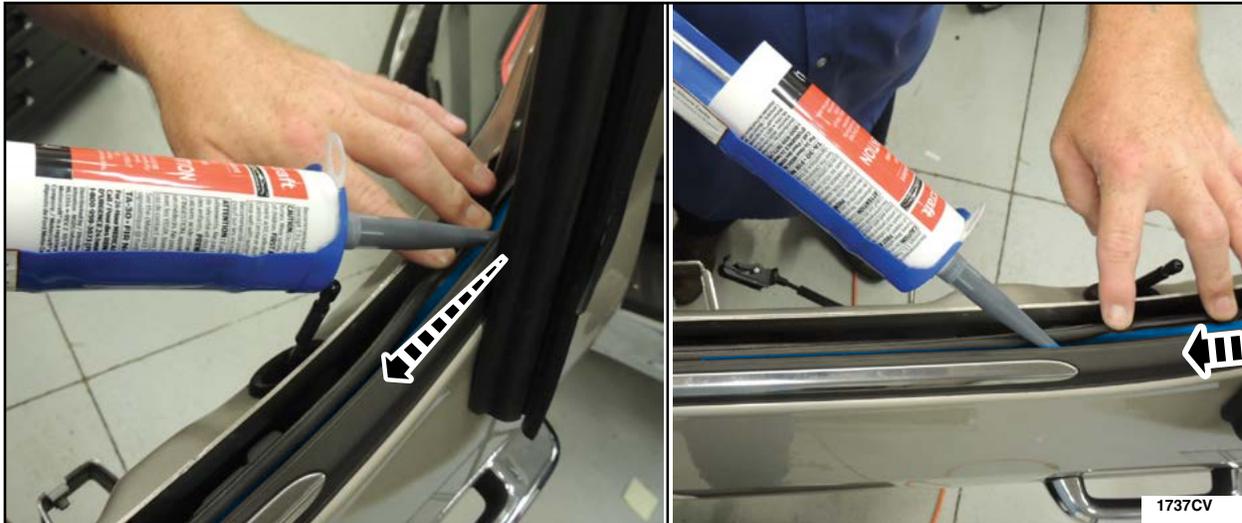
FIGURE 42

13. Apply a small bead of Motorcraft® TA-30 silicone sealant onto the highlighted area of the outer belt moulding, ensuring the two belt moulding clips shown in Figures 42 and 43 are completely covered. Using your finger, smooth out the sealant to establish an even surface. See Figures 42 and 43.

NOTE: A proper seal around the belt moulding clips shown in Figure 42 is crucial.

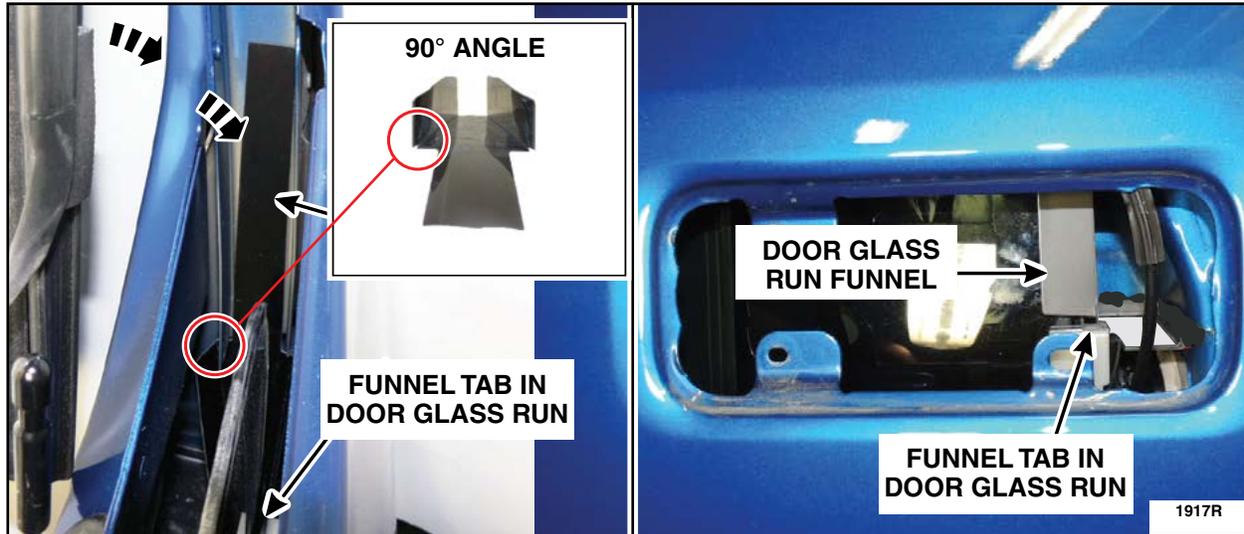
FIGURE 51

22. Lower the rear door window glass to the fully down position.
23. Install the door glass run funnel (132mm funnel wings), ensuring the lower tab is situated in the door glass run and the funnel sides sit at a 90° angle above the door glass run. See Figure 51.

NOTE: Ensure the funnel sides are at a 90° angle upon installation. It may be necessary to bend the sides of the funnel back to a 90° angle before installation.

NOTICE: When installing the rear door glass top run make sure not to bend or damage the door glass run funnel. Check through the exterior door handle opening to verify that the funnel is positioned correctly.
