**PRODUCT CAMPAIGN BULLETIN**

**APPLICABILITY:** 2019MY Ascent  
 2019MY Crosstrek Hybrid (PHEV)  
 2019MY Forester

**SUBJECT:** PCV Valve- Design Change

**NUMBER:** WUW-08R  
**NHTSA ID:** 19V-856  
**DATE:** 12/04/19  
**REVISED:** 12/17/19

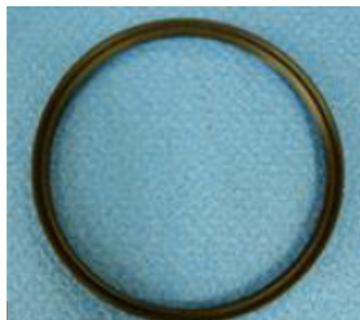
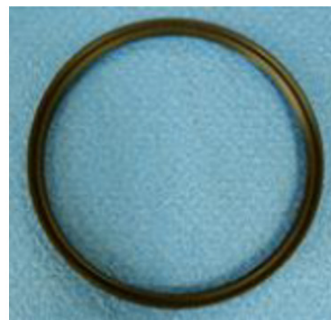
A Service Parts Kit, **p.n. X1181AA010** for use on **ASCENT** models only **is now available**. The kit will consist of a new PCV valve and the 2- **one-time use** o-rings required to be replaced when removing the intercooler assembly.

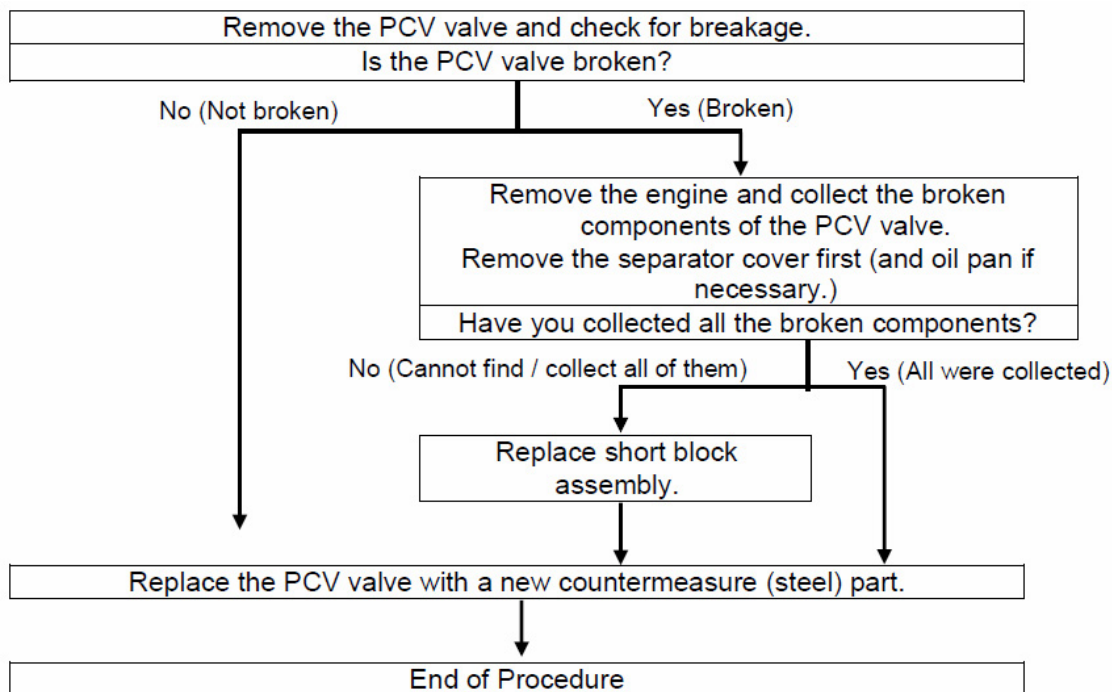
**Flow Chart:**

**Step 1:** Remove the PCV Valve following the procedure in the applicable Service Manual.

- If the PCV valve is **BROKEN (NG)**, proceed to **Step 2** and remove the engine following the procedure in the applicable Service Manual.
- If the PCV valve is **OK (NOT broken)**, replace it with a new PCV valve to complete the procedure following the applicable Service Manual. Proceed to the Claim Reimbursement and Entry Procedures section.

- If all the broken PCV valve components cannot be collected, replace the short block assembly along with a new PCV valve following the applicable Service Manual procedures.
- If all the broken PCV valve components are collected, install a new separator cover and PCV valve. Reassemble the vehicle in reverse order following the applicable Service Manual procedures to complete the procedure.
