PRODUCT CAMPAIGN BULLETIN

APPLICABILITY: 2017-18MY Impreza
2018MY Crosstrek

NUMBER: WUP-01R

SUBJECT: PCV Valve- Design Change

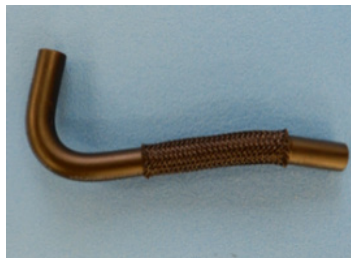
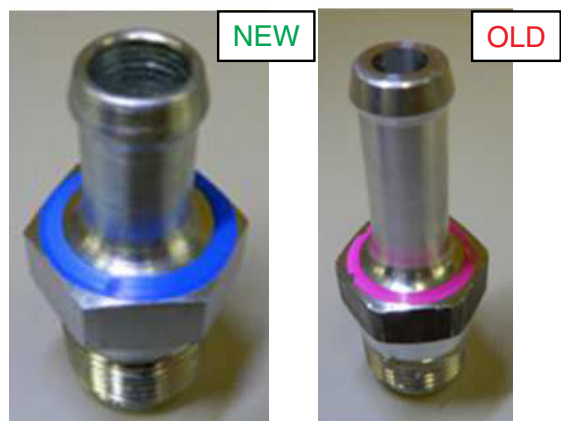
A new parts kit, **p.n. X1181AA000** consisting of a new steel PCV valve and hose is now available. The **NEW** -style PCV Valve is made of steel and has a **BLUE** ring above the hex portion as shown. The old -style is made of aluminum and has a **PINK** ring above the hex portion.

A photo of the new hose is also shown.
