SERVICE PROGRAM BULLETIN

APPLICABILITY: 2017-18 MY Impreza
 2018MY Crosstrek

NUMBER: WUR-03R

SUBJECT: Brake Hose Swelling Service Program

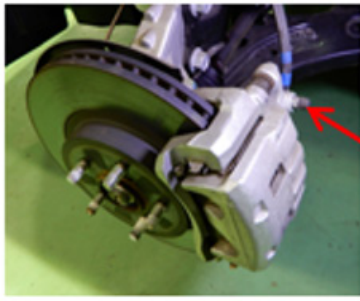
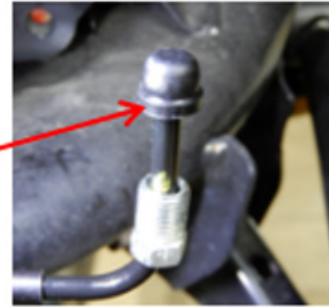
Rubber Bleeder
Screw Cap

- Before attempting to remove the flare nuts from the hoses, spray them with a silicone-free penetrant / lubricant to help make their removal easier and reduce chances of damaging the brake pipes. **Since the original brake hoses will be discarded, use a Vise-Grip® or equivalent to hold the brake hose female ends while breaking the brake pipe flare nuts loose. This will prevent damaging the mounting brackets on the frame rails.** Once removed, clean the flare nut with brake parts cleaner to remove any residual lubricant prior to reassembly.
- After removing the hose from the brake pipe, use a rubber caliper bleed screw cap on the end of the pipe to minimize fluid loss.

With either tool, use care to NOT deform or otherwise damage the brake pipe. When using a die, it is important to protect the brake pipe from being contaminated by metallic residue generated by repairing the threads. Use the bleeder cap as shown above to seal the end of the brake pipe. After the thread repair process is completed, wash away any metal chips or residue before removing the bleeder cap, reinstall the pipe, tighten the flare nut by hand and recheck the length as shown above to confirm it is less than 9mm. If it cannot be tightened by hand to less than 9mm, replace the brake pipe assembly to prevent a possible post-repair brake fluid leak.

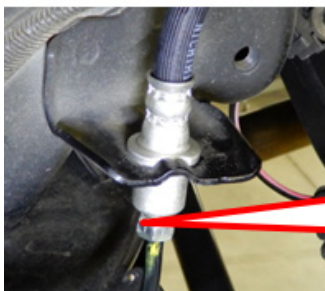
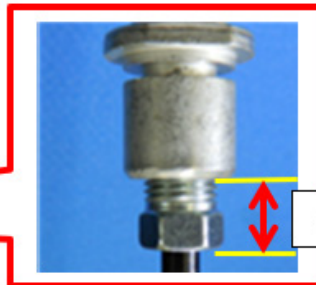
Less than 9mm

After threading the flare nut into the new hose by hand (NO Tools) as far as possible, measure the length of the insertion as shown in the image below. If the length shown below is more than 9mm, thread damage is likely. Loosen and remove the line and proceed below for further instruction.

If during removal a wrench is required to fully remove the flare nut from the brake hose, thread damage may have occurred. To determine this and address it where necessary, use the following process.

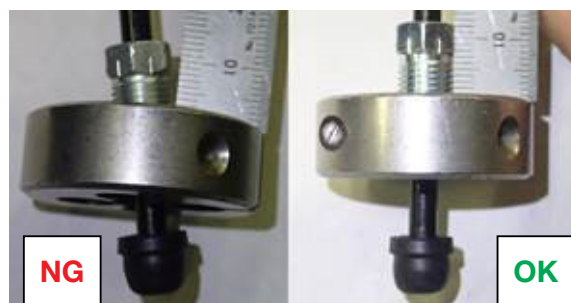
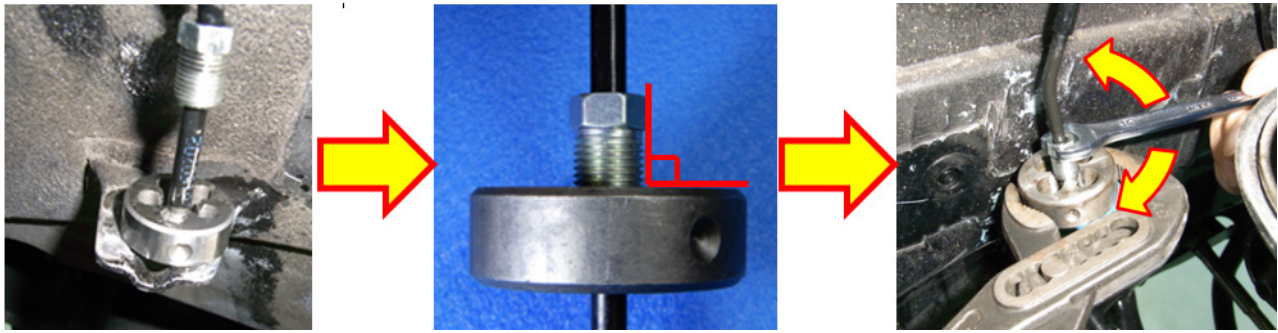
The flare nut thread size is M10 X 1.0 (thread pitch). If a wrench is needed to remove the flare nut, it will most likely also be needed when reinstalling the flare nut into the new hose end. To alleviate this, the use of a thread “chaser” to repair the flare nut threads is recommended over the use of a die to repair the flare nut threads. Using a thread chaser will clean and re-align the existing threads without removing much if any material whereas, a die will achieve the same results but, be more aggressive and may re-cut the damaged threads which must be avoided.

Regardless of which tool is used, it is **critical** for the flare nut to be “square” or perpendicular to either tool before proceeding as shown in the comparison photos below.

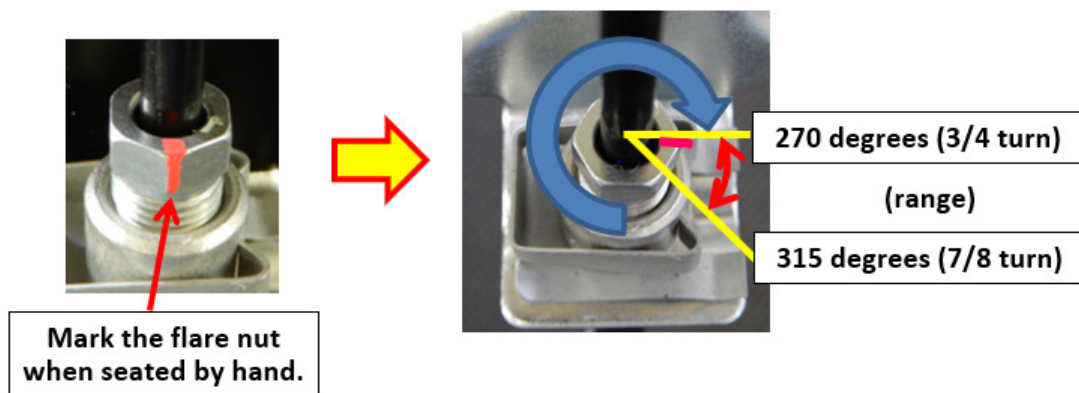
When applying the final tightening torque to a flare nut which has been cleaned with a die or thread chaser, do NOT use the standard torque wrench tightening method since the thread condition is now different from the original factory condition. Use the angle tightening method shown below after reaching the initial seated position after tightening the flare nut by hand. Once seated by hand, mark the flare nut as shown below, and tighten it an additional 270 to 315 degrees (3/4 to 7/8 turn).

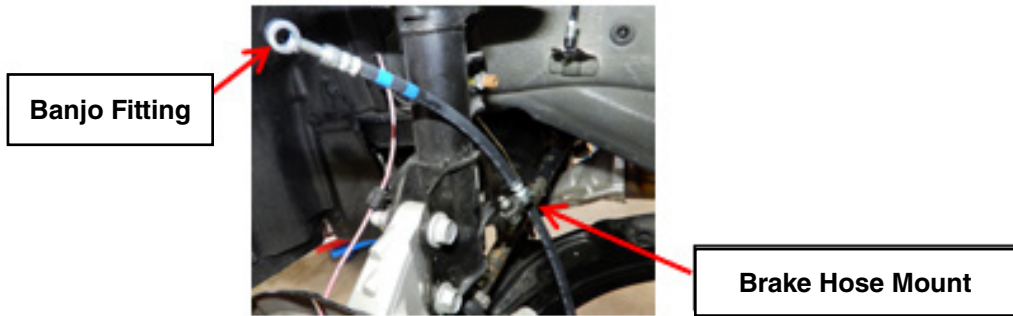
- During reassembly, always make sure all caliper to hose banjo bolt sealing washers have been removed and replaced with new to avoid leaks caused by stacking new washers on top of old ones.
- When securing the new front hose to the front strut bracket, position the caliper end banjo fitting as shown in the photo below. This eliminates any unnecessary twisting of the hose when reinstalling the banjo bolt.

IMPORTANT REMINDER: Always use all eight (8) **NEW** sealing washers included in the brake hose kit.

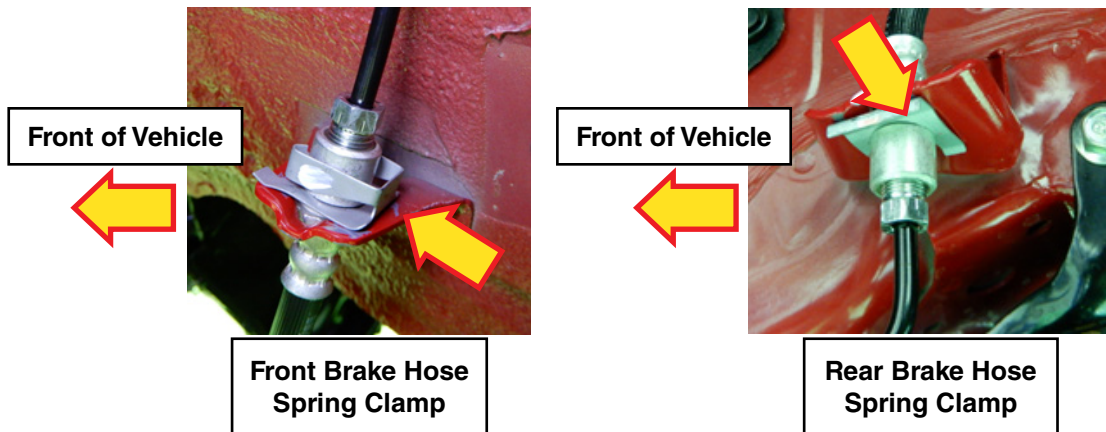
- 2) After refitting the brake pipes to the new brake hoses, always reinstall the spring clamps in the proper direction as shown below.
