SUBJECT: Customer Satisfaction Program 19B34
Certain 2018-2019 Model Year Mustang GT350 Vehicles
Gearshift Lever Assembly Reverse Lock-Out

CERTAIN 2018 - 2019 MODEL YEAR MUSTANG GT350 VEHICLES — GEARSHIFT LEVER ASSEMBLY REVERSE LOCK-OUT

SERVICE PROCEDURE

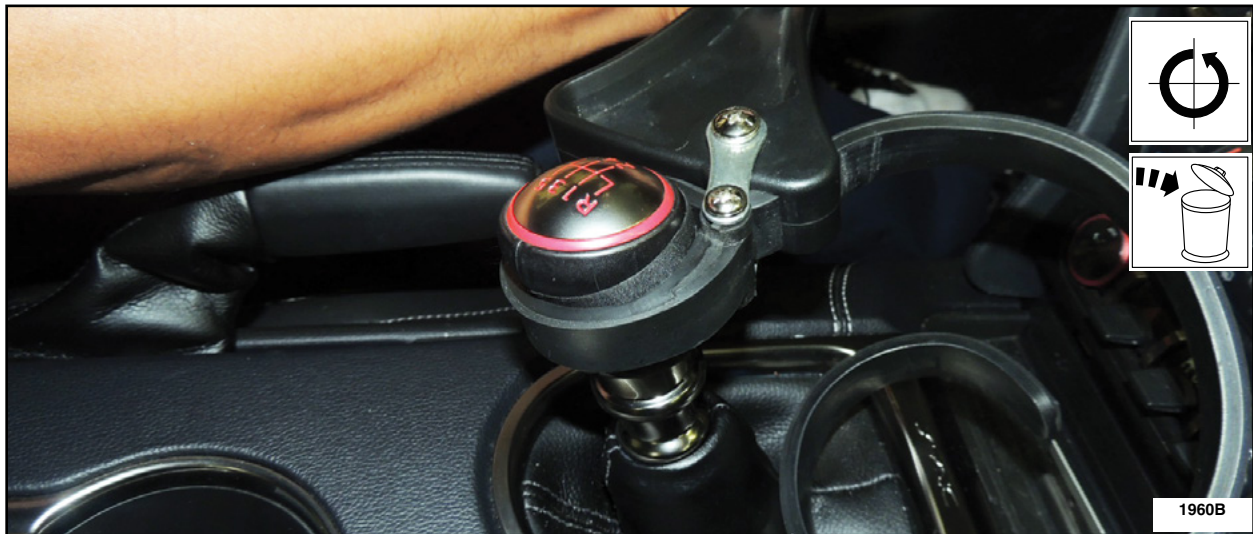
FIGURE 1

1. Using a strap wrench or suitable tool, turn the gearshift knob counter clockwise to remove and discard. See Figure 1.

NOTE: For an aftermarket shift knob that is to be re-used per customers request - first wrap the knob several times with tape (painters/gaffers tape recommended), and then use a rubber strap wrench as shown for knob removal.

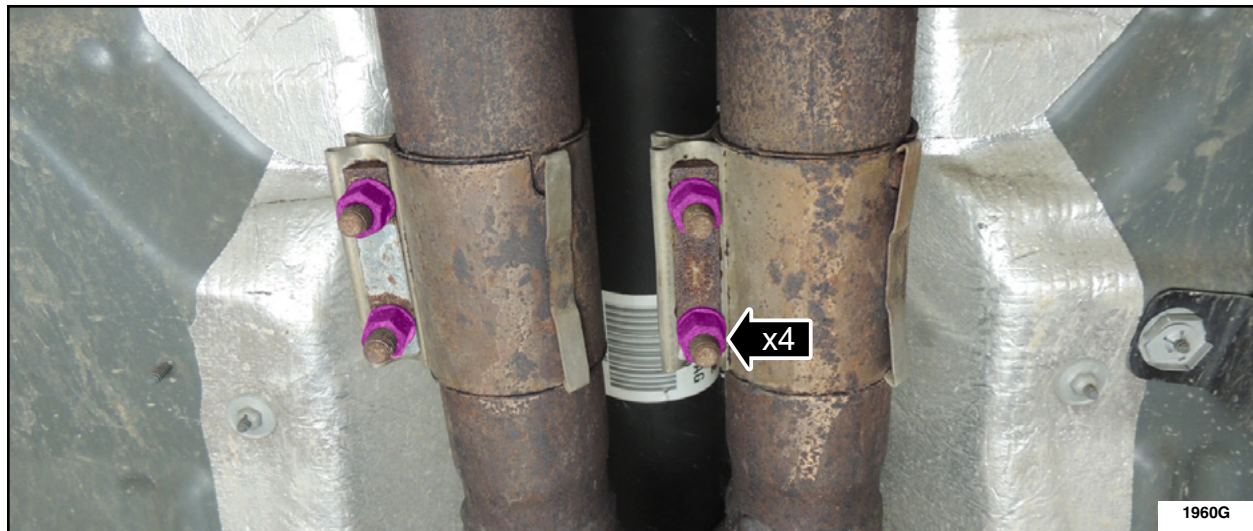
FIGURE 6

7. Loosen the exhaust clamp nuts. See Figure 6.

NOTE: Do NOT remove the exhaust system.

24. Install the four transmission crossmember bolts. See Figure 12.
- *Torque:* 46 lb.ft (63 Nm)
25. Install the four *new* driveshaft to transmission flange retainers. See Figure 9.
- *Torque:* 80 lb.ft (109 Nm)
26. Position the exhaust clamps forward to their correct locations and engage the safety retainers. See Figure 7.
27. Tighten down the exhaust clamp nuts. See Figure 6.
- *Torque:* 35 lb.ft (48 Nm)

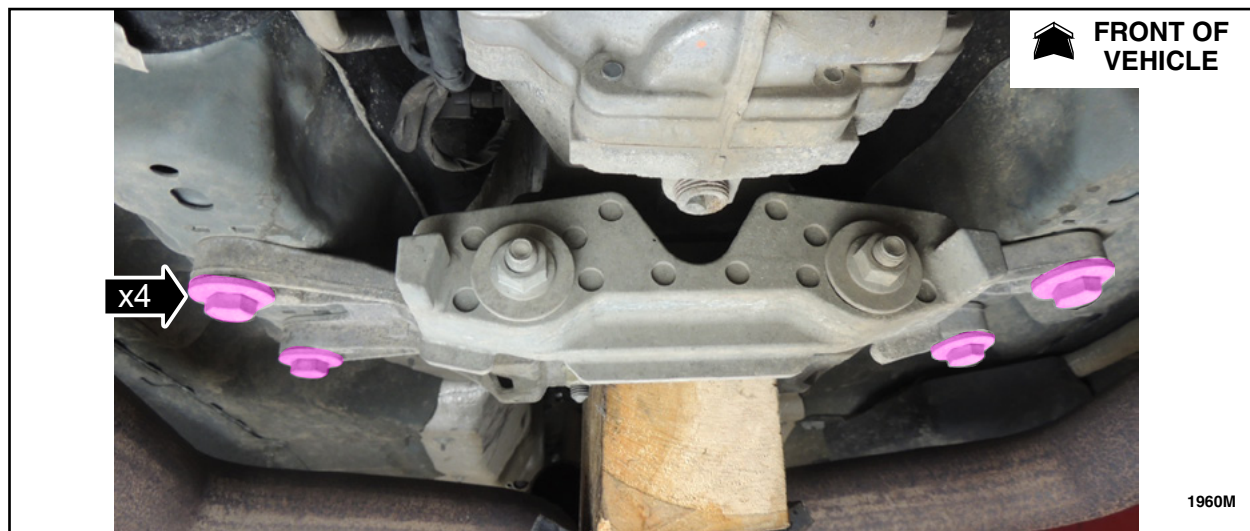
FIGURE 12

13. Remove the four transmission crossmember bolts. See Figure 12.

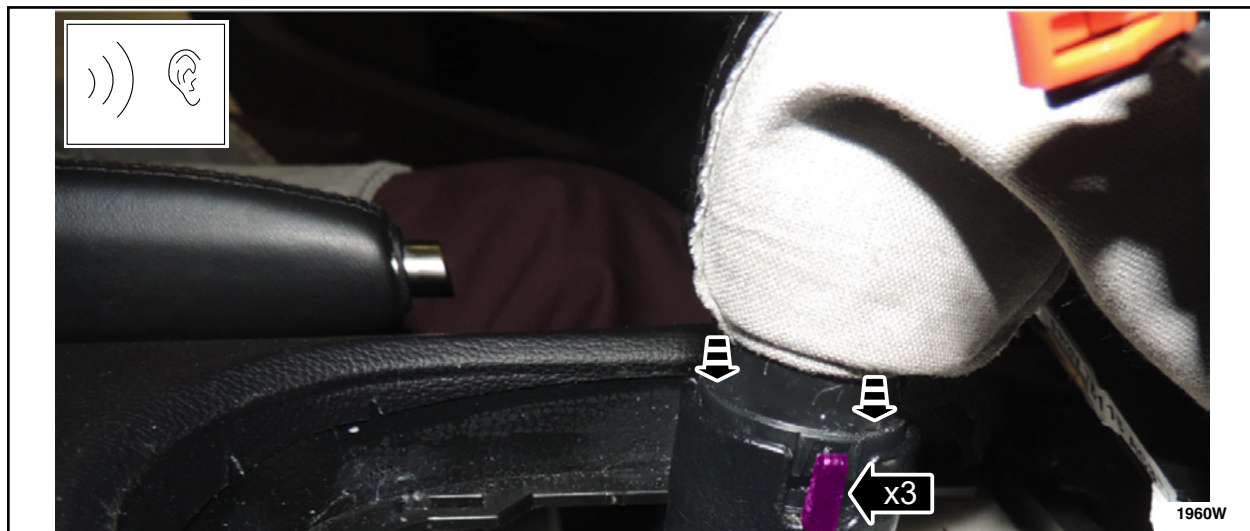
FIGURE 22

31. Install the gearshift lever boot onto the reverse lock out sleeve's three retention tabs. See Figure 22.

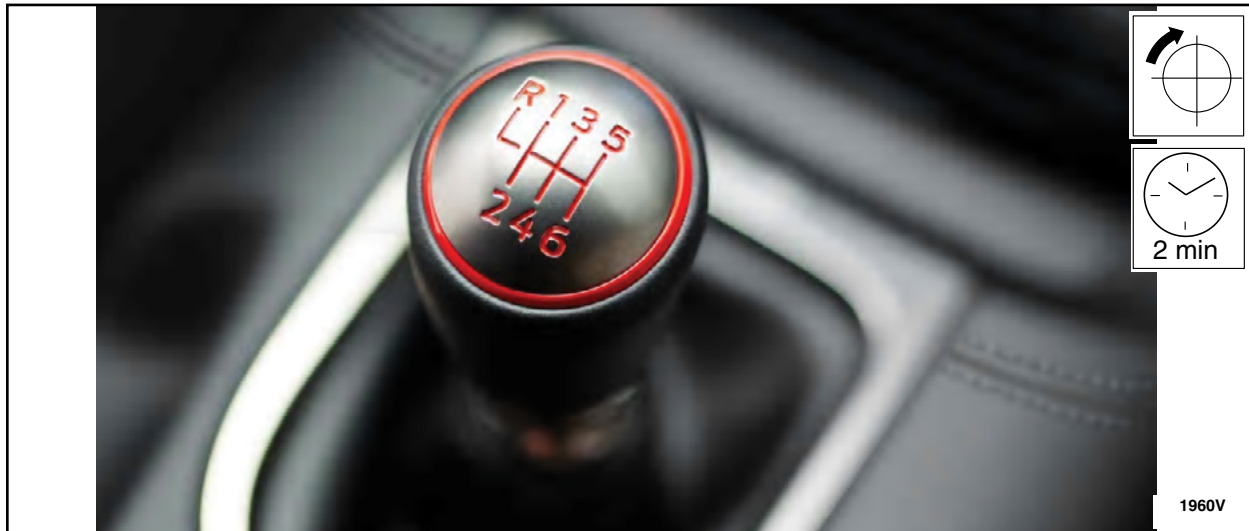
FIGURE 25

NOTE: The *new* gearshift lever assembly comes with a threadlocker patch. The knob must be squarely positioned with in two minutes of installation.

34. Install the *new* gearshift knob or the customer's aftermarket gearshift knob clockwise until bottomed out and then turn counterclockwise up to a maximum of 359 degrees to center. See Figure 25.

NOTE: Allow gearshift knob to set for 1 hour before releasing the vehicle.

NOTE: Notify the customer to allow the gearshift knob to set for 24 hours before any aggressive shifting.

NOTE: Once the 2 minute set time has passed, if the knob has been twisted and/or removed, fully remove the gearshift knob, clean the threads, and Apply Motorcraft® Threadlock and Sealer TA-25-B. Install the gearshift knob.
