SUBJECT: Customer Satisfaction Program 19B22
Certain 2012-2013 Model Year Fiesta Vehicles Operated in the USA Corrosion States
Battery Junction Box Clean and Seal

Customer Satisfaction Program 19B22

Certain 2012-2013 Model Year Fiesta Vehicles Operated in the USA Corrosion States -
Battery Junction Box Clean and Seal

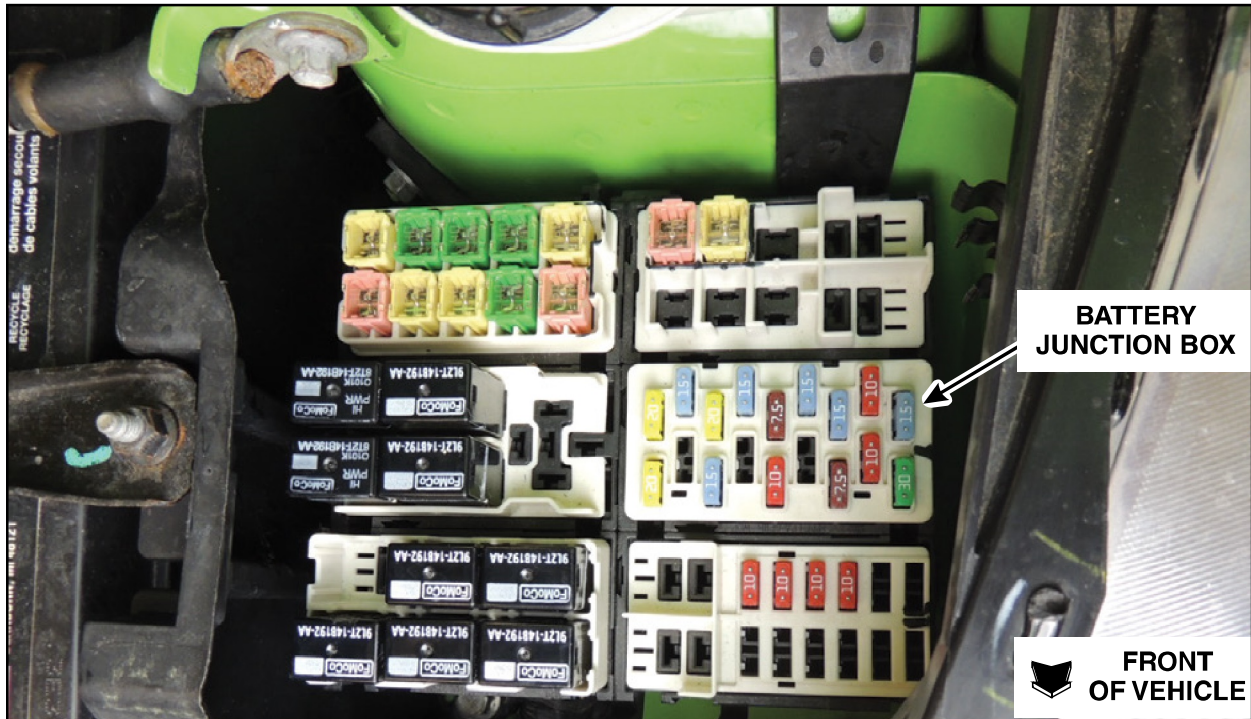
FIGURE 1

1. Disconnect the battery cable to ground. Please follow the Workshop Manual Procedures (WSM) in Section 414-01.
2. Remove the Battery Junction Box (BJB) cover and using compressed air, blow out any dirt and debris from the BJB. See Figure 1.

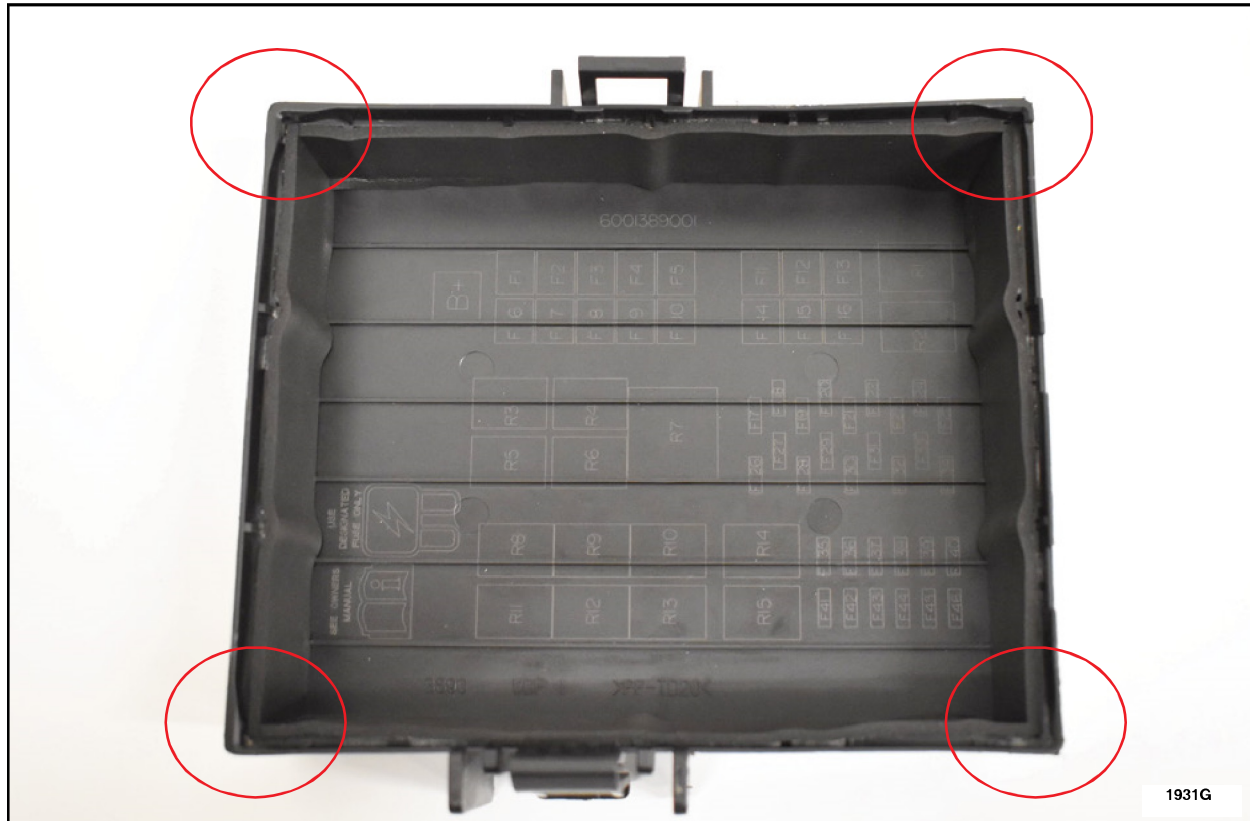
FIGURE 7

Completed foam seal kit installation
