SERVICE PROGRAM BULLETIN

APPLICABILITY: 2015-2016MY Legacy 2.5L
2015-2016MY Outback 2.5L

NUMBER: WUJ-95R

SUBJECT: Exhaust Pipe Front (EPF) Bellows Cracking

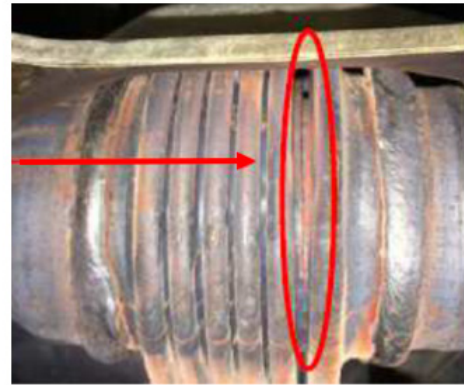
During transportation from the supplier, the spacing between the exhaust flanges may change due to vibration. Although the amount of this change is small, it is enough to require more force than normal to install the EPF onto the engine during vehicle assembly. The amount of force may have caused cracking to develop in the bellows section of the EPF resulting in exhaust leakage. Since the area of the leak is upstream of the catalyst, emission system performance may be compromised. In some cases, customers may notice an unusual noise and / or exhaust odor.

Description	Part Number	Application
Cal Spec. (PZEV) Kit	SOA635156	PZEV (Cal Spec) Vehicles
Fed Spec. Kit	SOA635157	Fed. Spec. Vehicles
Insulation Pad Adhesive	SOA868V9690	Both Fed and PZEV Vehicles

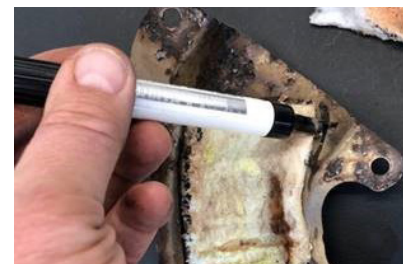
IMPORTANT: As each heat shield is **CAREFULLY** removed, use a permanent marker to outline the shape and positioning of each fiberglass insulation pad found on the inside of it whenever possible. A complete set of new insulation pads is included in the EPF kit and **ALL are to be replaced at reassembly.**

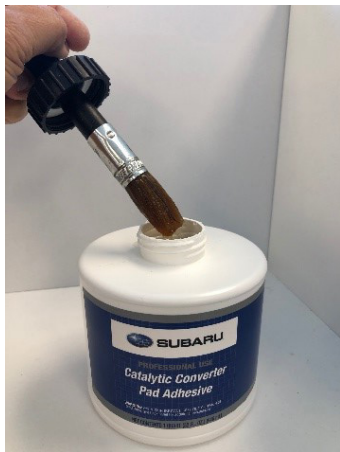
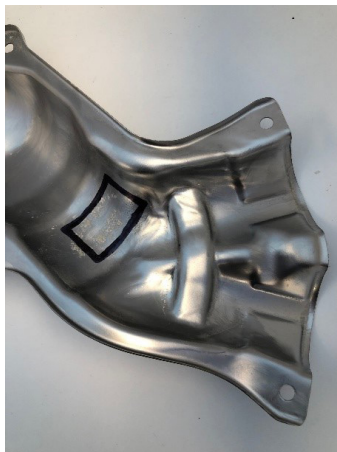
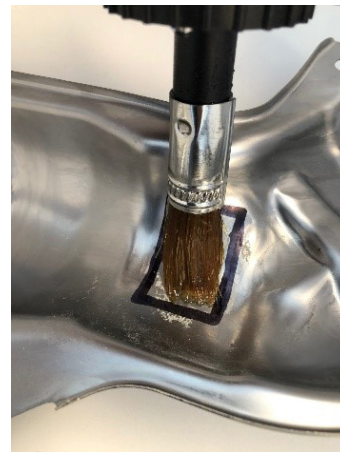
- Remove the brush cap from the adhesive container and apply a small amount of the material to each shield toward the center of where the new insulation pad will be positioned. Marking an outline for where the adhesive should be applied can also be used as shown below.

- For reference, a “dab” or two of adhesive about the size of a silver dollar is plenty. There is no need to cover the entire insulation pad area. Keep in mind, the adhesive is only used to hold the new insulation pads in place during EPF reassembly as they will be held (“clamped”) in position once all the retaining hardware is tightened.
- Apply the adhesive to the shield then press the new insulation pad onto it and all the contours of each shield. Repeat for each remaining shield and insulation pad.

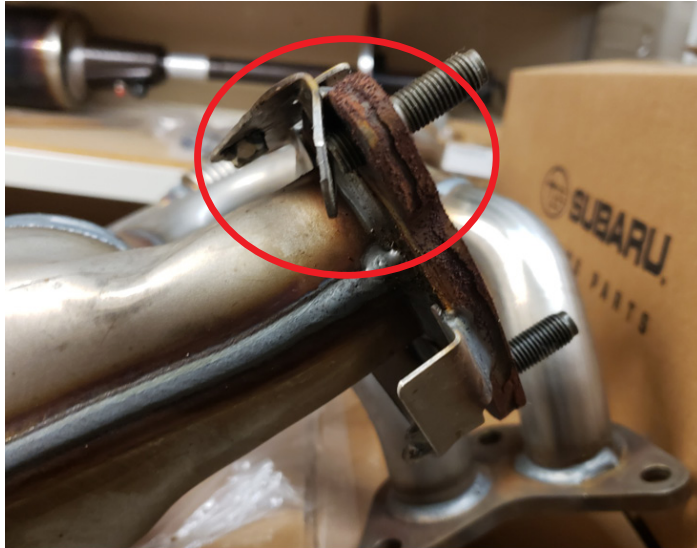
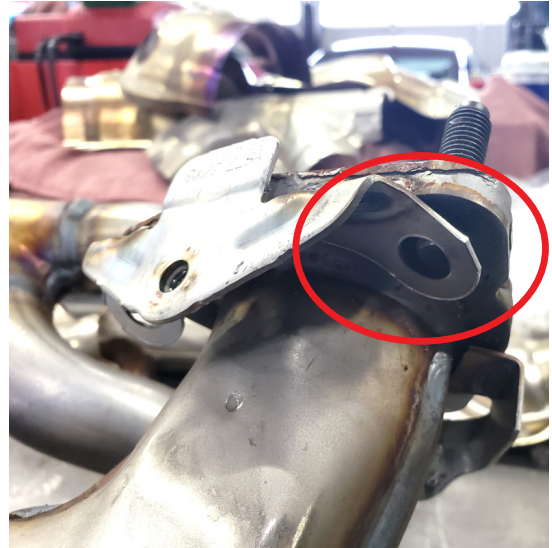
- Some reports have been received regarding the mounting bracket tabs as pictured below. Occasionally, the fastener holes in the bracket are not fully aligned with the holes in the center exhaust pipe mounting flange. The pictures show one of the center exhaust pipe mounting studs displacing the bracket tab. If this happens, it may cause the bolt hole for the converter shield to become mis-aligned (or, it may have no effect at all). This condition **MAY** require some **VERY CAREFUL** manipulation of the mounting bracket to re-align it with the converter shield bolt hole.

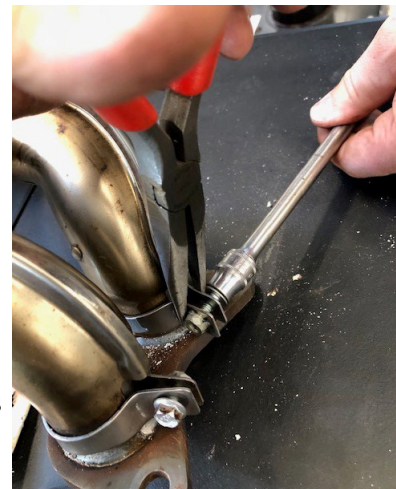
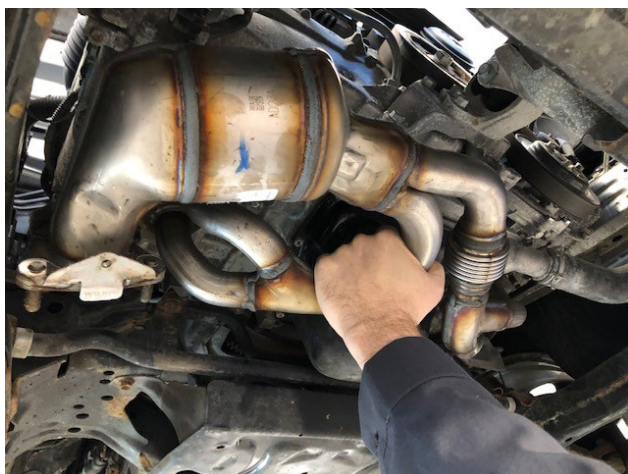
- Using a pair of needle nose pliers to squeeze the new clamps for the small shields at the flanges together will help make getting the bolts started much easier and avoid cross-threading.
- When reinstalling the A/F Sensors, **NEVER** apply anti-sieze compound on the threads.
- **BEFORE** installing the shields onto the new EPF, confirm the new EPF fits into place on the cylinder head exhaust studs properly **WITHOUT** any prying or other manipulation.

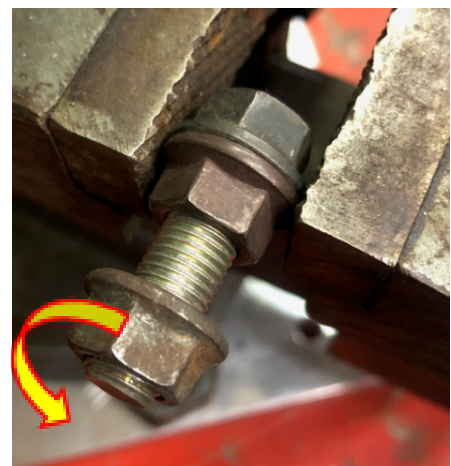
If the stud comes out of the head:

- Use two (2) of the “old” (removed previously) flanged EPF nuts tightened together flange to flange as shown to act as jam nuts on the head side of the stud threads.
- Clamp the stud in a vise, by the jam nuts to protect the stud threads as shown in the example photo here.
- Heat the seized nut as necessary to free it up then **CAREFULLY** remove using hand tools and penetrant.
- Use a thread chaser to repair the threads if necessary.
- Reinstall the stud into the cylinder head.
