# GLOBAL SAFETY FIELD INVESTIGATIONS DCS5453 URGENT - DISTRIBUTE IMMEDIATELY

Subject: 17336-06 - Special Coverage

Air Conditioning Condenser (Combi-Cooler) Refrigerant Leak

Models: 2015-2017 Cadillac Escalade, Escalade ESV

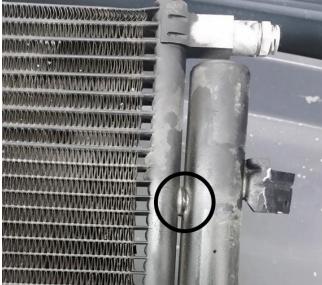
4873592

#### Cadillac Escalade shown. Other models are similar.

1. Locate the coupler (1) on the air conditioning condenser by looking through the identified area of the radiator grille.

Note: General Motors vehicles are manufactured with fluorescent dye installed in the A/C refrigerant system.

- Verify the air conditioning condenser is leaking in the specific area identified above. Refer to the appropriate diagnostic information in SI.
  - If the air conditioning condenser is NOT leaking in the specific area identified above, no further action is required. Inform the customer that any additional diagnosis and repairs are not covered under this special coverage.
  - If the air conditioning condenser is leaking in the specific area identified above, proceed to the next step.

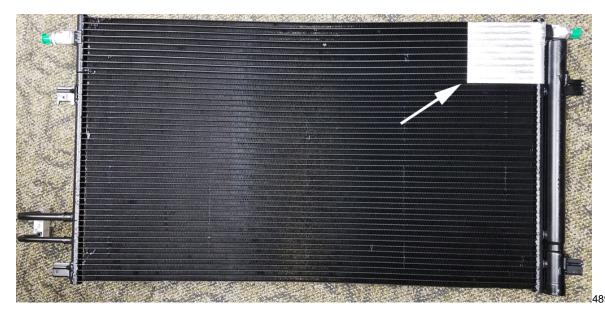
4892397

- Verify if an air conditioning condenser shield assembly is installed on the NEW air conditioning condenser as shown above.
  - If an air conditioning condenser shield assembly is installed, proceed to the next step.

- If an air conditioning condenser shield assembly is NOT installed, install the air conditioning condenser shield assembly as shown in the picture above.
- 5. Remove one of the plugs from the transmission fluid auxiliary cooler fitting.
- 6. Fill the transmission fluid auxiliary cooler full of transmission fluid.
- 7. Install the plug back into the transmission fluid auxiliary cooler fitting.
- 8. Install the NEW air conditioning condenser. Refer to Air Conditioning Condenser Replacement or Air Conditioning Condenser Replacement (L83 L86) in SI.
  - Discard the old sealing O-rings and install new O-rings when installing the new air conditioning condenser.
