**SUBJECT: NEW VEHICLE DEMONSTRATION / DELIVERY HOLD
 Customer Satisfaction Program 21B03 - *Supplement #5***
 Certain 2020 Model Year Super Duty F250-F600 Vehicles Equipped with a 10R140
 Transmission - Number One Planetary and Ring Gear Assembly

**NEW VEHICLE DEMONSTRATION / DELIVERY HOLD
Customer Satisfaction Program 21B03 - *Supplement #5***

CERTAIN 2020 MODEL YEAR SUPER DUTY F250-F600 VEHICLES EQUIPPED WITH A 10R140 TRANSMISSION — NUMBER ONE PLANETARY AND RING GEAR ASSEMBLY

SERVICE PROCEDURE

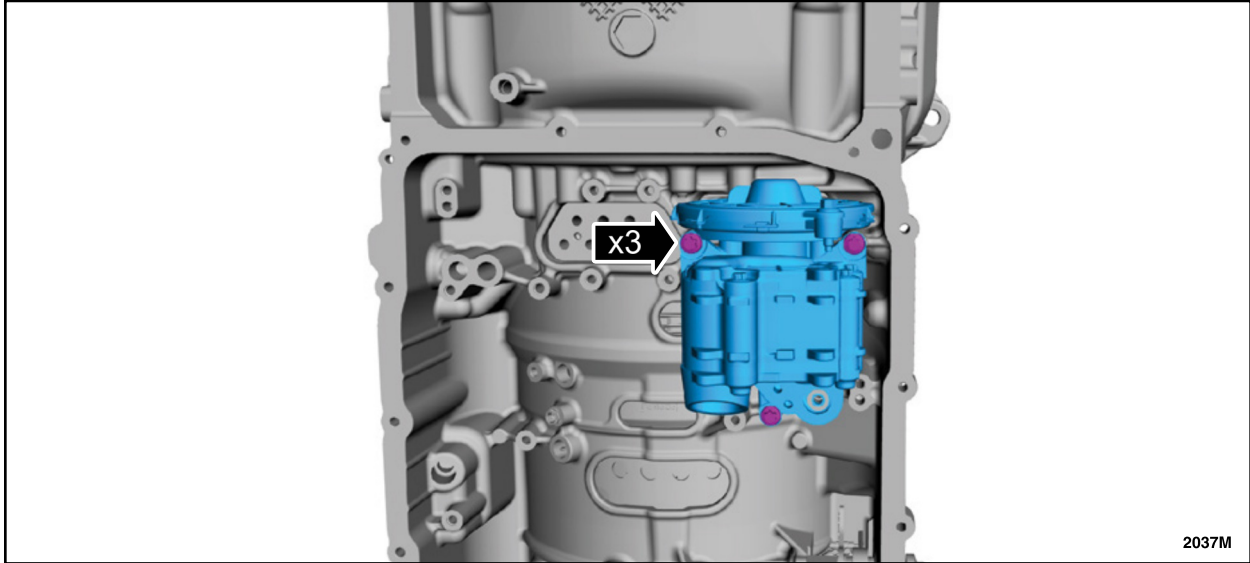
FIGURE 5

NOTE: Use a 10ep Torx Plus® socket for the transmission fluid pump bolts.

8. Remove the bolts and the transmission fluid pump. See Figure 5.

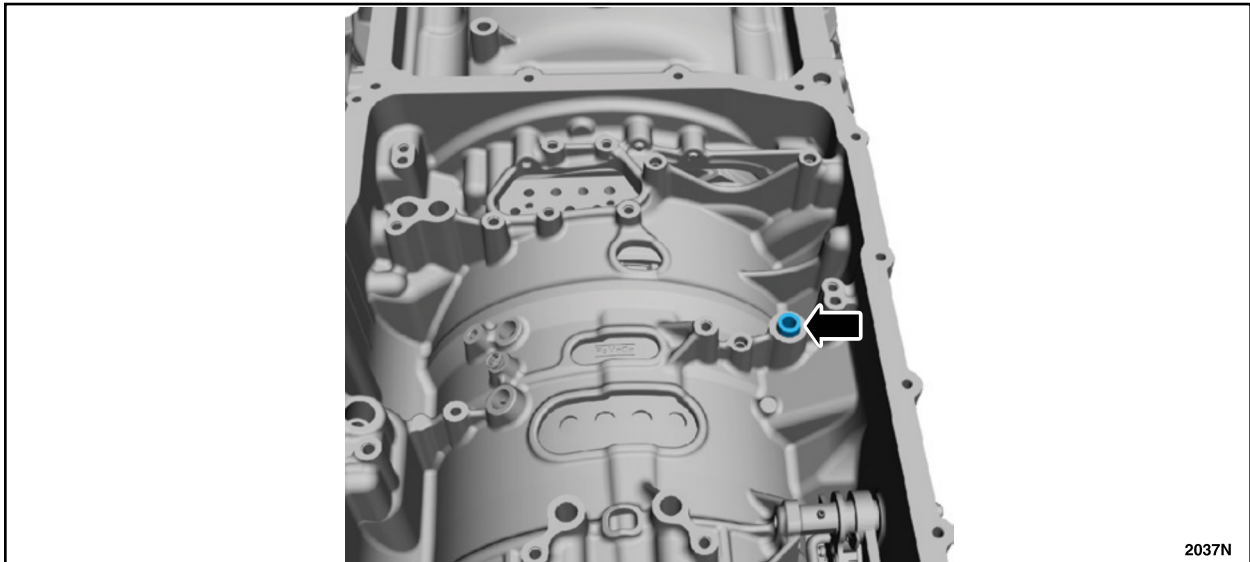
FIGURE 6

9. Remove the transmission fluid pump seal. See Figure 6.

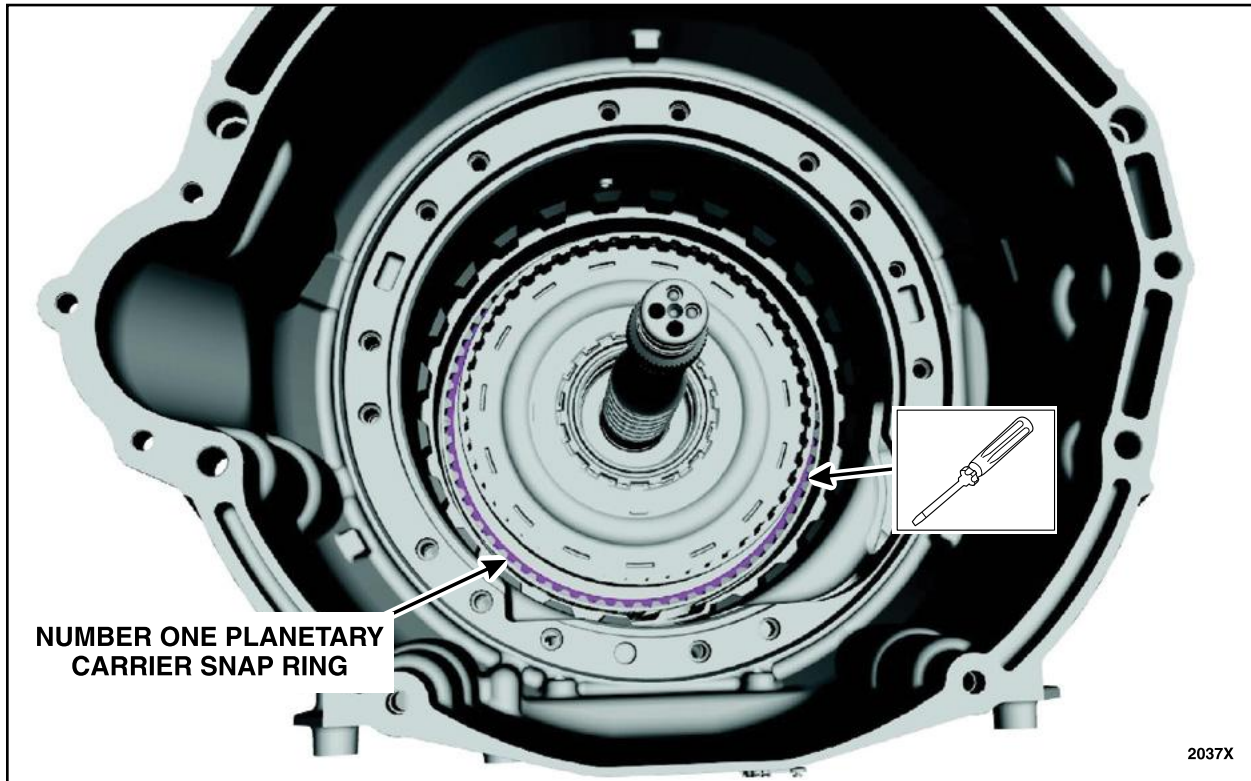
FIGURE 15

18. Using a long flat head screwdriver, install the number one planetary carrier snap ring. Be sure that the snap ring is fully seated. See Figure 15.

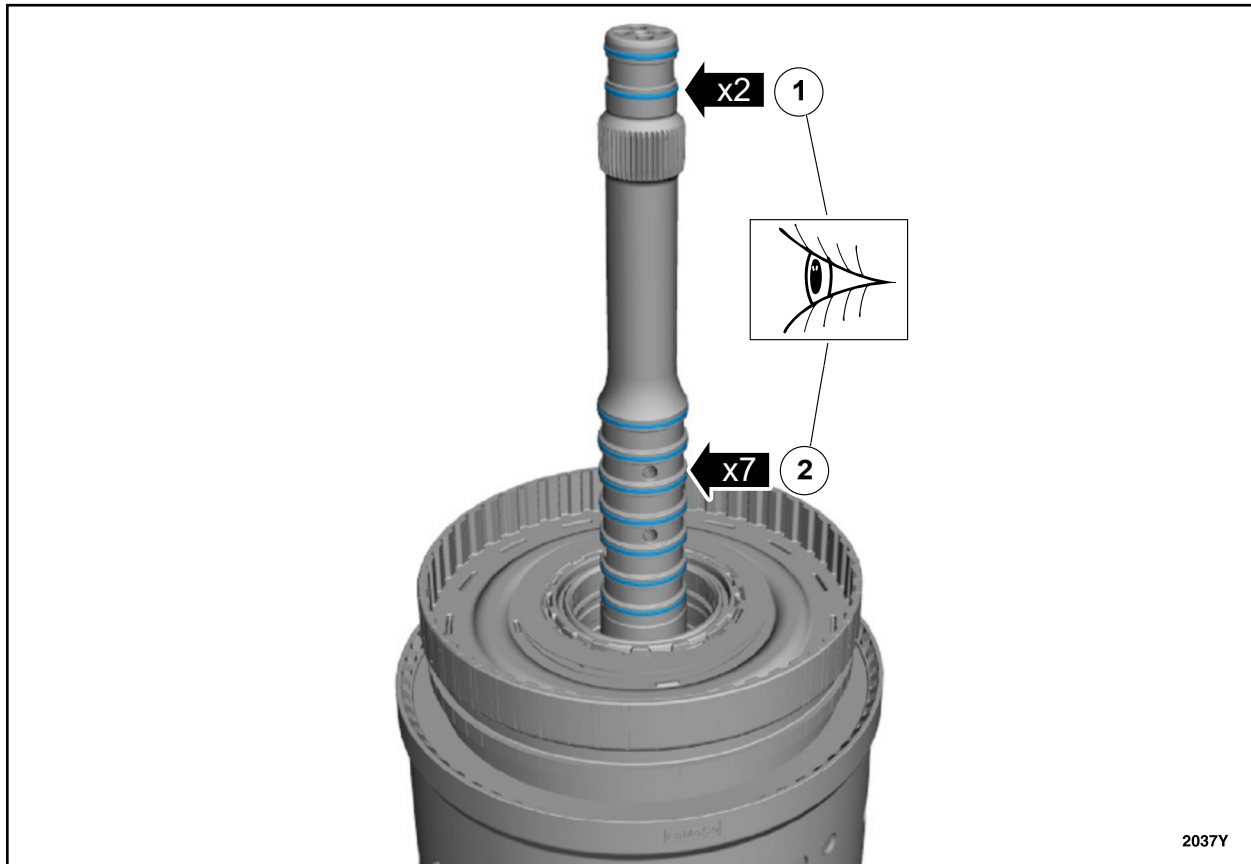
FIGURE 17

20. Inspect the input shaft seals for damage. See Figure 17. Do any of the input shaft seals show signs of damage?

1. Torque converter seals.
2. Front support assembly seals.

If **YES** - Remove the damaged seals, then proceed to Step 21.

If **NO** - Proceed to Step 27.

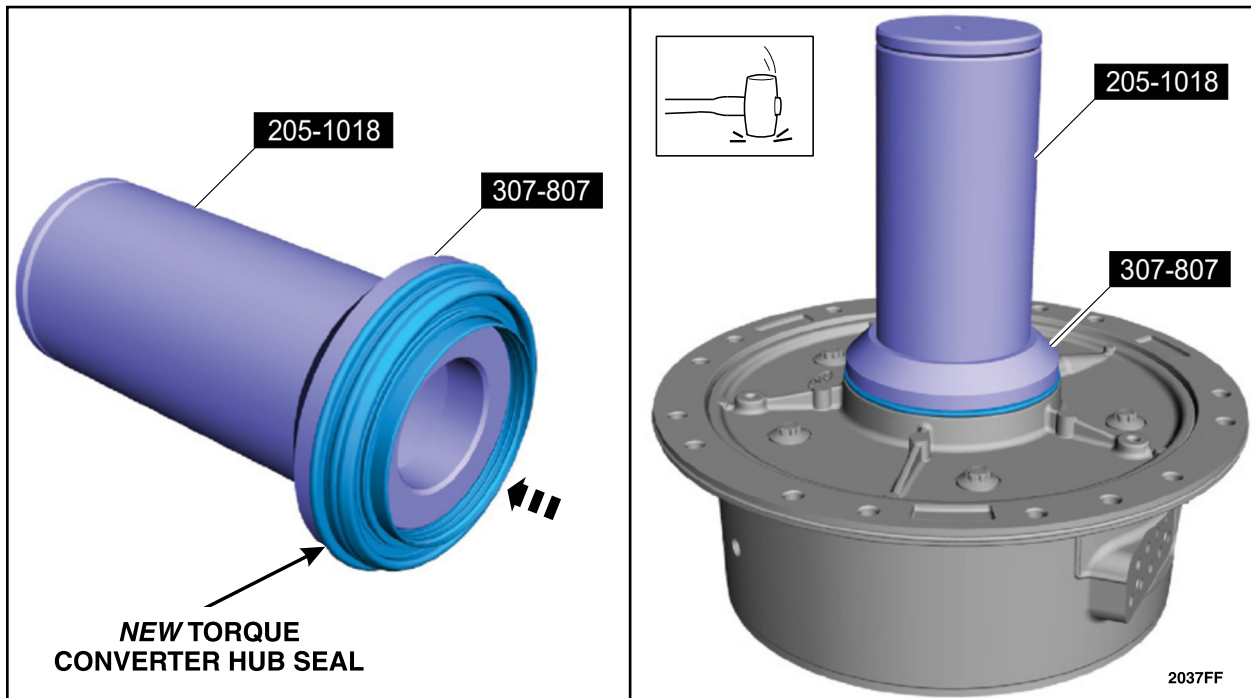
FIGURE 24

27. Install the *new* torque converter hub seal on special tools 205-1018 and 307-807. Using the special tools and a rubber mallet, install the *new* torque converter hub seal. See Figure 24.

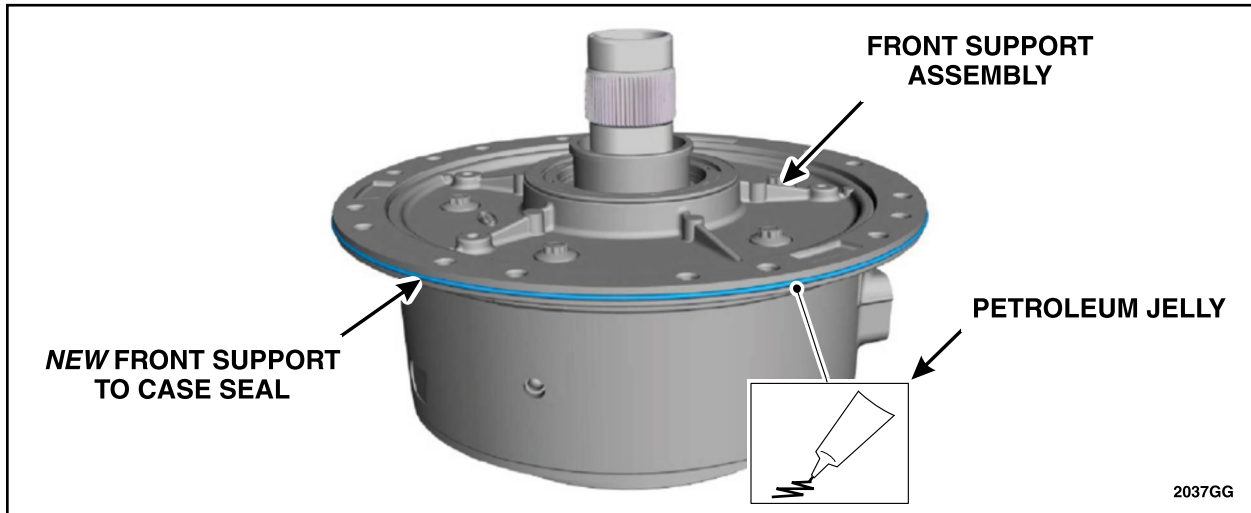
FIGURE 25

28. Install the *new* front support-to-case seal. Lubricate the seal with petroleum jelly. See Figure 25.

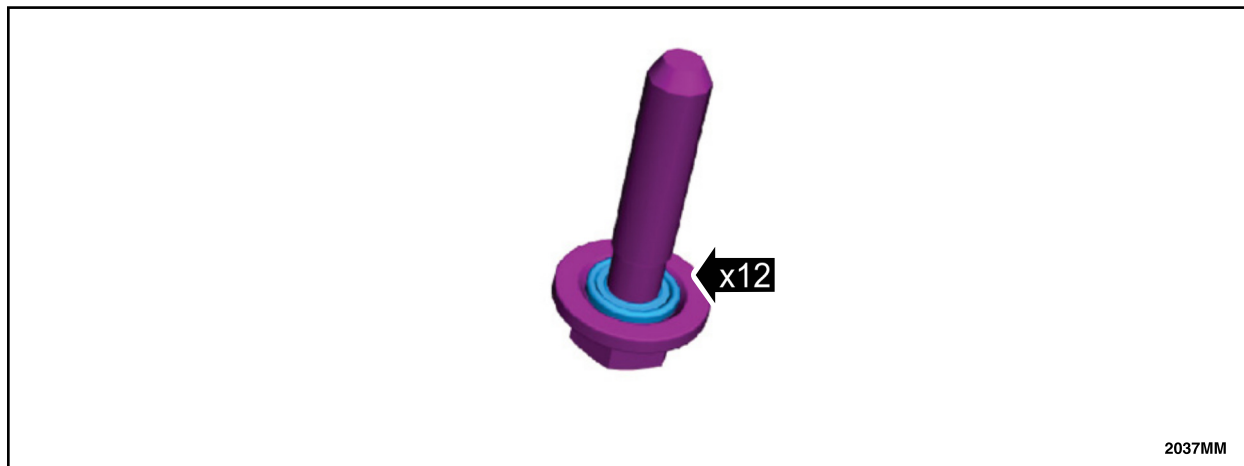
FIGURE 31

35. Install the new front support assembly bolt washers. See Figure 31.

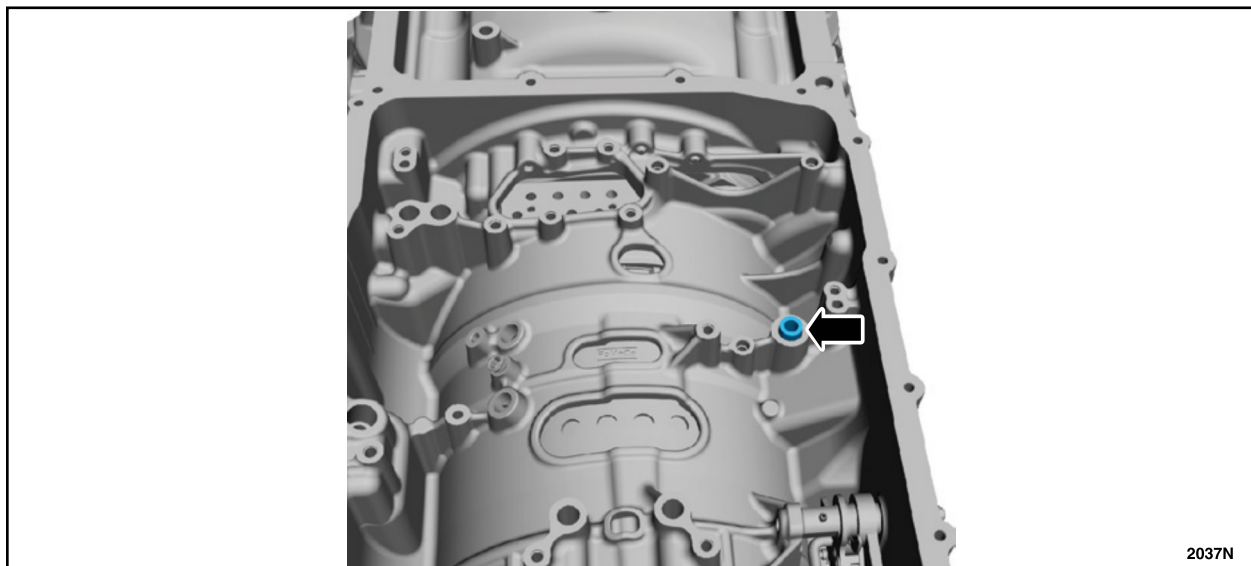
FIGURE 36

40. Install the transmission fluid pump seal. See Figure 36.
