SUBJECT: **Recommended New Vehicle Delivery Hold -
 Component Installation Program 22G05 - Supplement #2**
 Certain 2022 Model Year F-150 and Super Duty Vehicles
 Exterior Badge Retrofit

**Recommended New Vehicle Delivery Hold -
Component Installation Program 22G05 - *Supplement #2*
Certain 2022 Model Year F-150 and Super Duty Vehicles
Exterior Badge Retrofit**

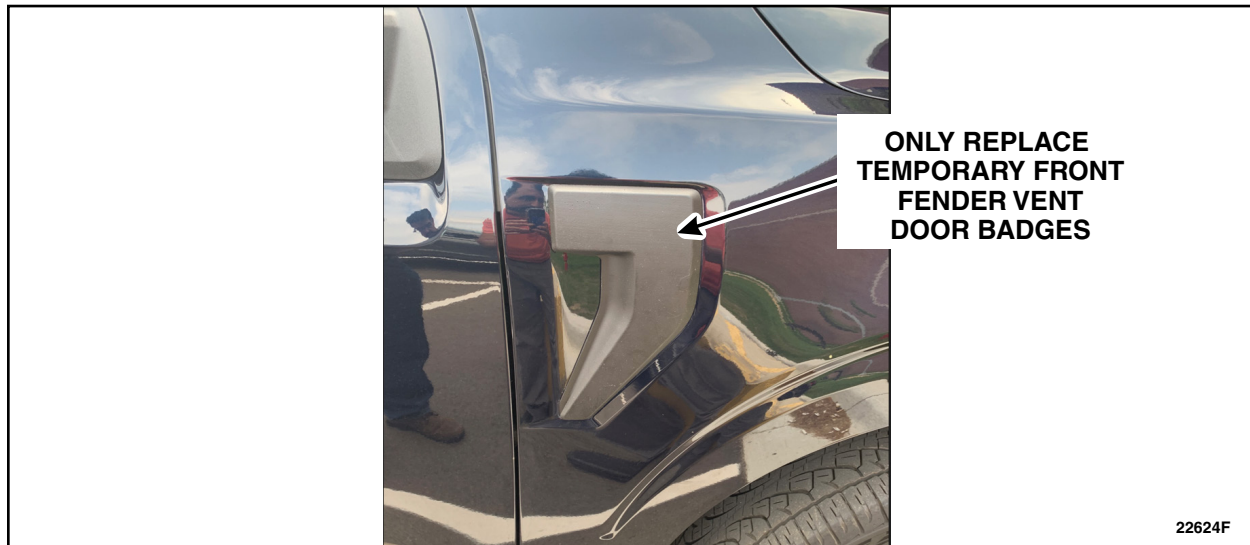
FIGURE 1

1. Using a plastic trim tool, remove the LH side temporary front fender door badge. See Figure 1.

NOTE: RH side shown, LH side similar.

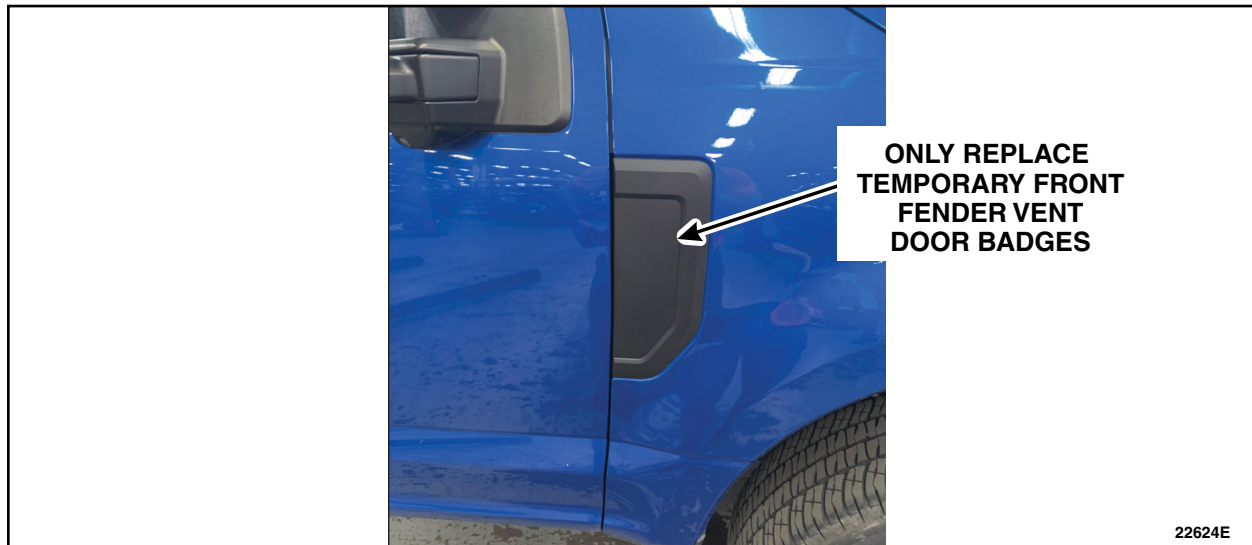
FIGURE 1

1. Using a plastic trim tool, remove the LH side temporary front fender door badge. See Figure 1.

NOTE: RH side shown, LH side similar.

NOTE: To remove temporary badge metal clips from the body - release the metal clip from the back side by pushing up so the clips rotate into the holes.

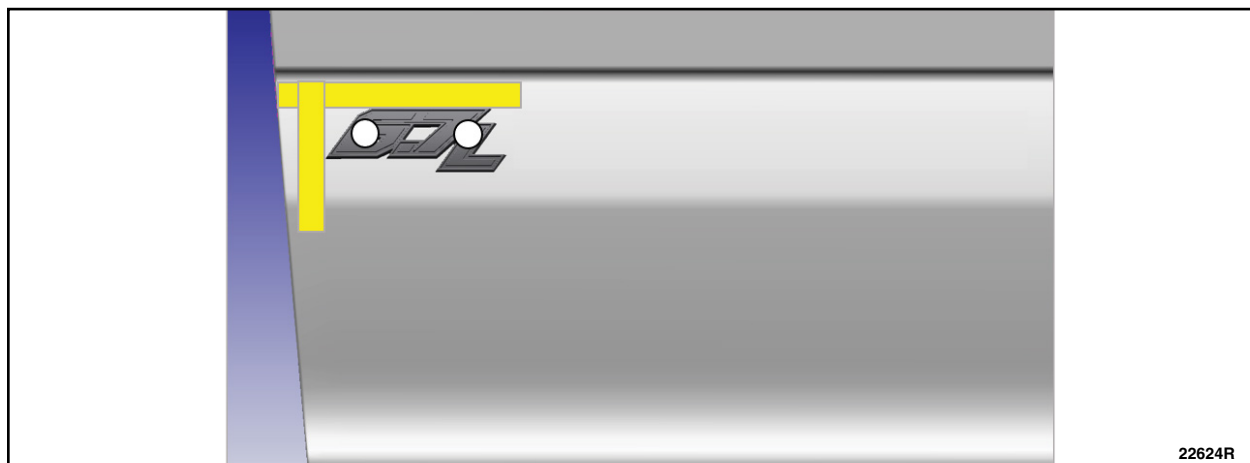
FIGURE 5

19. Remove the tape liner from the back of the badge and install to the door using the locating tape to properly align the badge. See Figure 5.
20. Using medium hand pressure, press for 3 seconds at a minimum of 2 separate locations along the length of the badge until the tape is fully adhered. See Figure 5.
