PRODUCT CAMPAIGN BULLETIN

APPLICABILITY: 2005-2009 Subaru Legacy and Outback
 2009-2013 Subaru Forester
 2008-2011 Subaru Impreza, WRX, and STI
 2012-2014 Subaru WRX and STI

NUMBER: WQK-47R

SUBJECT: Brake Line Corrosion

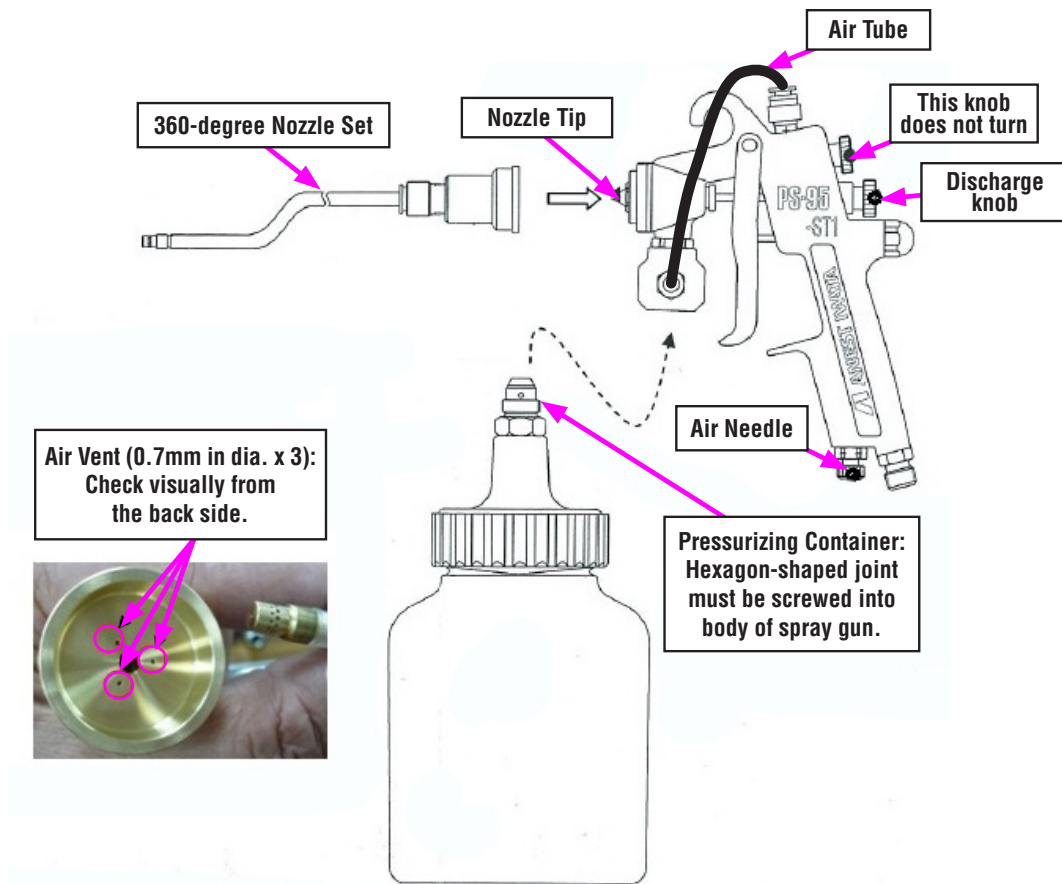
(2-1) Assembling of Spray Gun:

IMPORTANT: Be careful not to damage or deform the nozzle tip.

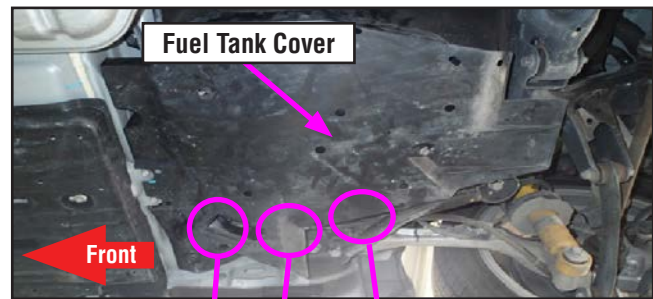
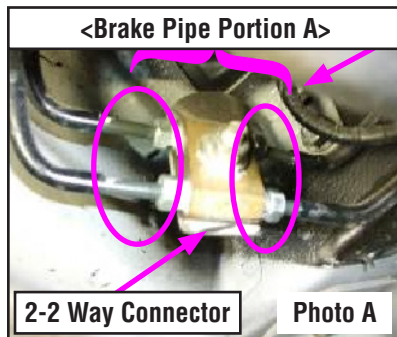
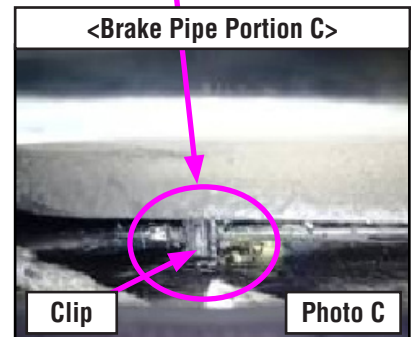
(2-1) Confirm the location of Brake Pipe Portion A around 2-2 Way Connector by opening inspection hole cover. (Photo 1 and A)

(2-2) Confirm the location of Brake Pipe Portion B and C through side gap of fuel tank cover. (Photo B and C)

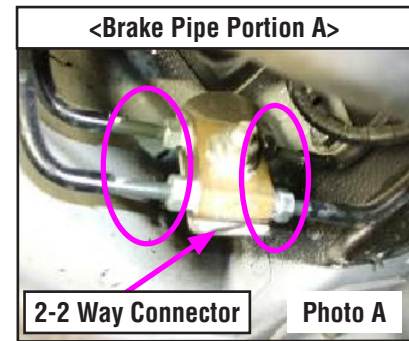
(4-1) Check for fluid leakage for Brake Pipe Portion A. (Photo A)

(5-2) If brake fluid leakage is verified, Proceed to [Step 4] “**BRAKE PIPING REPLACEMENT**”.

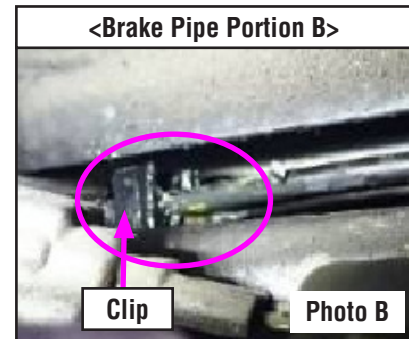
(4-2) Check for fluid leakage from Brake Pipe Portion B. (Photo B)

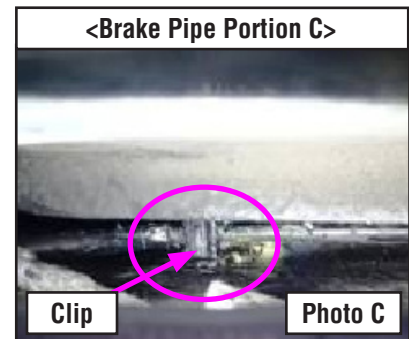
(4-3) Check for fluid leakage from Brake Pipe Portion C. (Photo C)

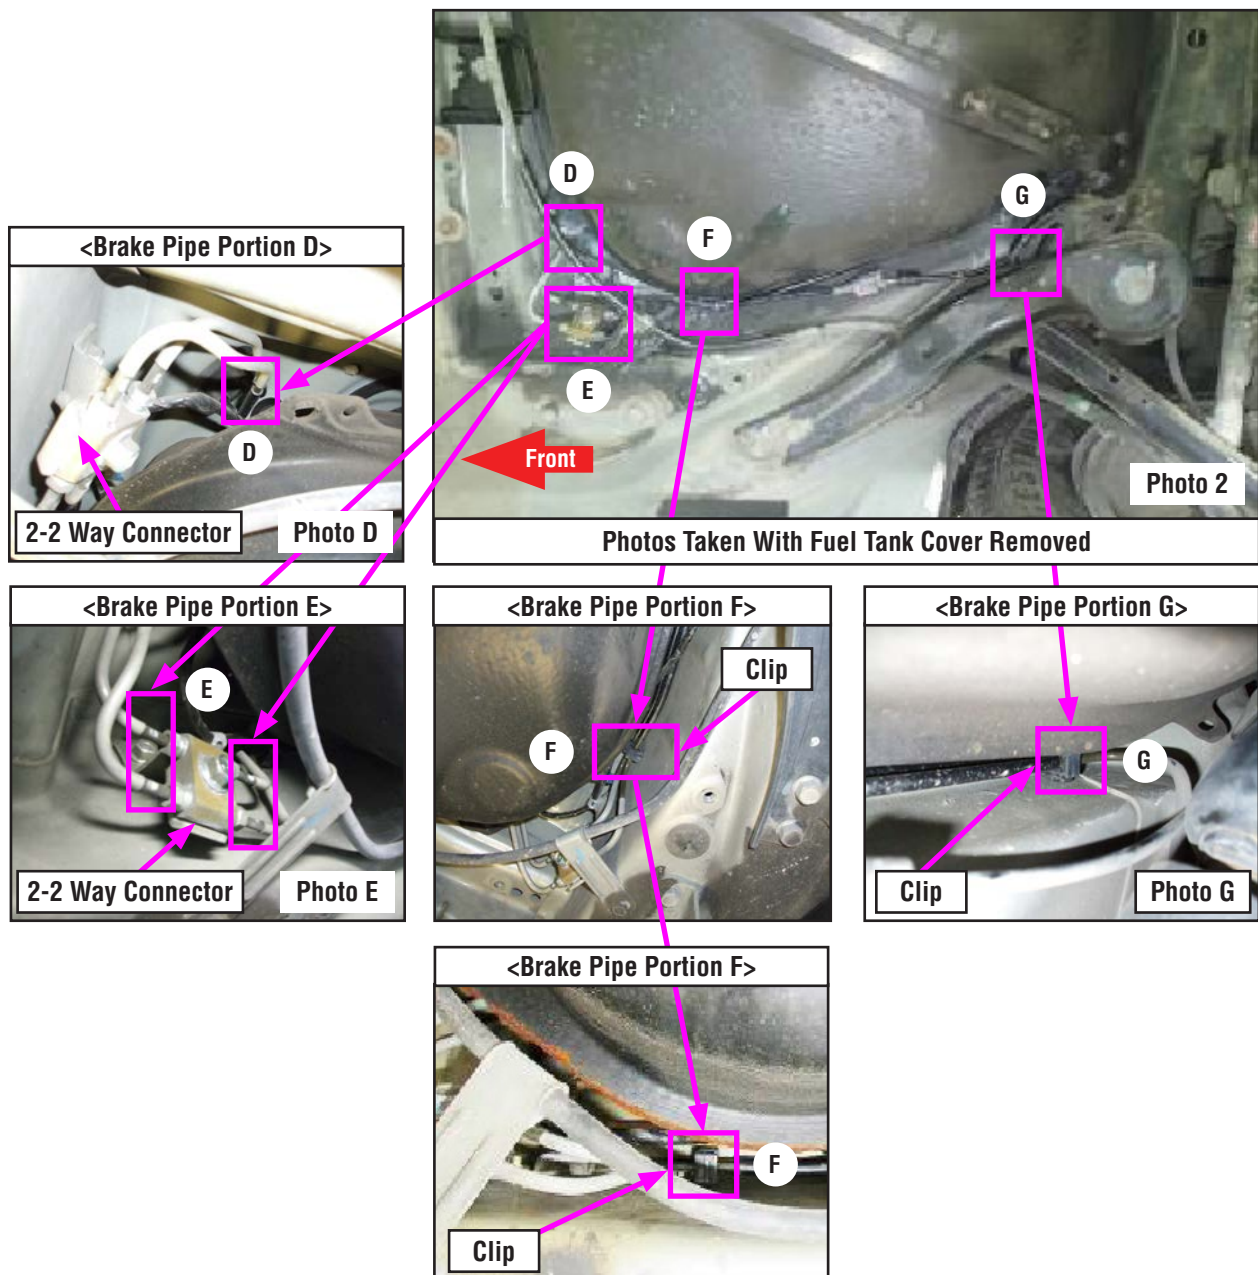
(2-3) Confirm the location of Brake Pipe Portion F in the rear of 2-2 Way Connector.
(Photo F)

(2-4) Confirm the location of Brake Pipe Portion G through the side gap of fuel tank.
(Photo G)

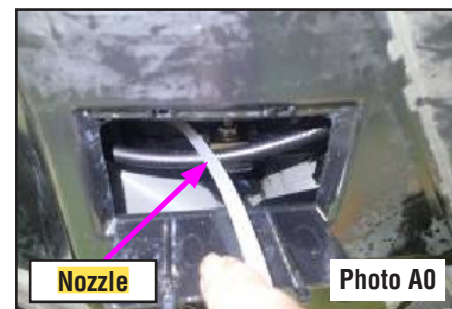
- (2-1-1) Open the inspection hole door in the fuel tank cover and insert the nozzle. (Photo A0)

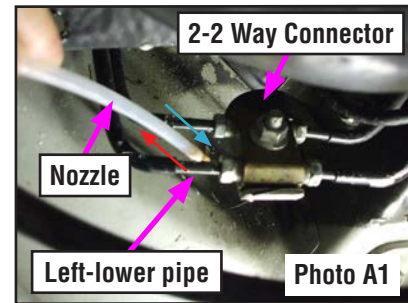
(2-1-2) Insert the nozzle over the left-lower pipe of the 2-2 Way Connector. Remove the nozzle while spraying for 3 seconds or more. (Photo A1)

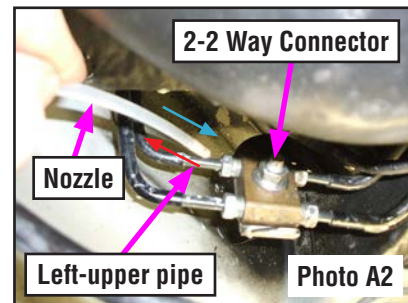
(2-1-3) Insert the nozzle over the left-upper pipe of the 2-2 Way Connector. Remove the nozzle while spraying for 3 seconds or more. (Photo A2)

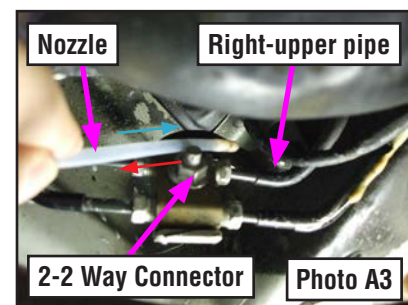
(2-1-4) Insert the nozzle over the right-upper pipe of the 2-2 Way Connector. Remove the nozzle while spraying for 3 seconds or more. (Photo A3)

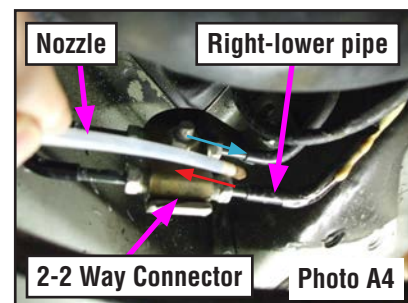
(2-1-5) Insert the nozzle over the right-lower pipe of the 2-2 Way Connector. Remove the nozzle while spraying for 3 seconds or more. (Photo A4)

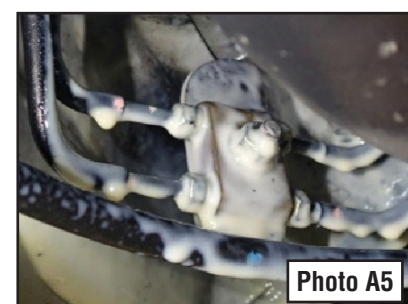
- Spray until the sprayed wax material drips. (Photo A5)
- To insure the proper amount of wax is applied, follow the steps listed above closely.

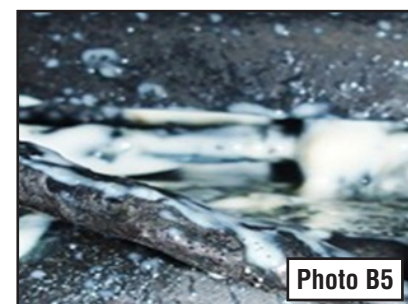
- Spray until the sprayed wax material drips. (Photo B5)
- To insure the proper amount of wax is applied, follow the steps listed above closely.

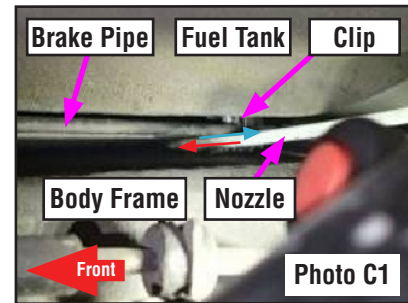
(2-3-1) Insert the nozzle between the brake pipe and the body frame in front of the clip as far as possible. Remove the nozzle while spraying for 3 seconds or more. (Photo C1)

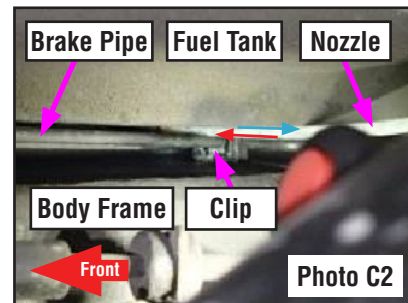
(2-3-2) Insert the nozzle between the brake pipe and the fuel tank in front of the clip as far as possible. Remove the nozzle while spraying for 3 seconds or more. (Photo C2)

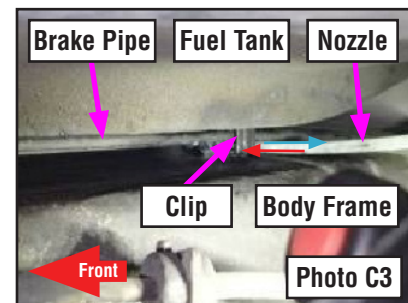
(2-3-3) Insert the nozzle between the brake pipe and the **body frame** at the rear of the clip as far as possible. Remove the nozzle while spraying for 3 seconds or more. (Photo C3)

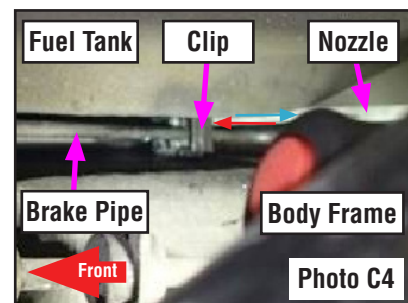
(2-3-4) Insert the nozzle between brake pipe and **fuel tank** at the rear of the clip as far as possible. Remove the nozzle while spraying for 3 seconds or more. (Photo C4)

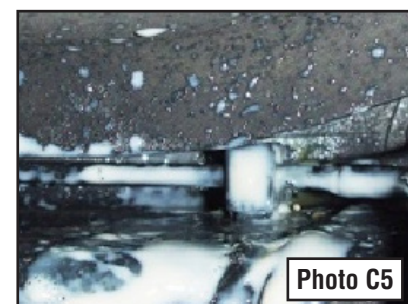
- Spray until the sprayed wax material drips. (Photo C5)
- To insure the proper amount of wax is applied, follow the steps listed above closely.

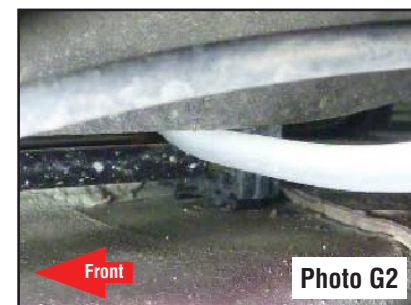
(2-1-3) Insert the nozzle in front of the clip between the brake pipe and the fuel tank. Remove the nozzle while spraying for 3 seconds or more. (Photo G2)

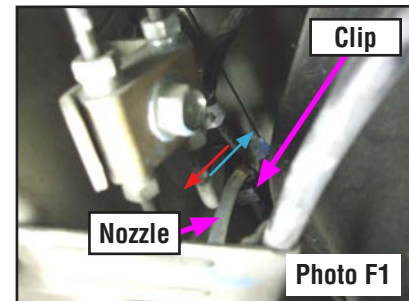
(2-2-2) Insert the nozzle in front of the clip until the nozzle touches body frame. Remove the nozzle while spraying for 3 seconds or more. (Photo F1)

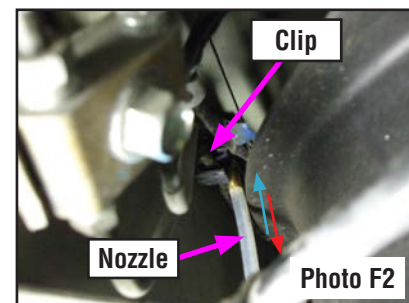
(2-2-3) Insert the nozzle in rear of the clip until nozzle touches the body frame. Remove the nozzle while spraying for 3 seconds or more. (Photo F2)

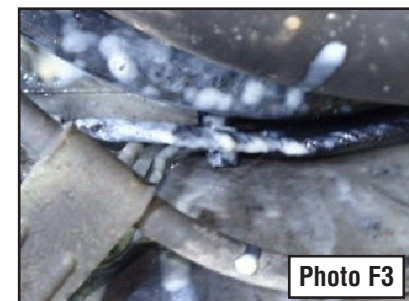
- Be sure to spray until sprayed wax material drips. (Photo F3)
- To insure the proper amount of wax material is applied, follow the steps listed above closely.

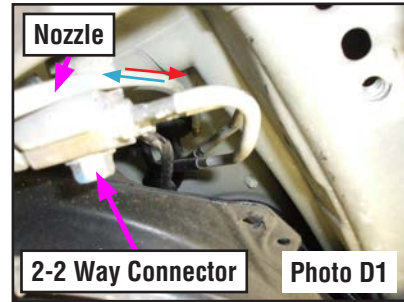
(2-3-1) Insert the nozzle to the left side of the 2-2 Way Connector. Remove the nozzle while spraying for 3 seconds or more. (Photo D1)

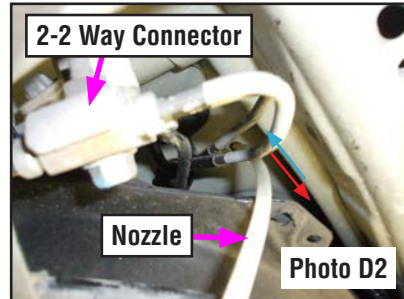
(2-3-2) Insert the nozzle to the right side of the 2-2 Way Connector. Remove the nozzle while spraying for 3 seconds or more. (Photo D2)

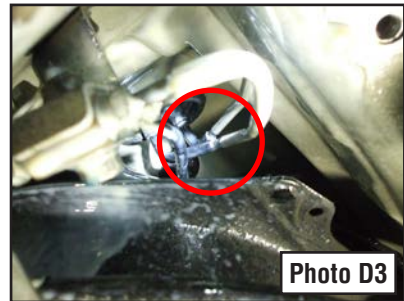
- Be sure to spray until sprayed wax material drips. (Photo D3)
- To insure the proper amount of wax is applied, follow the steps listed above closely.

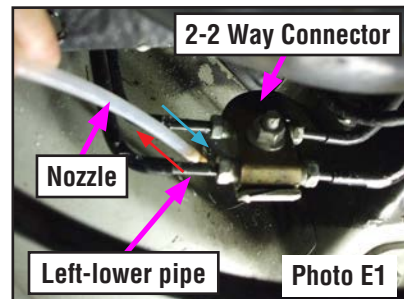
(2-4-1) Insert the nozzle over the left-lower pipe of the 2-2 Way Connector. Remove the nozzle while spraying for 3 seconds or more. (Photo E1)

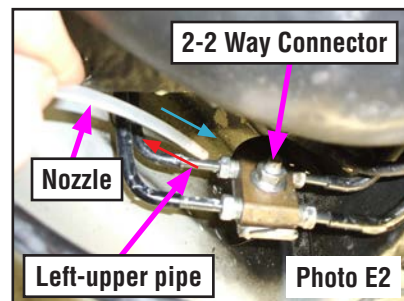
(2-4-2) Insert the nozzle over the left-upper pipe of the 2-2 Way Connector. Remove the nozzle while spraying for 3 seconds or more. (Photo E2)

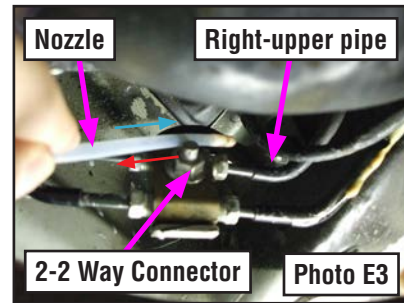
(2-4-3) Insert the nozzle over the right-upper pipe of the 2-2 Way Connector. Remove the nozzle while spraying for 3 seconds or more. (Photo E3)

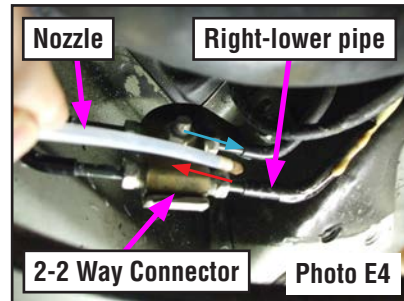
(2-4-4) Insert the nozzle over the right-lower pipe of the 2-2 Way Connector. Remove the nozzle while spraying for 3 seconds or more. (Photo E4)

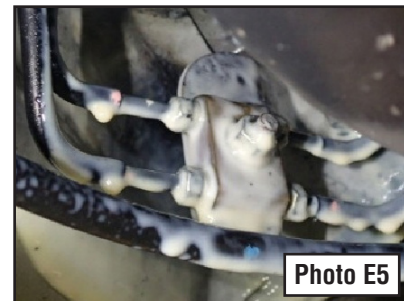
- Spray until the sprayed wax material drips. (Photo E5)
- To insure the proper amount of wax is applied, follow the steps listed above closely.
