## **Additional Information Regarding the WQE-41 Puddle Light Campaign**

**FROM:** Subaru of America, Inc.

**DATE:** 3/13/2013

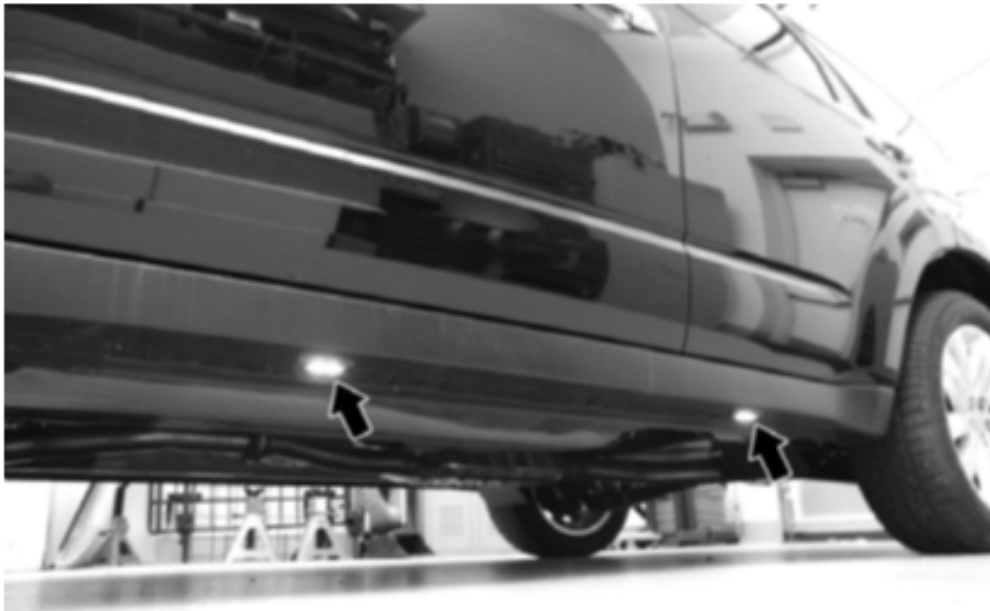
First and foremost, verify the vehicle is equipped with Genuine Subaru accessory puddle lights. If the vehicle is not equipped, release the vehicle as no correction is required.

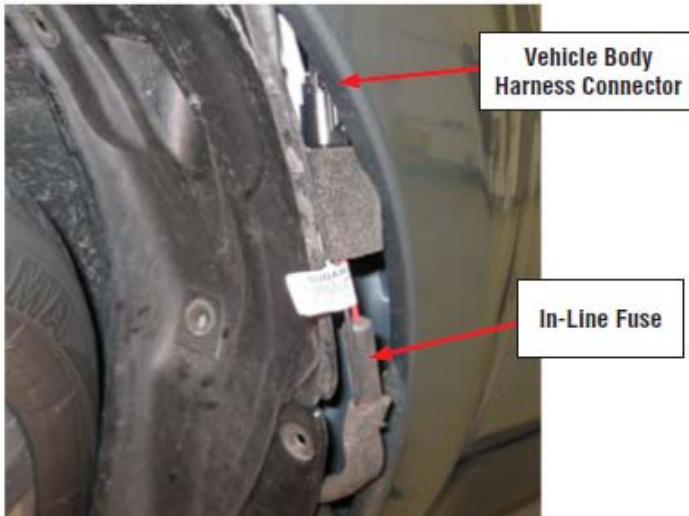
- Before disconnecting any connections, be sure to disconnect the vehicle's battery as listed in the Campaign Service Procedure or you risk the possibility of damage to the BIU from a voltage spike.
- The In-Line Fused Puddle Light Harness referenced in the Labor Descriptions above is shown in the image below. As long as the puddle lights are fully functioning, this harness does not require replacement and does not require a Fused Mini-Harness installation. This type of harness (with In-Line Fuse) is also the current replacement part. Again, a Mini-Fused Harness is not required when this type of harness is present and all related puddle lights are functioning correctly.
