**SUBJECT: NEW VEHICLE RECOMMENDED DELIVERY HOLD
Customer Satisfaction Program 23B04**

Certain 2023 Model Year Transit
Missing Rear Vinyl Floor Covering

CERTAIN 2023 MODEL YEAR TRANSIT VEHICLES — VINYL FLOOR COVER

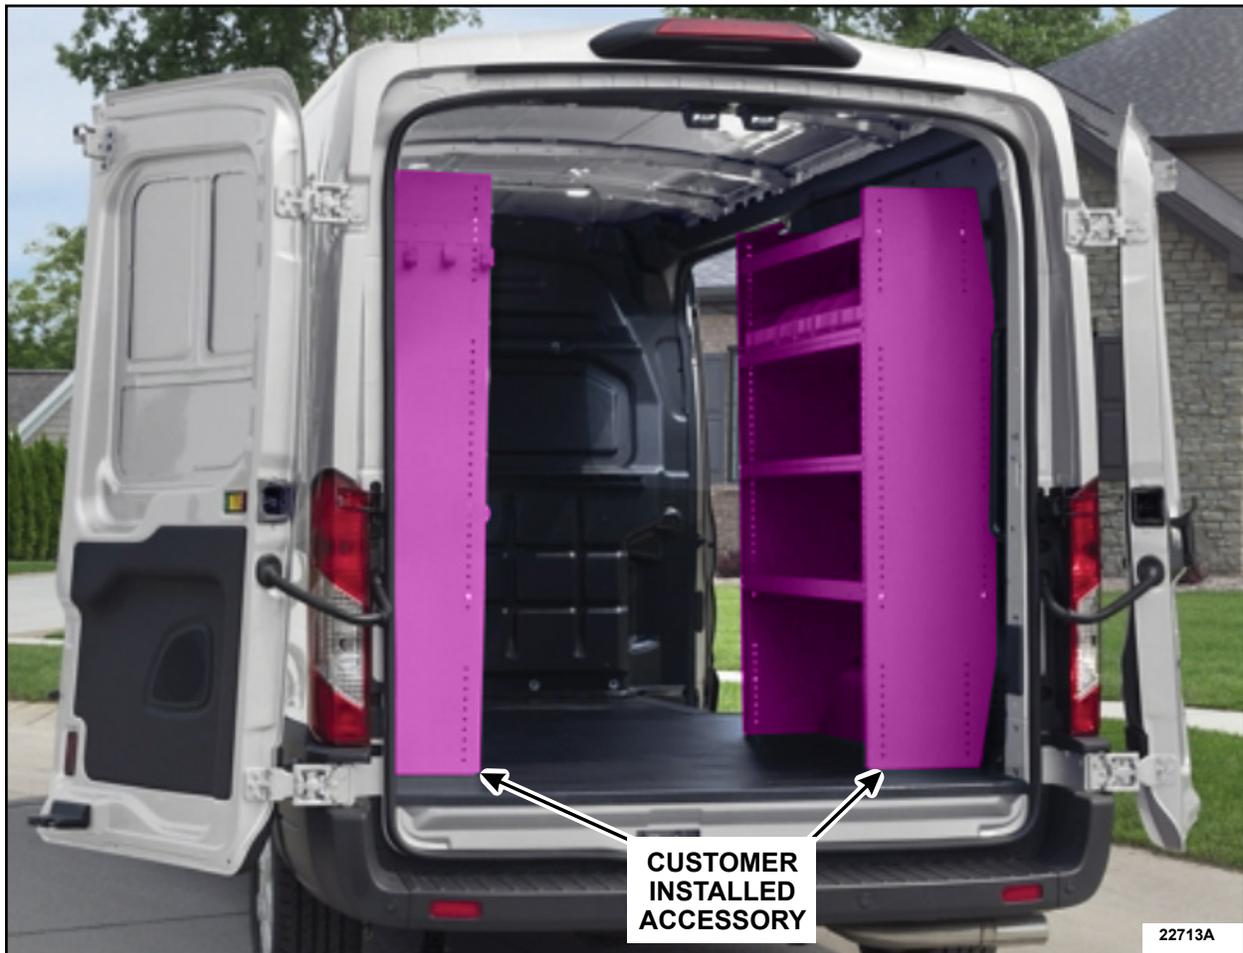
FIGURE 1

1. If equipped, remove any customer installed accessory such as tool racks, storage racks, or any other floor mounted accessory. See Figure 1.

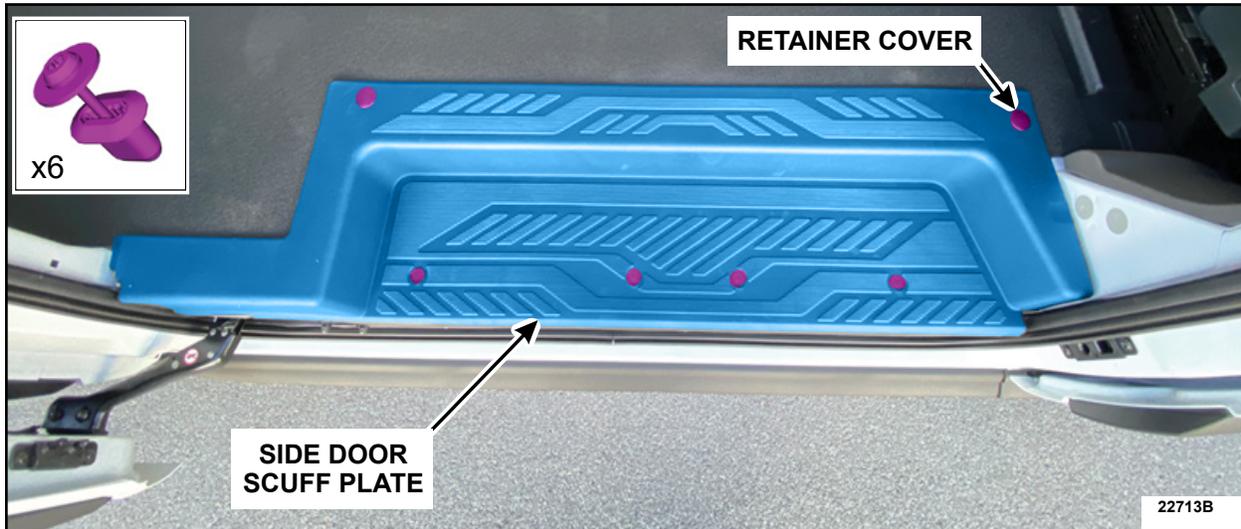
FIGURE 2

2. If equipped, remove the second row seats. Follow the Workshop Manual (WSM) procedures in Section 501-10B.
3. If equipped, remove the third row seats. Follow the WSM procedures in Section 501-10C.
4. If equipped, remove the additional row seats. Follow the WSM procedures in Section 501-10D.
5. If equipped, remove the pin-type retainer covers, retainers and the side door scuff plate. See Figure 2.

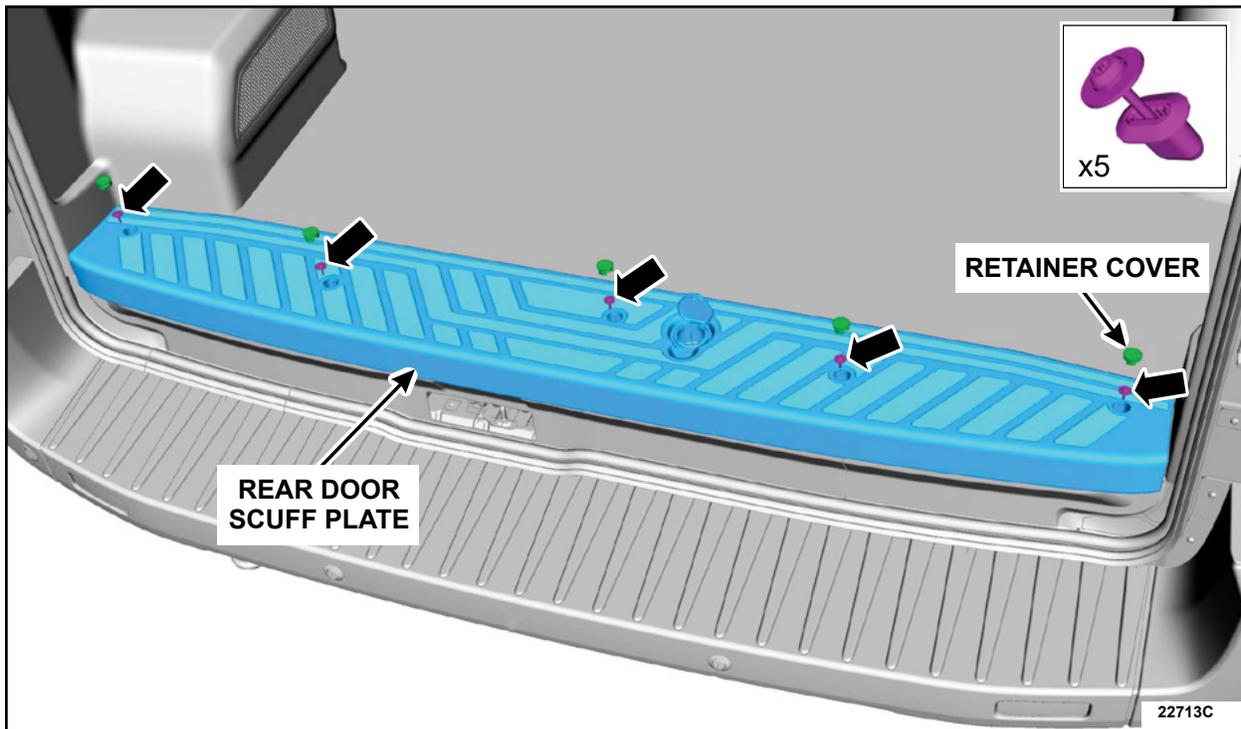
FIGURE 3

6. If equipped, remove the pin-type retainer covers, retainers and the rear door scuff plate. See Figure 3.

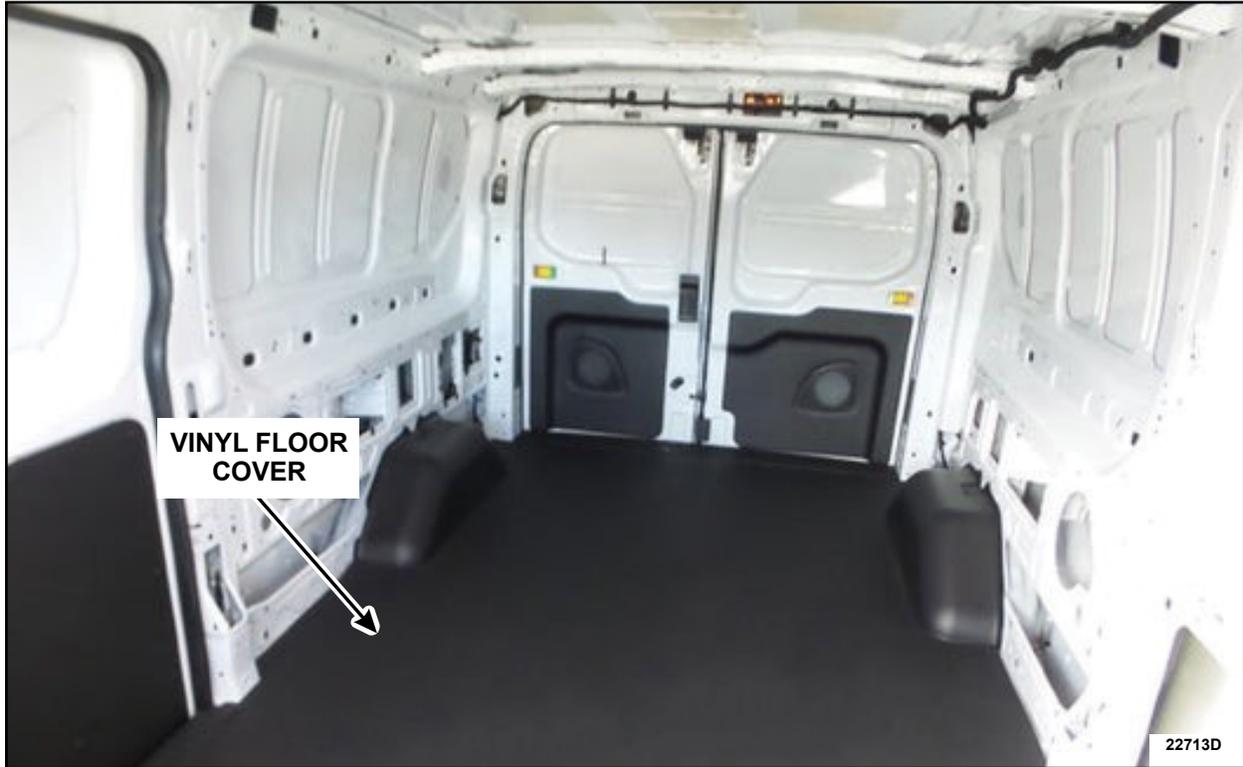
FIGURE 4

7. With the aid of a second technician, install the one piece vinyl floor cover. See Figure 4.

8. Reassemble the vehicle by reversing the disassembly procedures.
