SUBJECT: NEW VEHICLE RECOMMENDED DELIVERY HOLD

Update Before Sale 23U07

Certain 2024 Model Year Mustang Vehicles Equipped with Front Recaro Seats
Mismatched Front Recaro Seats Inspection/Replacement

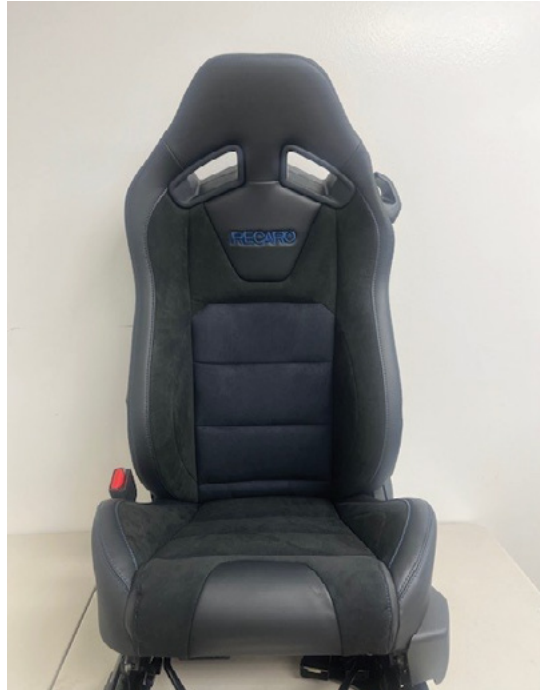
FIGURE 1

VINYL/SUEDE
BLACK ONYX

1. Using the Vehicle Identification Number (VIN) and the Recaro Seat Material/Color Look-Up Tables attachment, find the material/color your VIN should be equipped with. Inspect both front Recaro seats for having the correct material and color Recaro seats as indicated in the attachment. Refer to Figures 1, 2 and 3 for material and color examples.

Vinyl/Suede – Black Onyx

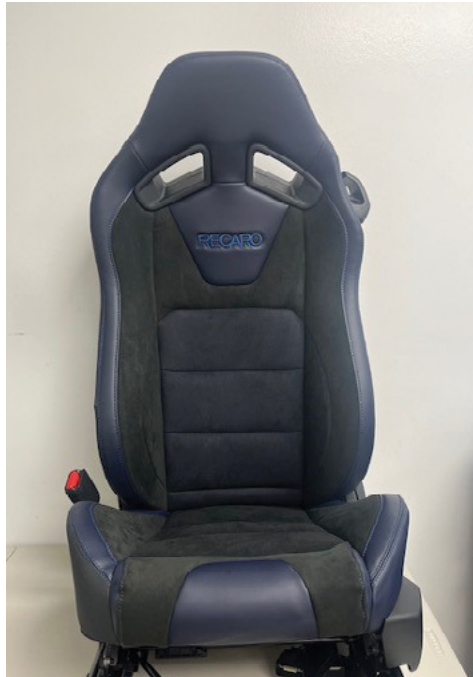
FIGURE 2

VINYL/SUEDE
DEEP INDIGO

Vinyl/Suede – Deep Indigo

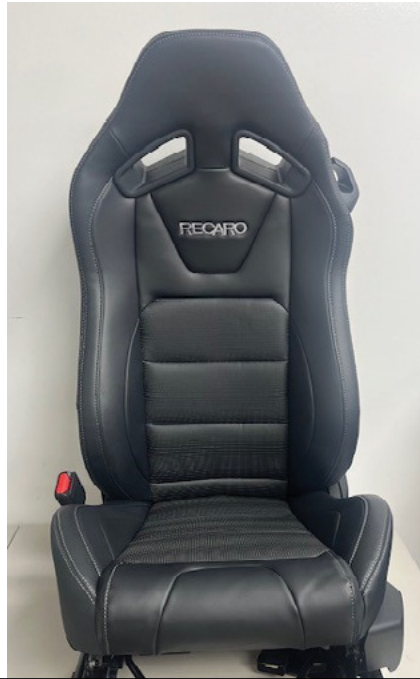
FIGURE 3

LEATHER
BLACK ONYX

Leather – Black Onyx
