TO: Mercedes-Benz Dealer Principals, General Managers, Sales Managers, Service Managers, Parts Managers	FROM: Gregory Gunther, Department Manager, Vehicle Compliance and Analysis, Engineering Services
RE: Emission Recall Campaign Notification Replace Incorrect Catalyst MY18-19 GLE-Class (166/292 platform)	DATE: October 09, 2020

Campaign No. 2020050006, July 2020

SUBJECT: **Model GLE and GLS-Class vehicles (166/292 platform)**
Model Year 2018-2019
Incorrect Catalyst

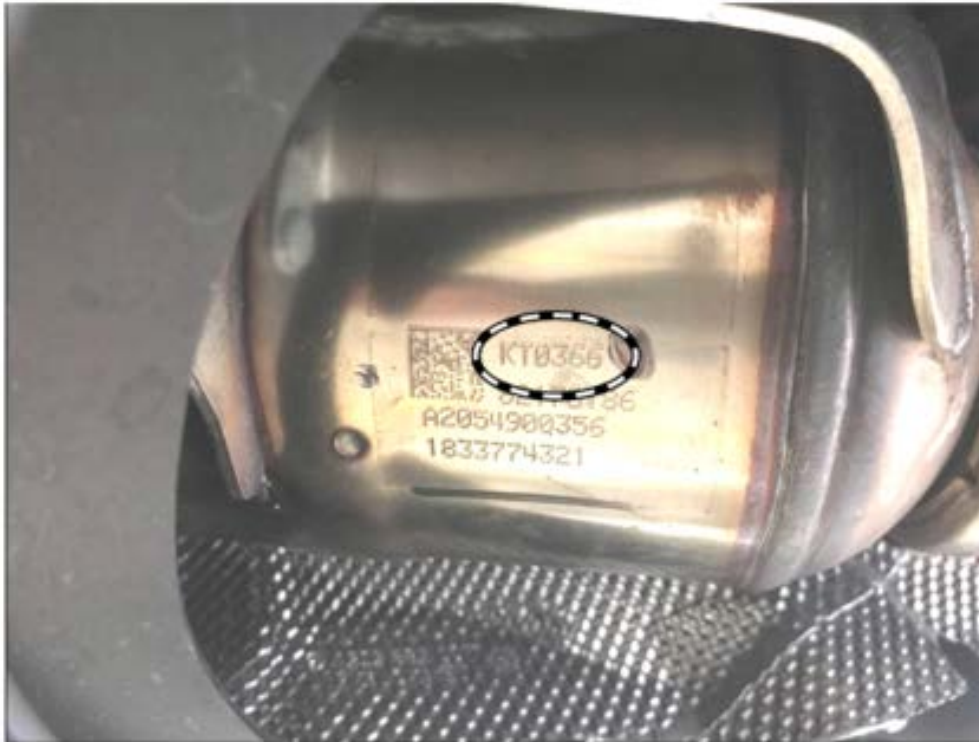
Figure 1

1. Remove lower engine compartment lining.
 For basic data, see **AR61.30-P-1001GQ**.
2. Check which KT number is stamped on the left and right catalytic converters (**Figure1**).
 For vehicles with engine **M157**, KT number **KT A050** must be stamped on the catalytic converter.
 For vehicles with engine **M276**, KT number **KT 0354** must be stamped on the catalytic converter.
 For vehicles with engine **M278**, KT number **KT 0366** must be stamped on the catalytic converter.

- a. **KT number** on catalytic converter **not OK**: Carry out **work procedure**.
- b. **KT number** on catalytic converter **OK**: **End measure**.

1. Replace left and/or right catalytic converters.
 For basic data, see **AR49.10-P-5500GQC** for **M276**.
 For basic data, see **AR49.10-P-5500MLJ** for **M278** and **M157**.

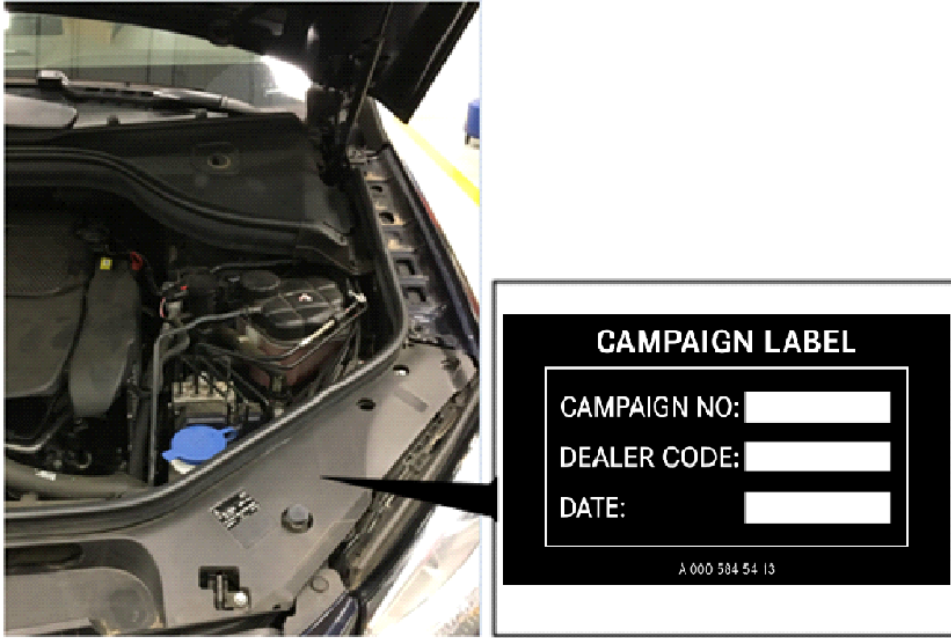
Figure 1

Apply Proof of Correction Label (A 000 584 54 13) to area identified in **Figure 1**. Fill in the blank areas of the label. The campaign number for the California Proof of Correction is unique and must be entered as such (200506), your dealer code, and the date of the repair, using a black permanent marker.

i Note: Clean bonding surface prior to affixing label.
