RE: [Service Campaign 2020040022 Launch Notification](#)
MY19 238 (E-Class) Right Drip Rail Retaining Tabs

Service Campaign Bulletin

Campaign No. 2020040022, May 2020

SUBJECT: **Model E-Class vehicles (238 platform)**
Model Year 2019
Right Drip Rail Retaining Tabs

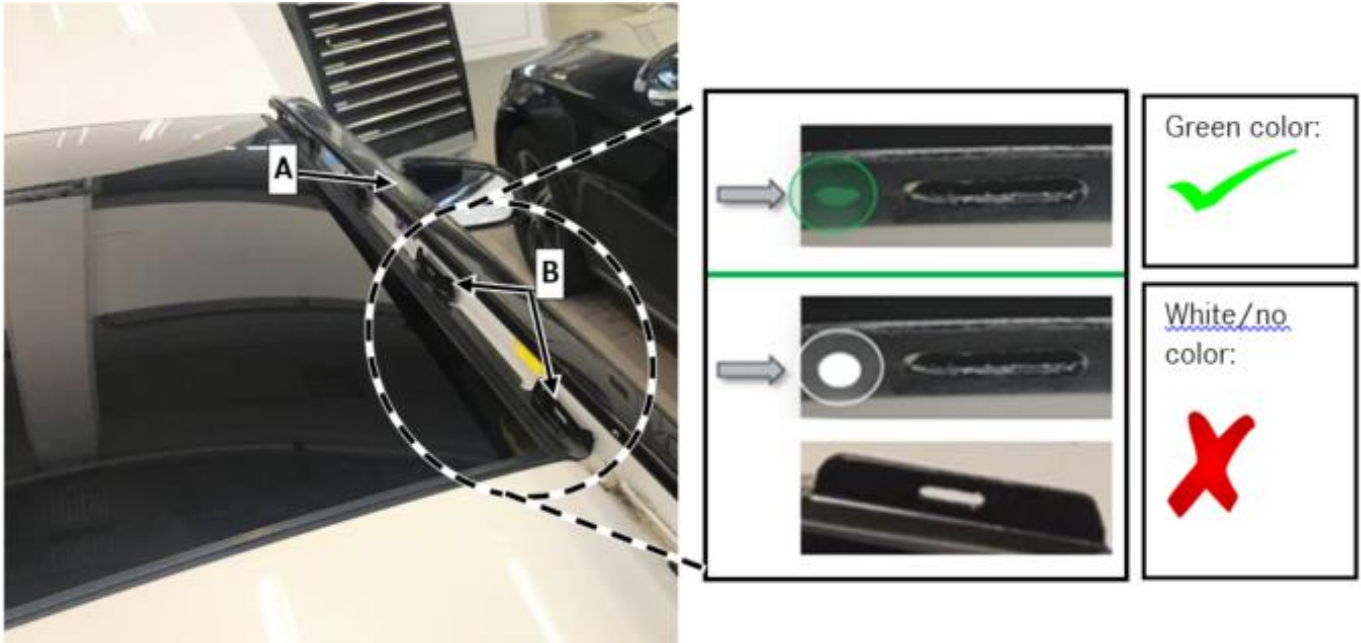
**Figure 1**

1. Unfasten right drip rail (**A, figure 1**) from the rear to the center of the panoramic sliding sunroof.
2. Check the exterior of the two rear retaining tabs (**B, figure 1**) for green color coding.

- a. Green color coding ***not*** present on retaining tabs: Perform **scope of work**.
- b. Green color coding present on retaining tabs: **End measure**.
