Campaign No. 2023030016, April 2023

Revision A: 01/17/2024

SUBJECT: **Model GT (190 platform)**  
**Model Year 2021**

## **Check Front Diffuser Attachment Point Seal**

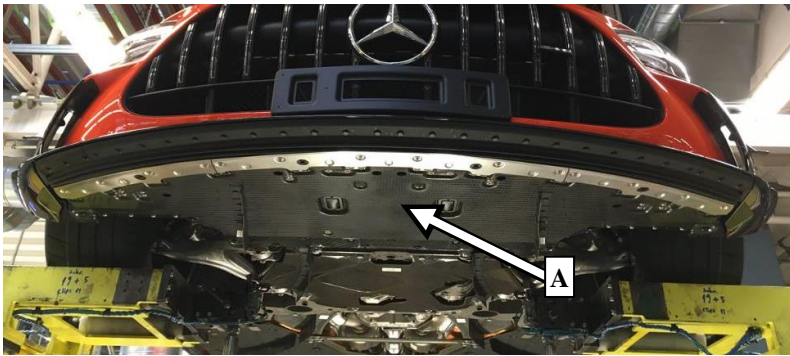
Figure 1

1. Remove lower front diffuser (A, figure 1).

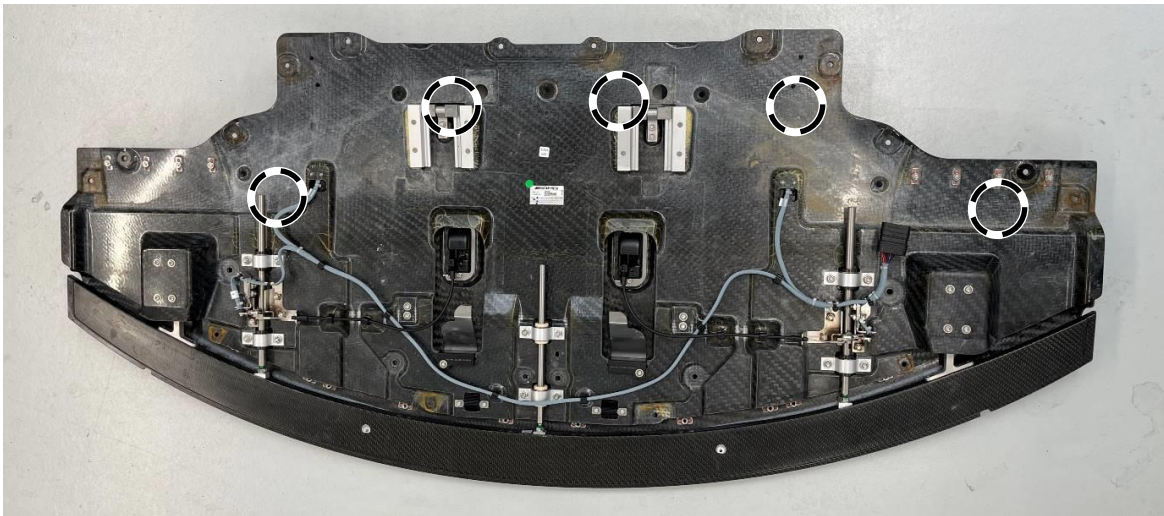
Figure 2

2. Clean 5 threaded connection points (figure 2) of removed front diffuser with **isopropanol** and check for corrosion.

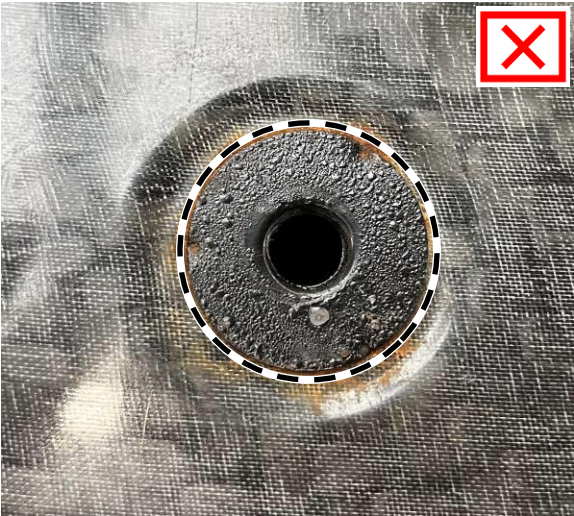
Figure 3, **not OK**

**i** Figure 3 → Metal inserts are corroded (**not OK**)

- a. Metal inserts are **severely corroded** (figure 3): Perform **work procedure A**.
- b. Metal inserts are **not** and/or **only slightly corroded at the edge** (figure 4): Perform **check/test procedure B**

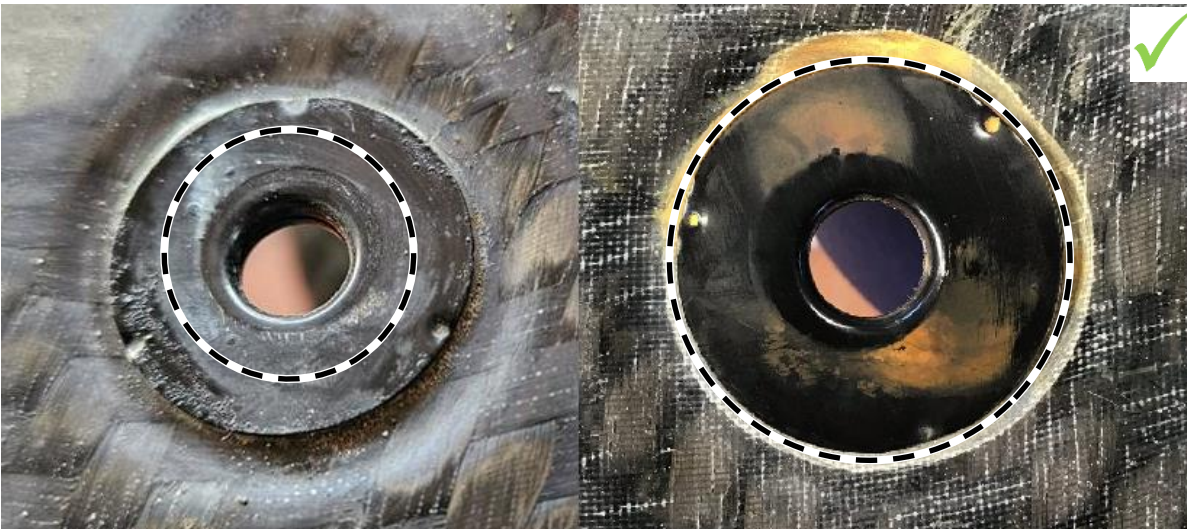
Figure 4, **OK**

**i** Figure 4 → Metal inserts are not/slightly corroded at edge (**OK**)

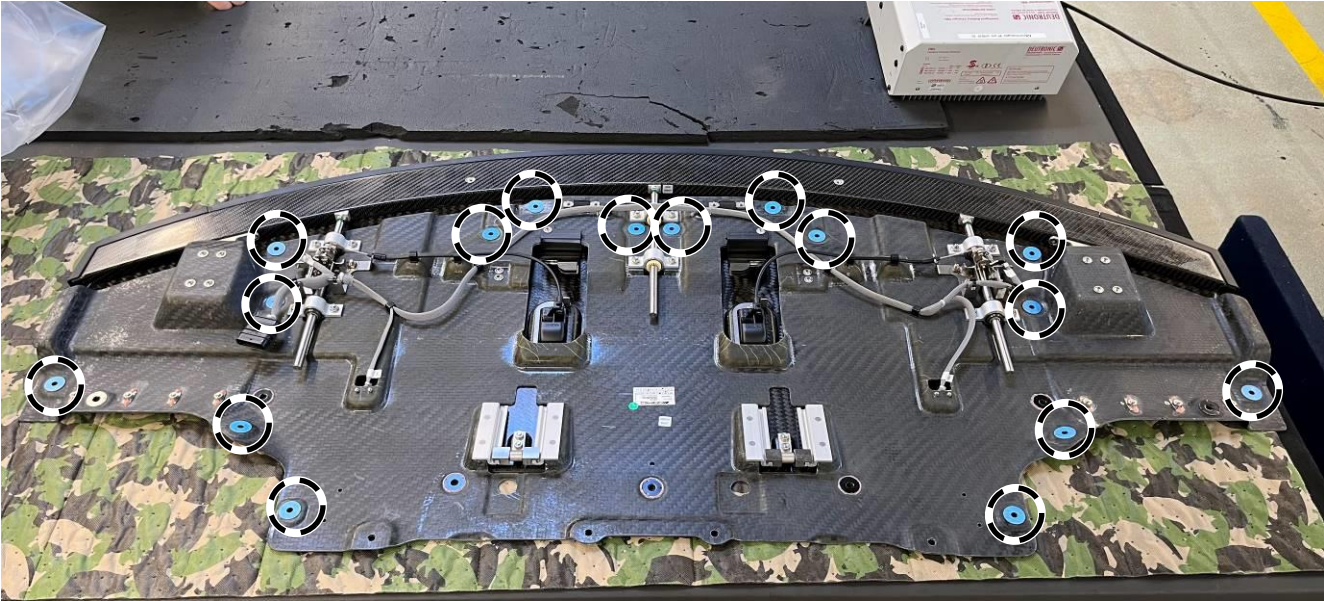
**Figure 5**

1. Check the removed front diffuser to see whether all 16 (blue aramid pads) are affixed to the marked locations (figure 5).

- a. All 16 (aramid pads) are **present** (figure 5): Carry out **work procedure B**.
- b. All 16 (aramid pads) are **not present** (figures 11 and 12): Perform **work procedures B and C**.
