Service Campaign Bulletin

Campaign No. 2023030016, April 2023

SUBJECT: **Model GT (190 platform)**
Model Year 2021

Check Front Diffuser Attachment Point Seal

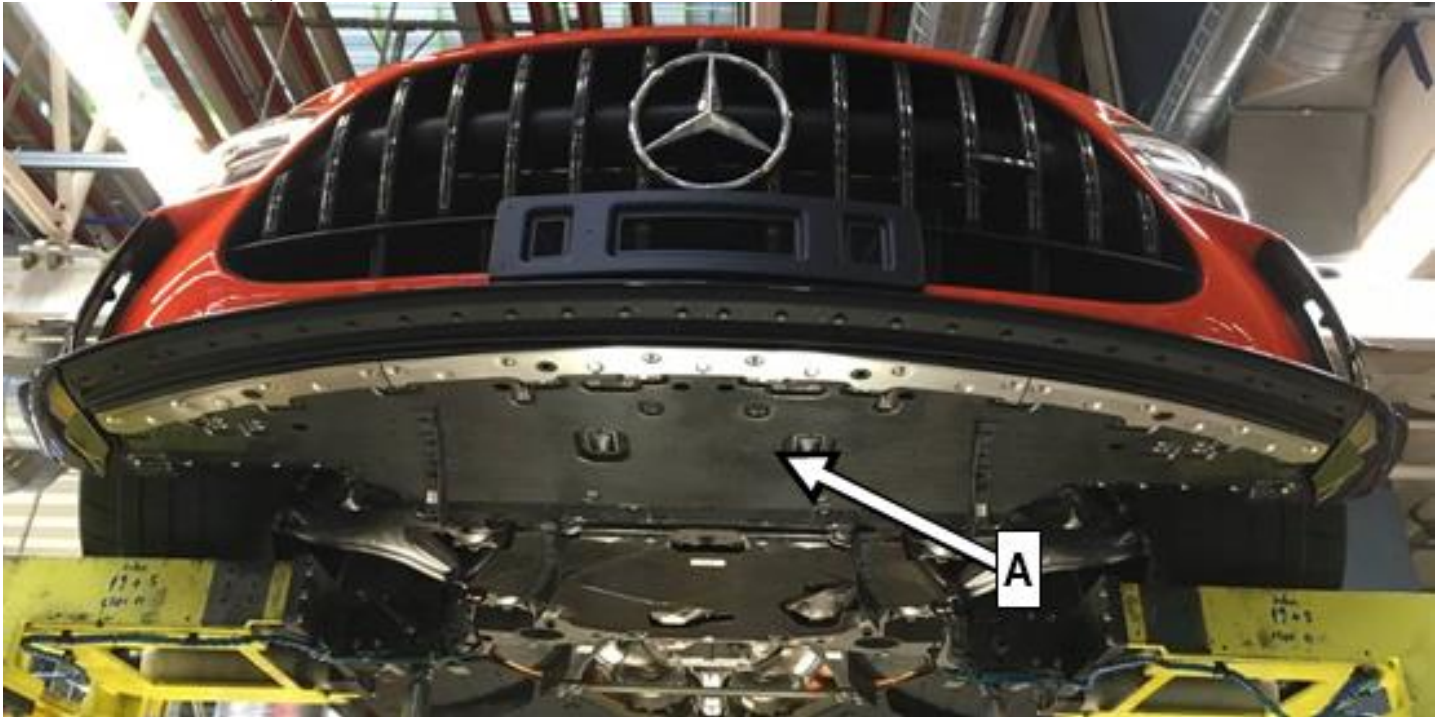
Figure 1

1. Remove lower front diffuser (A, Figure 1).

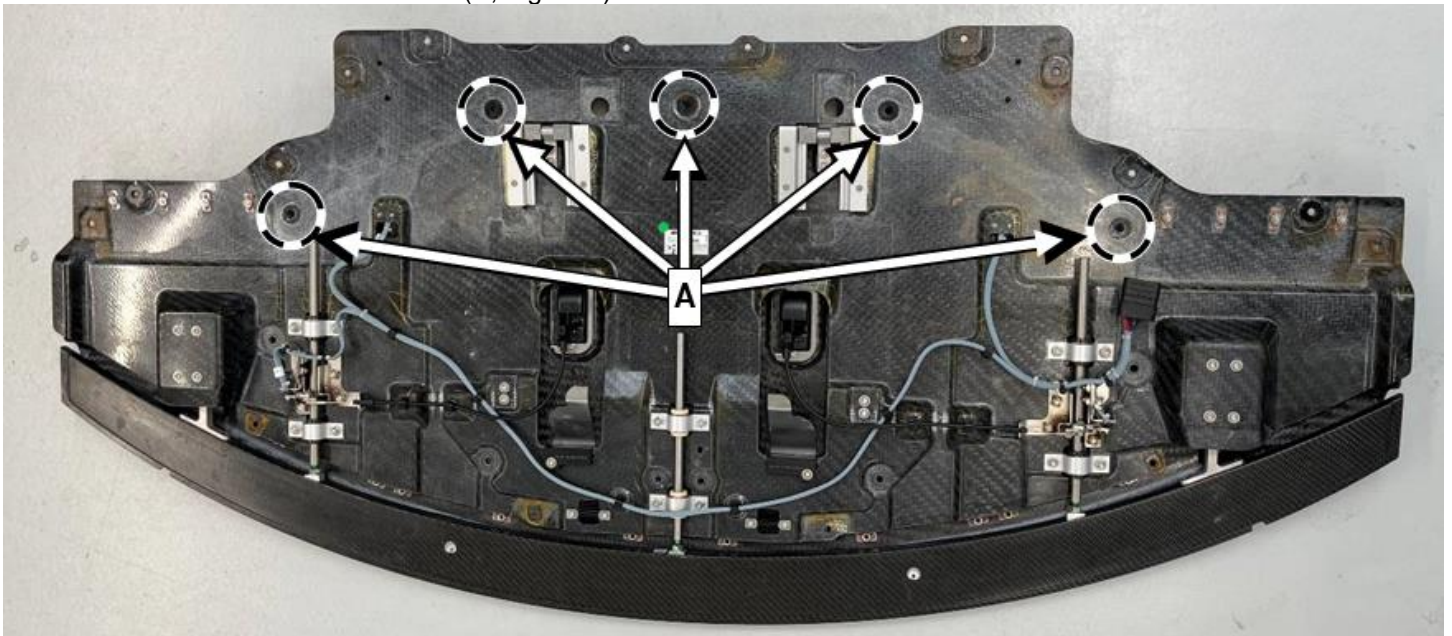
Figure 2

2. Check the 5 threaded connections (A, Figure 2) of the removed front diffuser for corrosion.

1. Clean all 5 attachment points (Figure 2) of the front diffuser with isopropanol and let dry (Figure 6).

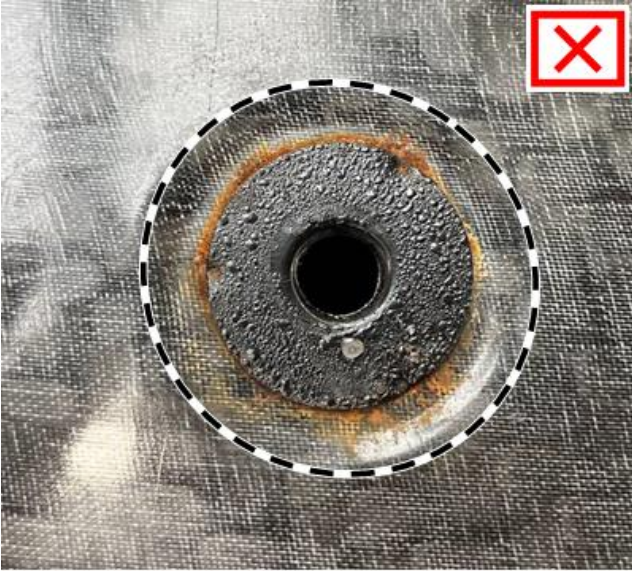
Figure 3 (areas are *corroded* = not OK)

i Figure 3 → Areas are corroded (*not OK*)

- a. Areas are *corroded* (Figure 3): Carry out **work procedure A**.
- b. Areas are *not corroded* (Figure 4): Carry out **Check/test procedure B**.

1. Replace front diffuser.

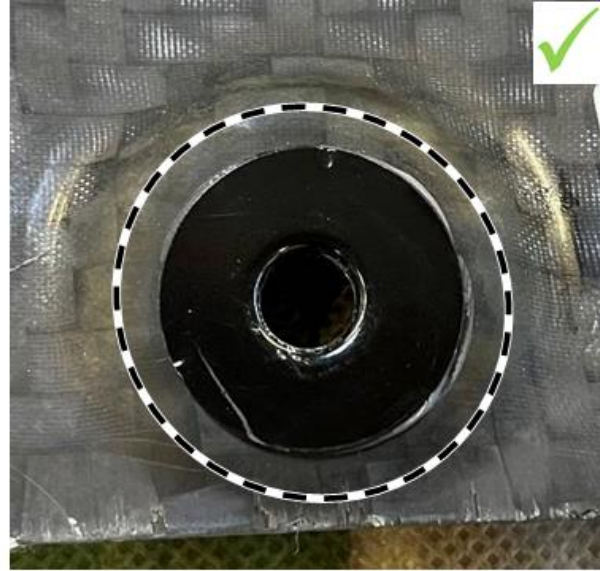
Figure 4 (areas are *not corroded* = OK)

i Figure 4 → Areas are not corroded (*OK*)

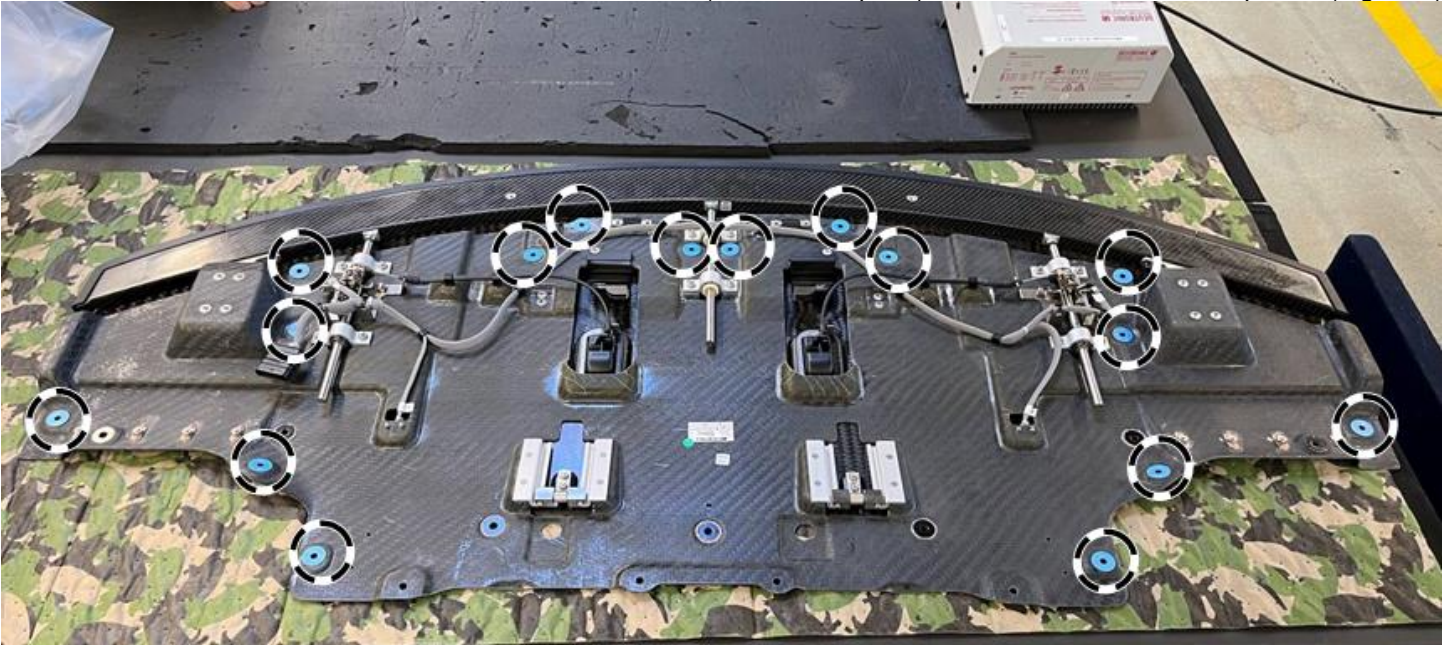
Figure 5

1. Check the removed front diffuser to see whether all 16 (blue aramid pads) are bonded in the marked places (Figure 5).

- a. All 16 (aramid pads) are **present** (Figure 5): Carry out **work procedure B**.
- b. All 16 (aramid pads) are **not present** (Figures 11 and 12): Perform **work procedure B and C**.
