RECALL CAMPAIGN BULLETIN

NTB17-115a

VOLUNTARY SAFETY RECALL CAMPAIGN 2016 ROGUE; FRONT PASSENGER SEAT

CAMPAIGN ID #: PC599

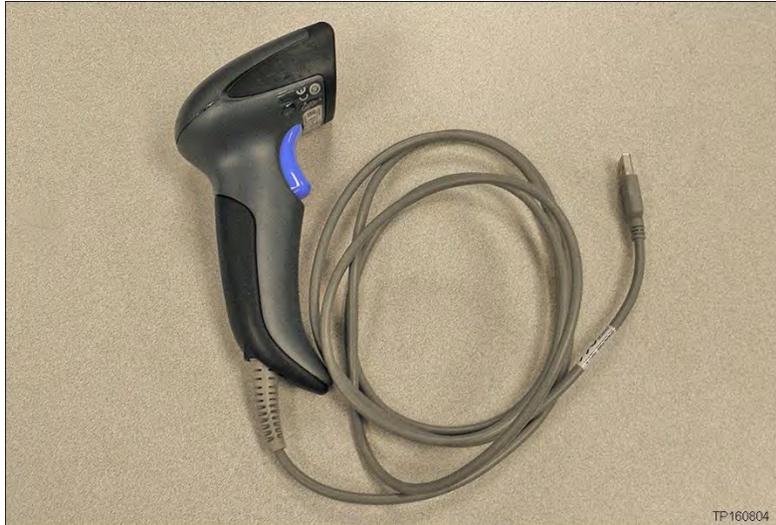
Figure A1

Quick Scan Tool (J-52352)

- Each dealer has been shipped one Quick Scan Tool (J-52352).
- Additional tools can be obtained from Tech•Mate at 1-800-662-2001.

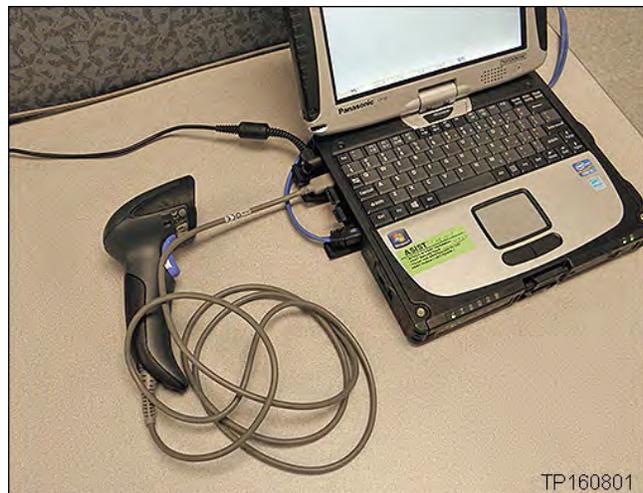
Figure A2

- a. Attach the quick scan tool (J-52352) to your CONSULT PC USB port.

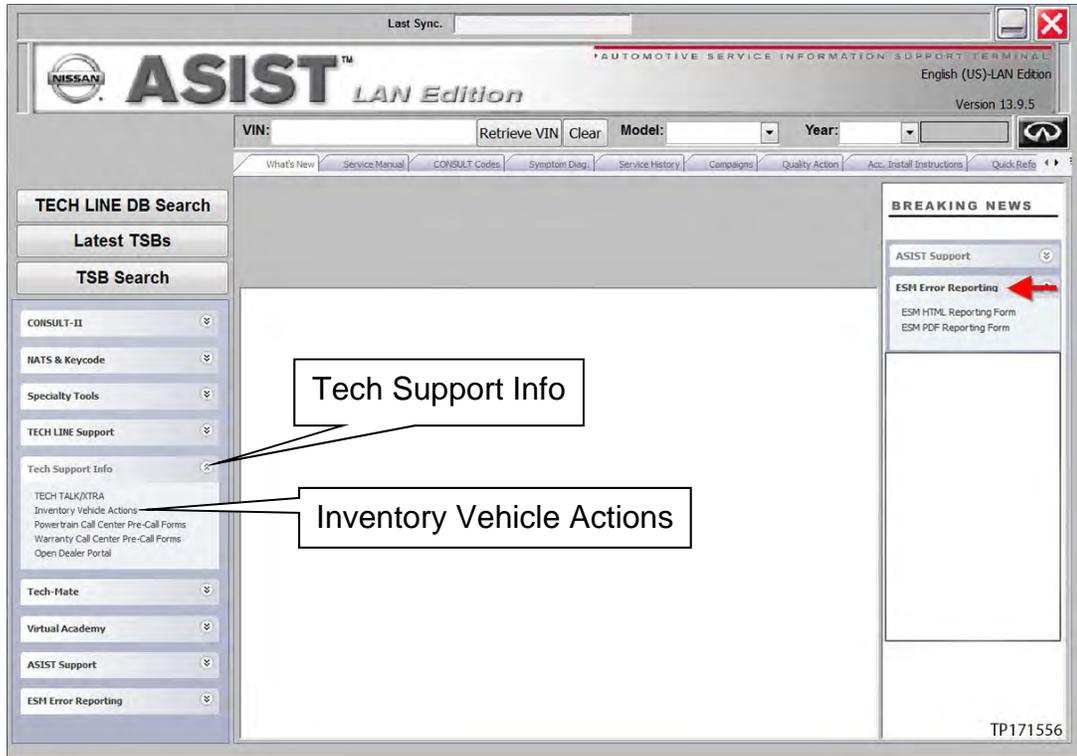
Figure A3

- b. On the left side of the ASIST main menu, select **Tech Support Info**, then **Inventory Vehicle Actions**.

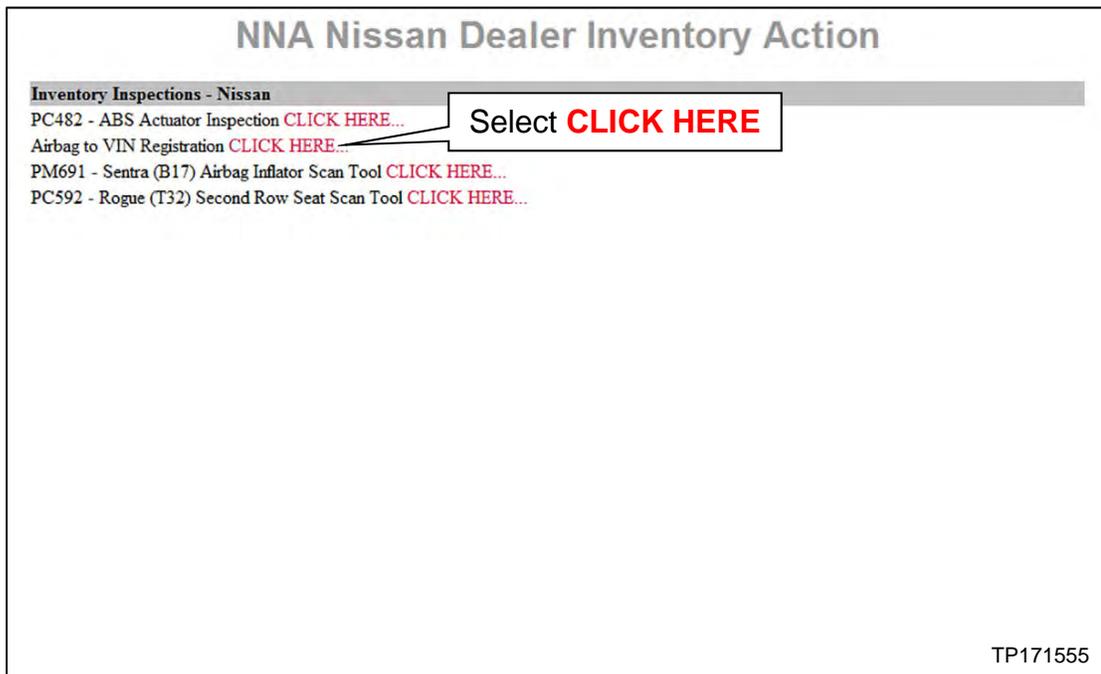
Figure A4

- c. Select **CLICK HERE** ("AirBag to VIN Registration").

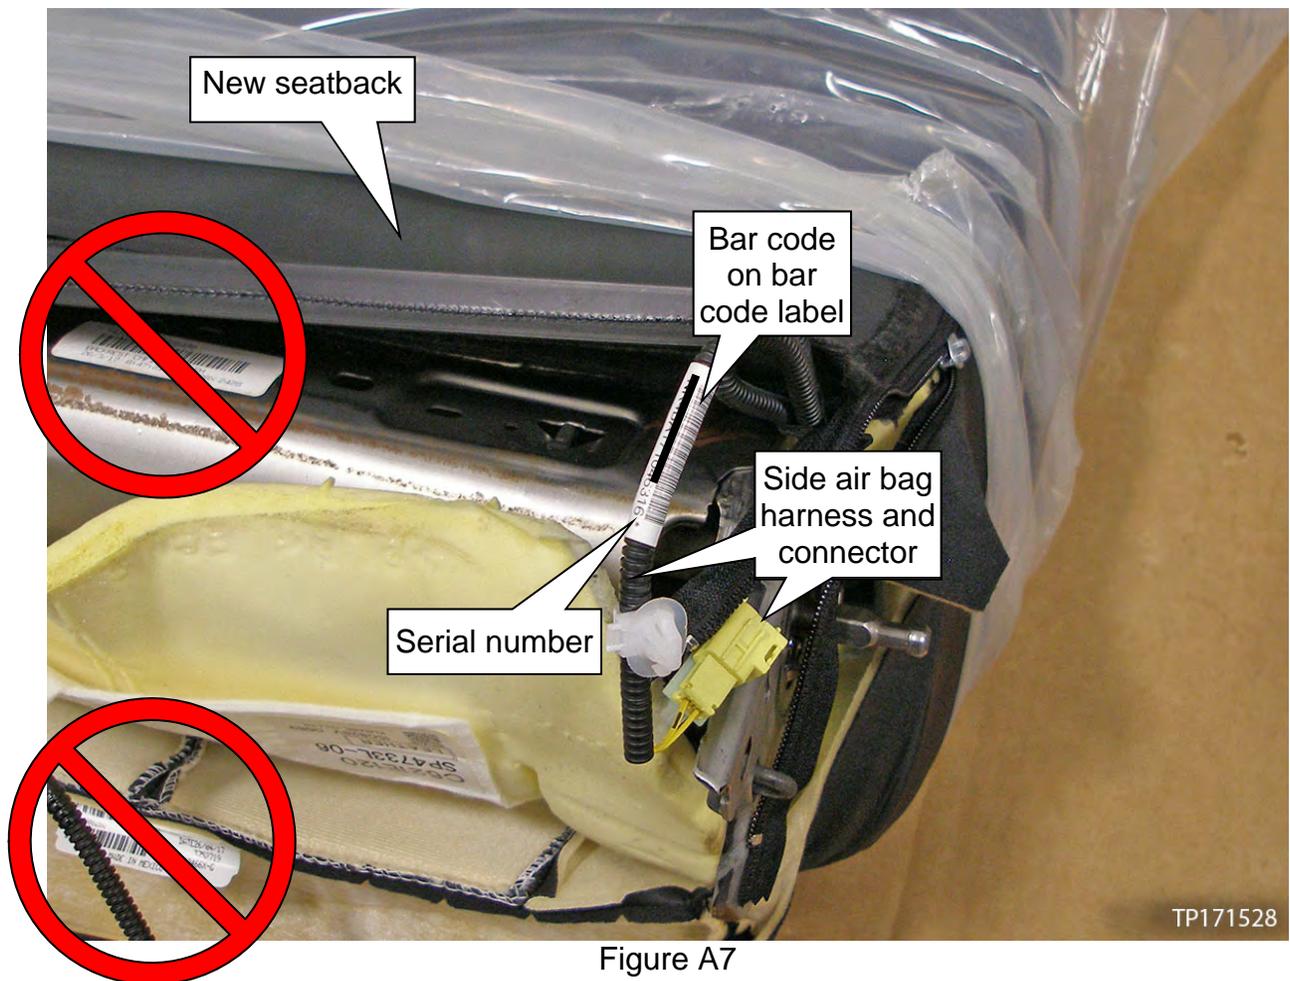
Figure A7

- e. Use the quick scan tool to scan the bar code (serial number) on the new module.
- Access the bar code label (see Figure A7).
 - Hold the scan tool approximately 6 inches away from the bar code label.
 - The serial number will automatically populate (see Figure A6 on previous page).

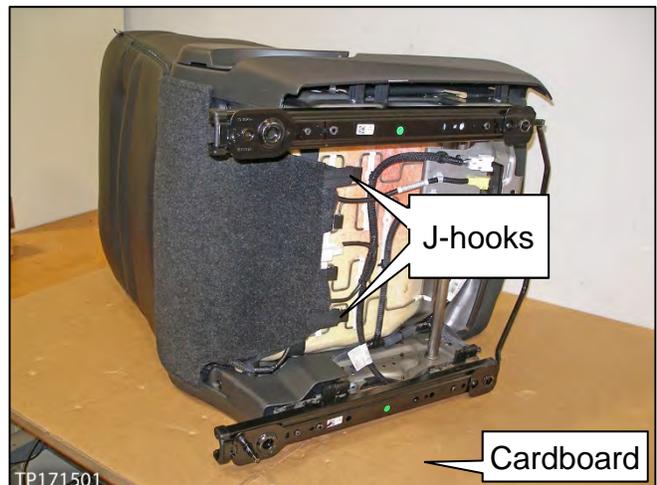
Figure 1

6. Place the seat on its left side.
7. Unfasten the two (2) J-hooks shown in Figure 1.

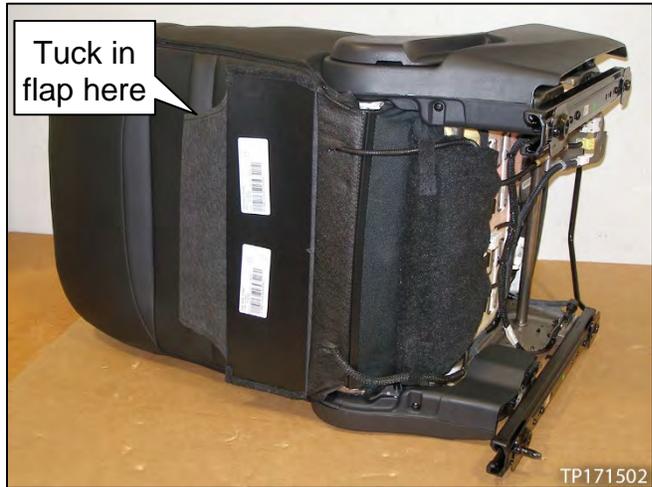
Figure 2

- Tuck the seat flap in the rear seat pocket.

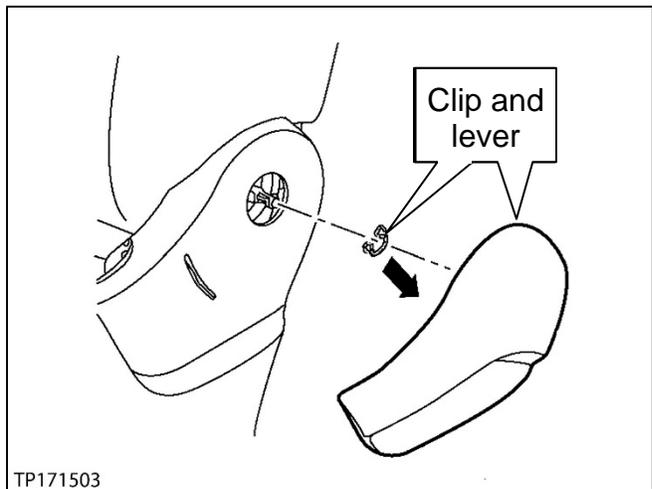
Figure 3

- Using a suitable tool, remove the clip, and then remove the recline lever.

WARNING: Wear eye protection. When removing, this clip may eject as a projectile.

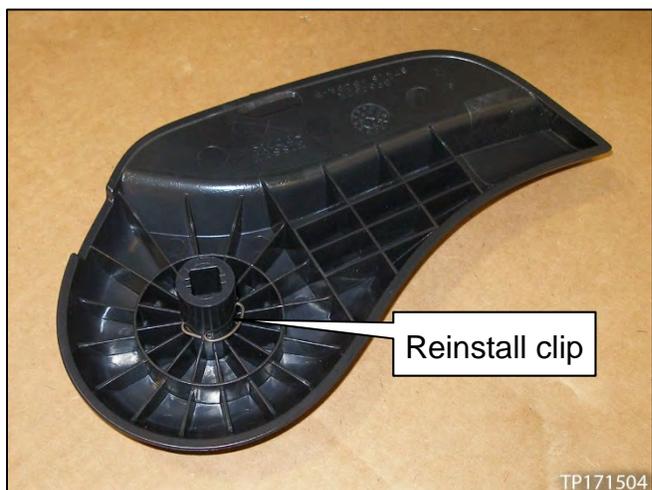
Figure 4

- To keep from losing the clip, fasten it onto the recline lever now.
 - This clip can be left on. When reinstalling, the recline lever only needs to be pushed back on its square shaft.

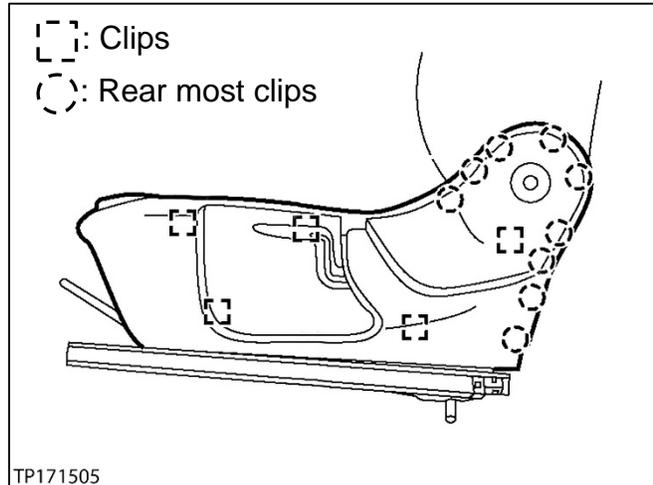
Figure 5

9. Remove the seat cushion outer finisher RH with a suitable plastic trim tool as follows:

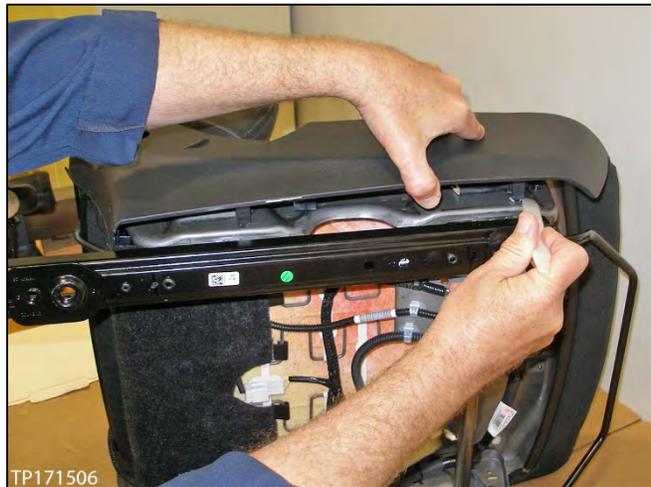
Figure 6

- a. Start by unsnapping the two (2) clips at the front of the finisher with a suitable plastic trim tool.

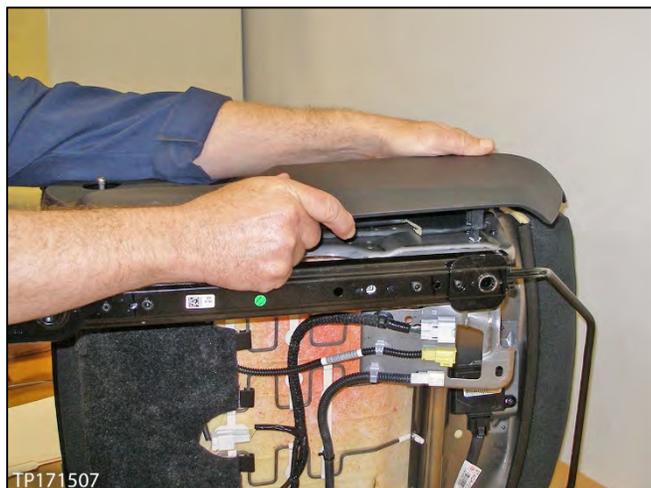
Figure 7

- b. Unsnap the remaining clips with exception of the rear most clips.

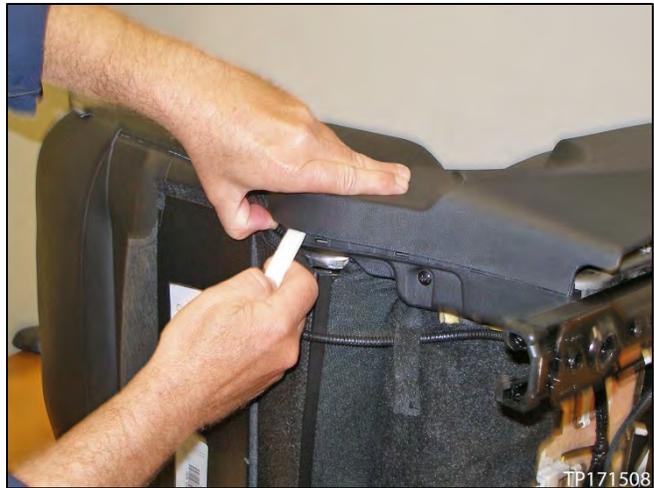
Figure 8

- c. Unsnap the rear most clips with a suitable plastic trim tool.

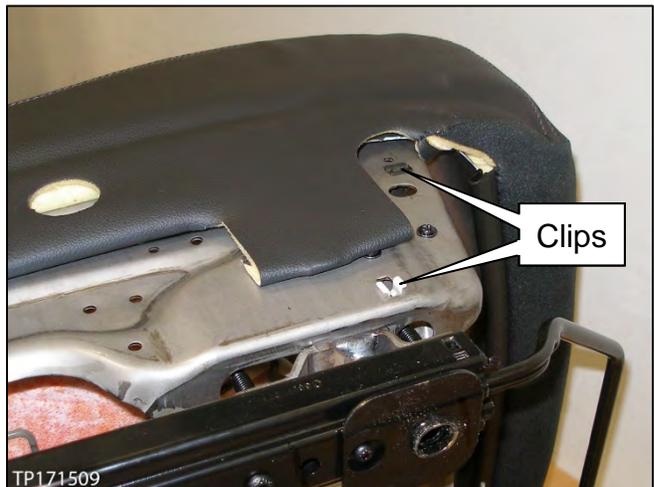
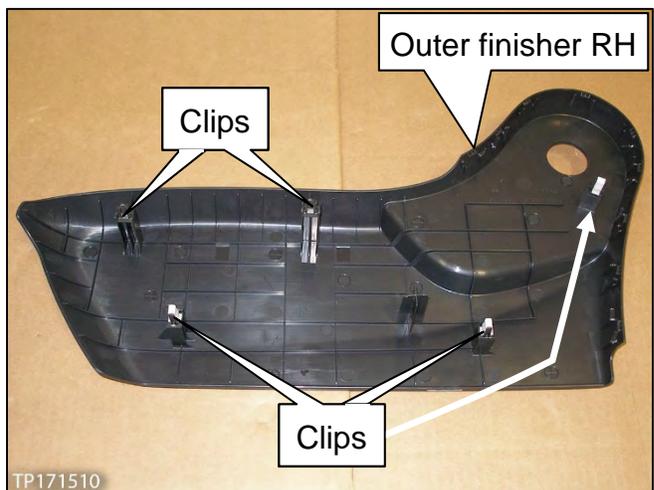
NOTE: Some of the metal or plastic clips may stay lodged in the lower seat frame. Remove, and then reinstall the clips on the seat cushion outer finisher RH now.

- See Figure 9 and 10.

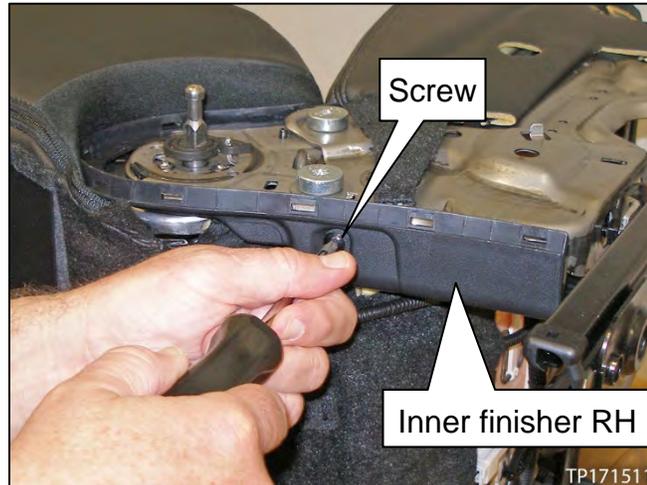
Figure 11

10. Remove the screw, and then remove the seat cushion inner finisher RH.

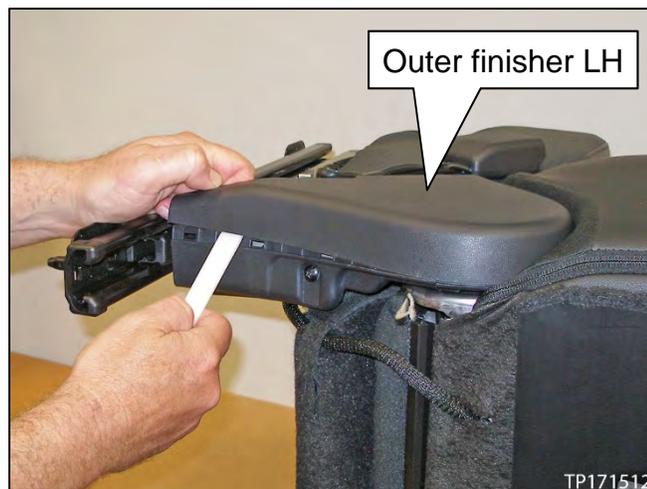
Figure 12

12. Remove the seat cushion outer finisher LH with a suitable plastic trim tool.

NOTE: To access the finisher, the seatback may need to be reclined back.

- To remove the finisher, slightly pry outward on the seat belt buckle.

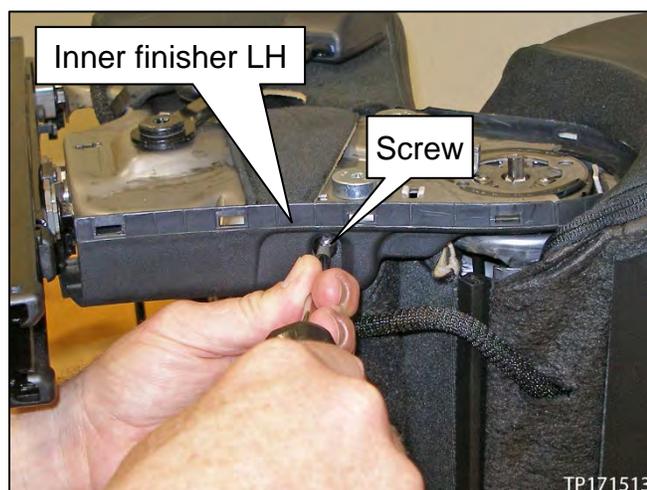
Figure 13

13. Remove the screw, and then remove the seat cushion inner finisher LH.

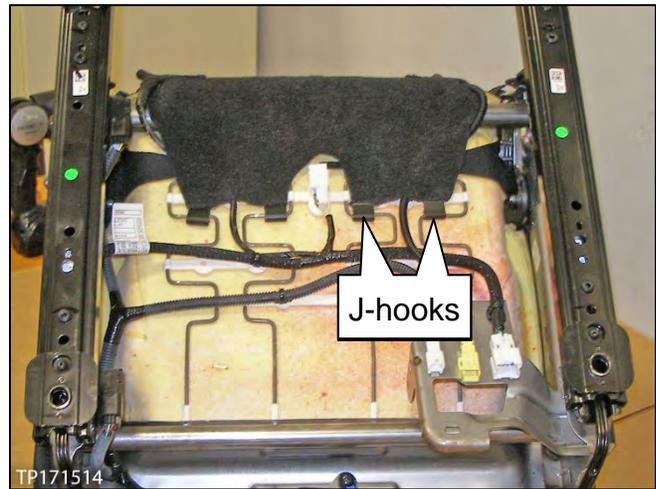
Figure 14

15. Unfasten the two (2) J-hooks shown in Figure 14.

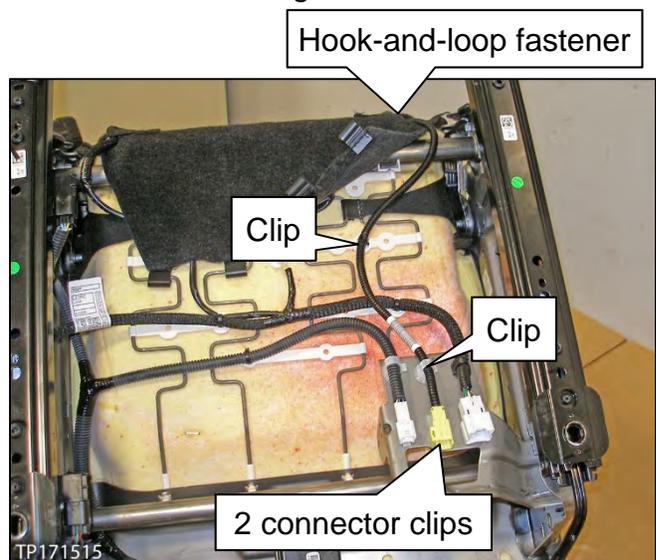
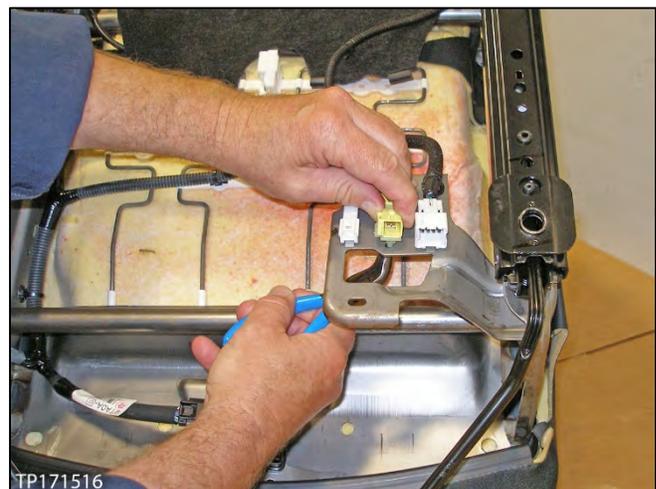
16. Unfasten the four (4) side air bag electrical harness and connector clips, and hook-and-loop fastener (see Figure 15 and 16).

- Loosely tie a knot in the harness to help keep it from getting in the way.

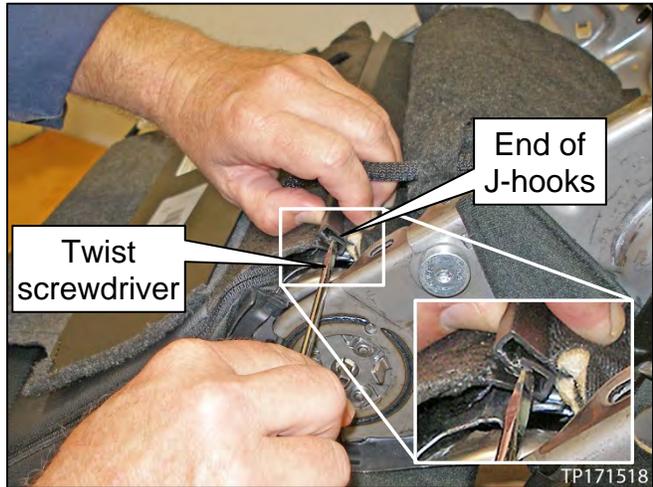
Figure 17

17. Start unfastening the long J-hooks from each other at one end with a suitable tool such as a narrow flat blade screwdriver.

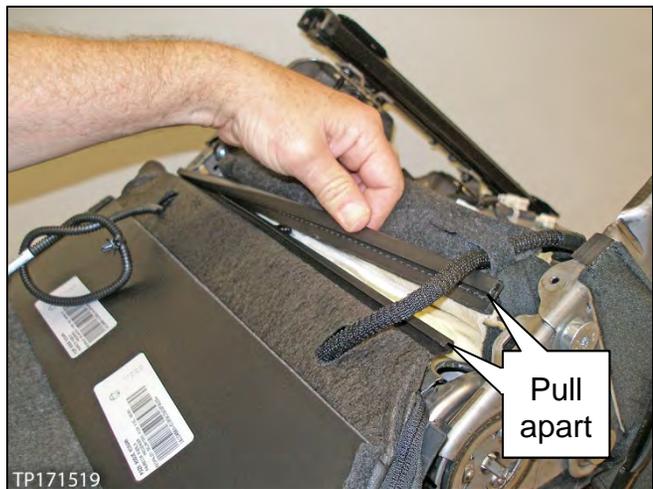
Figure 18

18. Once started, completely unfasten the J-hooks by pulling apart.

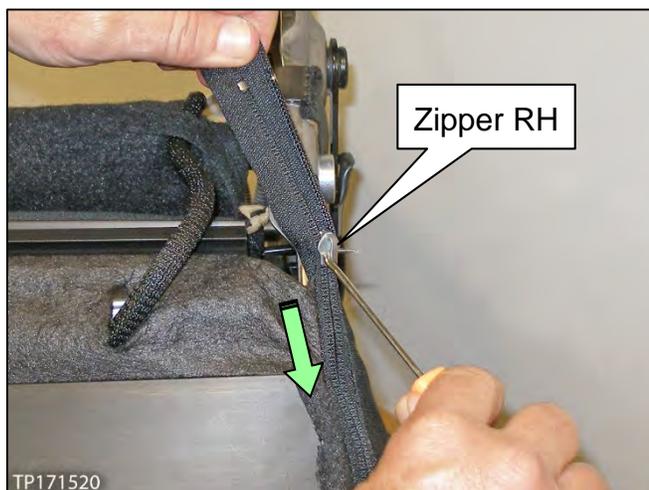
Figure 19

19. Unzip both seatback trim zippers with a suitable tool such as a hooked pick.

- The zipper RH is shown in Figure 19. The zipper LH is not shown, but is similar.

CAUTION: Be careful not to scratch or tear seat trim.

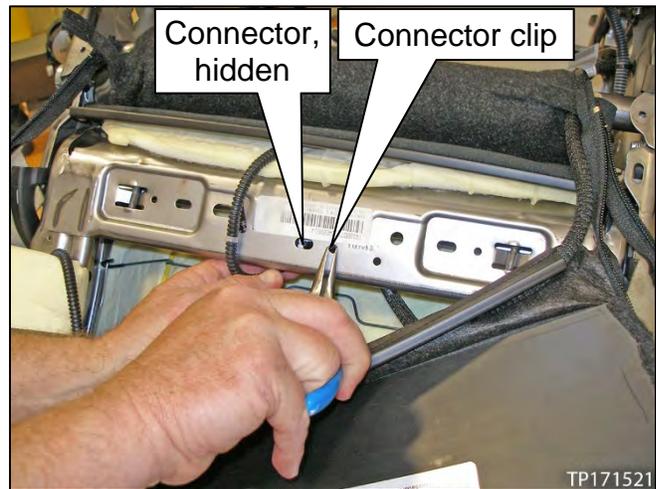
Figure 20

20. Unfasten the seat heater electrical harness from the seat cushion assembly as follows:

- a. Unclip the seat heater electrical connector from the seatback frame assembly.
- b. Disconnect the seat heater electrical connector (picture not shown).

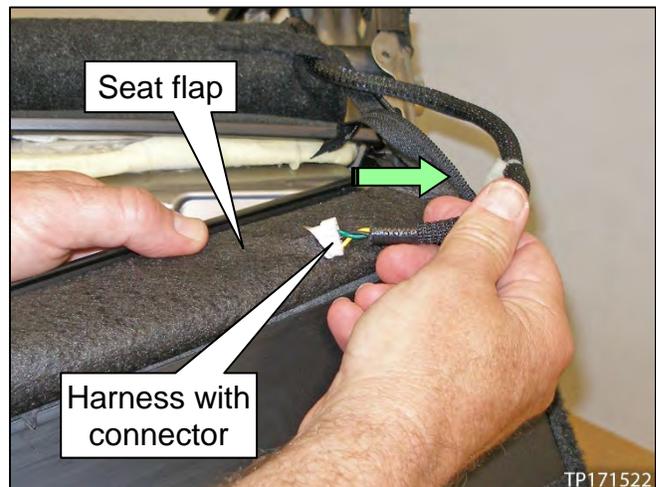
Figure 21

- c. Pull the seat heater electrical harness with connector through the seat flap.

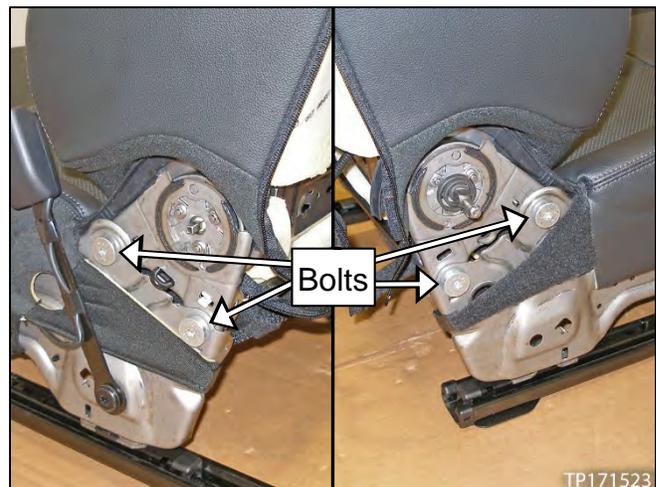
Figure 22

22. Remove the four (4) T40 TORX® seatback assembly bolts.

- If the TORX® portion strips out, use suitable locking pliers to remove the bolt(s).
- These bolts will be replaced with new ones. Do not reuse the old bolts.

- Before assembly/installation, verify the new seatback matches the old one.
- T40 TORX® bolts torque: 35 N•m (3.6 kg-m, **26 ft-lbs**)

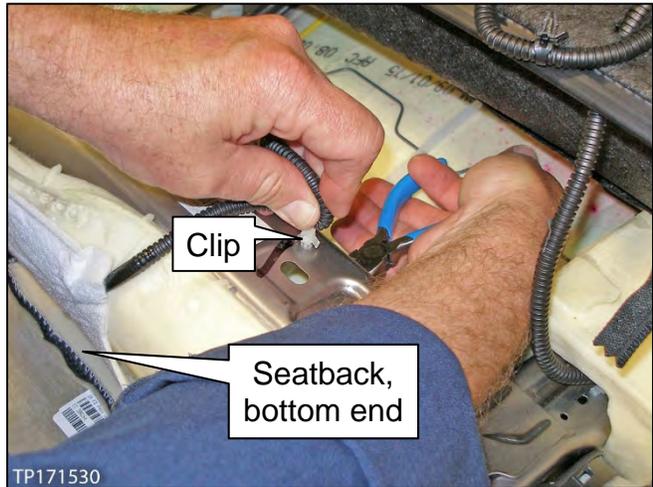
Figure 23

24. Unfasten the seat heater electrical harness clip.

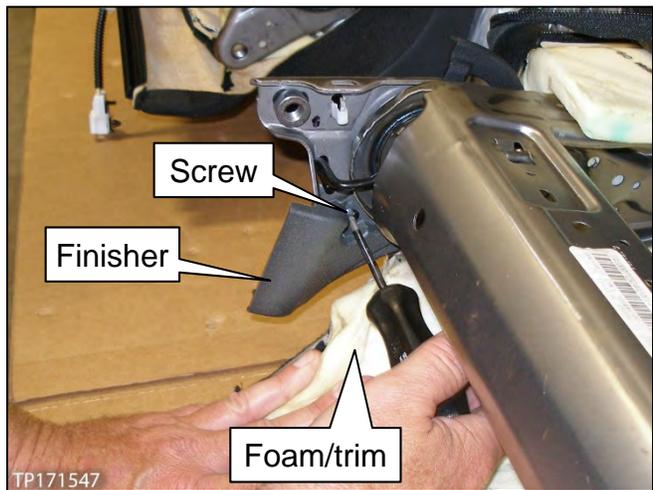
Figure 24

25. Remove the seat cushion inner finisher LH screw.

- To access this finisher, fold down the seatback foam/trim.

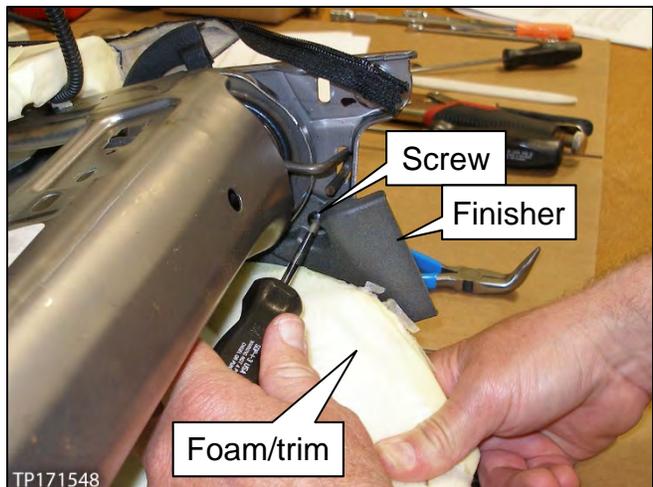
Figure 25

26. Remove the seat cushion inner finisher RH screw.

- To access this finisher, fold down the seatback foam/trim.

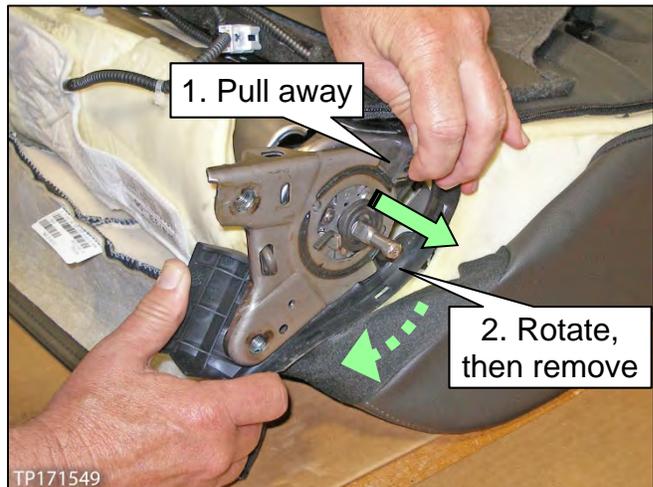
Figure 26

27. Remove both finishers.

- a. Carefully pull the finisher end away from the seatback as shown in Figure 26.
- b. Rotate the finisher rearward (as shown in Figure 26), and then remove it from the seatback.

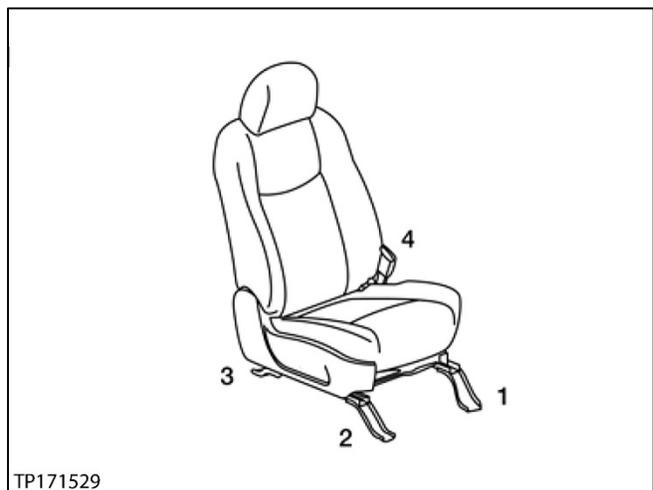
- Refer to the ESM, section SE-Seat, for seat installation.
- Seat-to-floor bolts torque: 40 N•m (4.1 kg-m, **30 ft-lbs**)
- See Figure 27 for seat-to-floor bolts torque sequence.
