Revised July 2015

Dealer Service Instructions for:

Safety Recall P60 / NHTSA 14V-634

Alternator

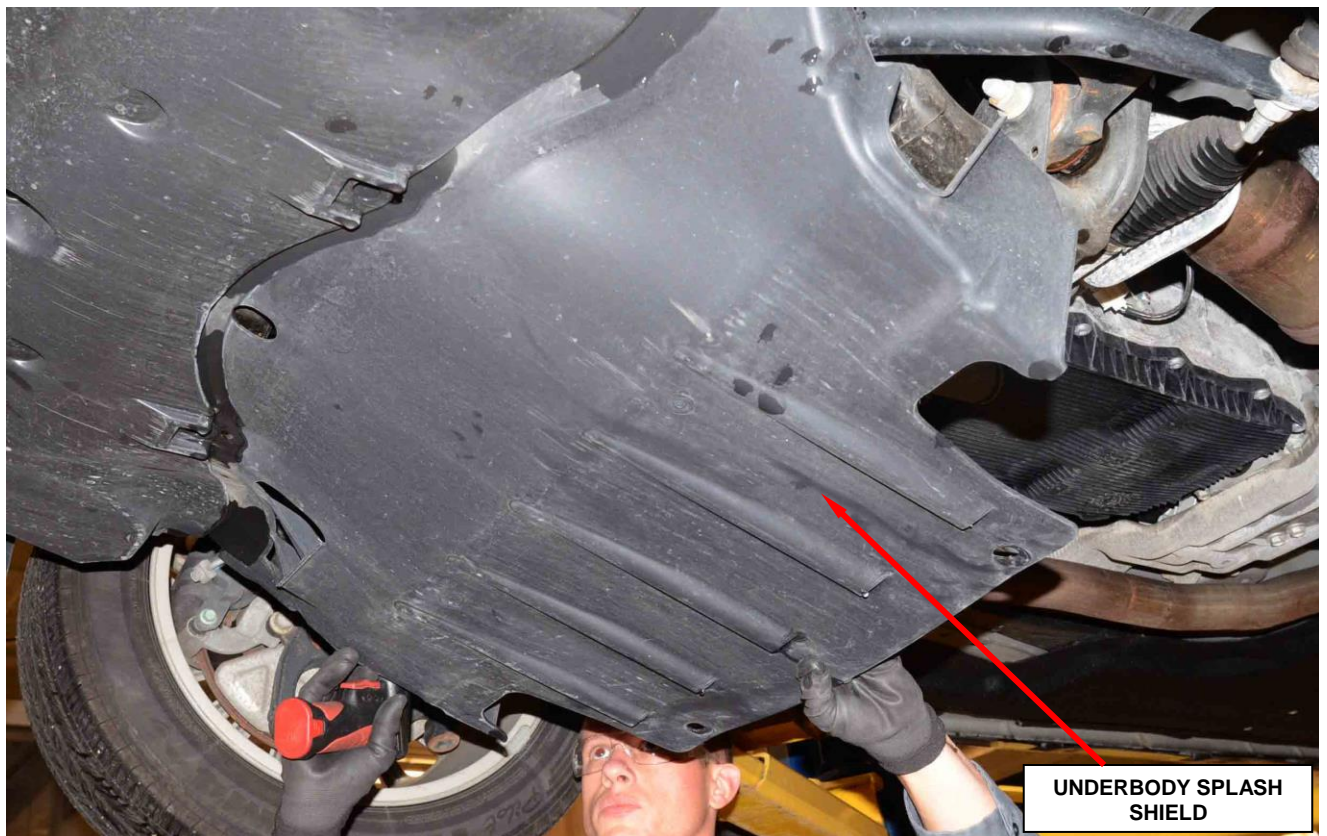
Figure 4 – Underbody Splash Shield

8. Remove the underbody splash shield retainers and remove the underbody splash shield. (Figure 4)

20. Position the underbody splash shield and install the underbody splash shield retainers.
21. Lower the vehicle from the hoist.
22. Rotate the accessory drive belt tensioner counterclockwise until it contacts the stop and install the accessory drive belt onto the pulleys and slowly release the tensioner.
