Dealer Service Instructions for:

## **Safety Recall R08 / NHTSA 15V-090**

### **Transaxle Park Rod**

**2015 (UF) Chrysler 200**

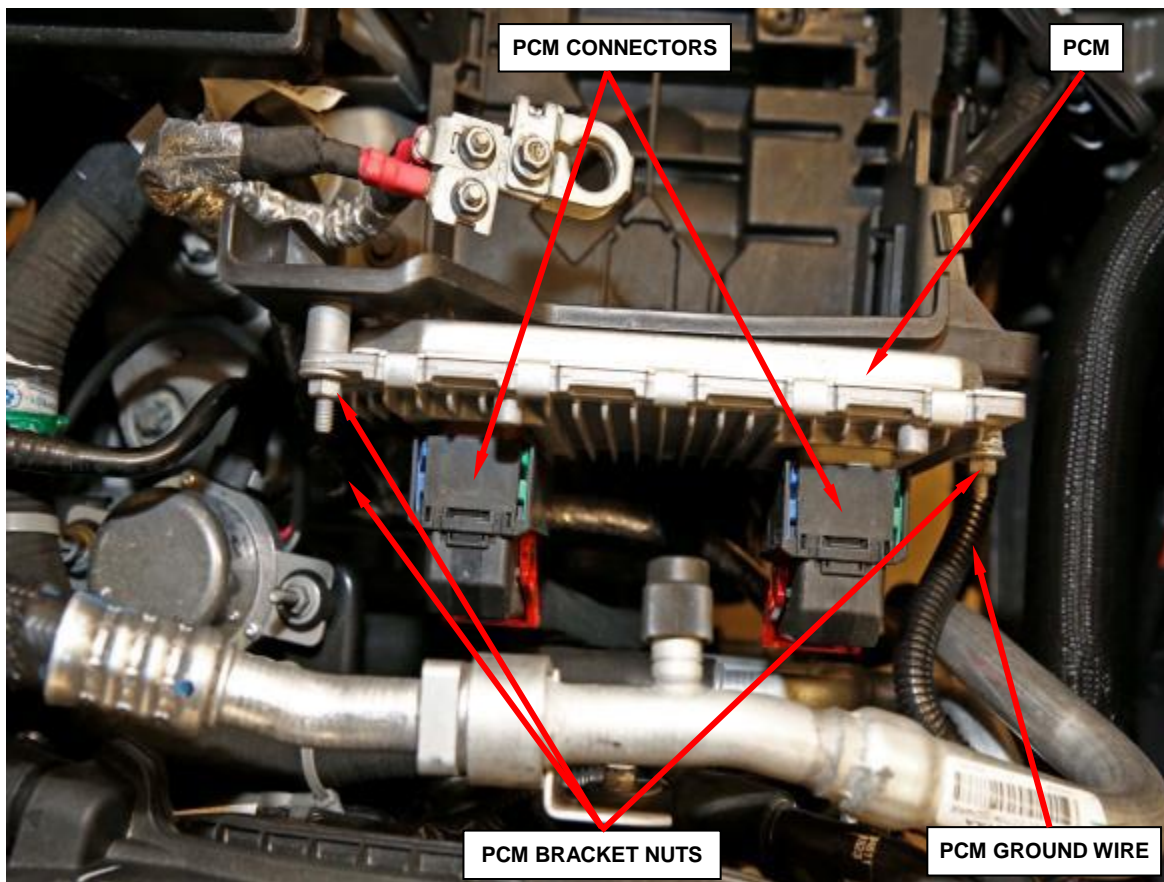
**Figure 1 – Powertrain Control Module (PCM)**

1. Position the vehicle over an appropriate hoist.
2. Remove and save the engine appearance cover.
3. Remove and save the battery.
4. Disconnect the two Powertrain Control Module (PCM) electrical connectors from the PCM (Figure 1).
5. Remove and save the three PCM bracket nuts, the PCM ground wire, and the PCM (Figure 1).

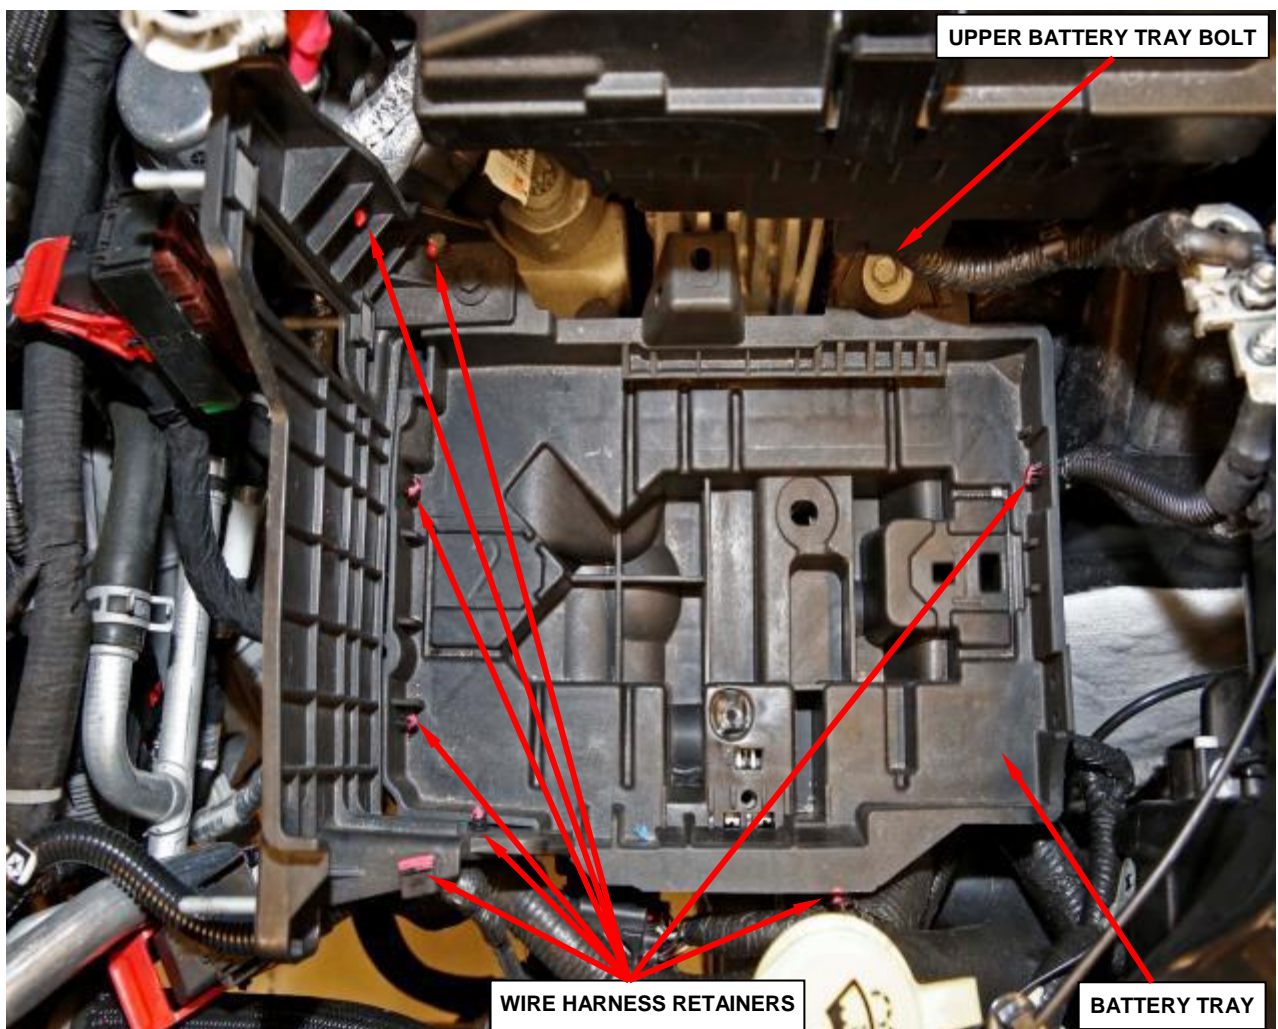
**Figure 2 – Wiring Harness Retainers**

6. Remove and save the wiring harness retainers from the battery tray (Figure 2).
7. Remove and save the upper battery tray bolt (Figure 2).
8. Raise the vehicle to an appropriate height.

26. Use the following steps to install the battery tray.
  - a. Position the battery tray in the vehicle.
  - b. Loosely install the upper battery tray bolt (Figure 2).

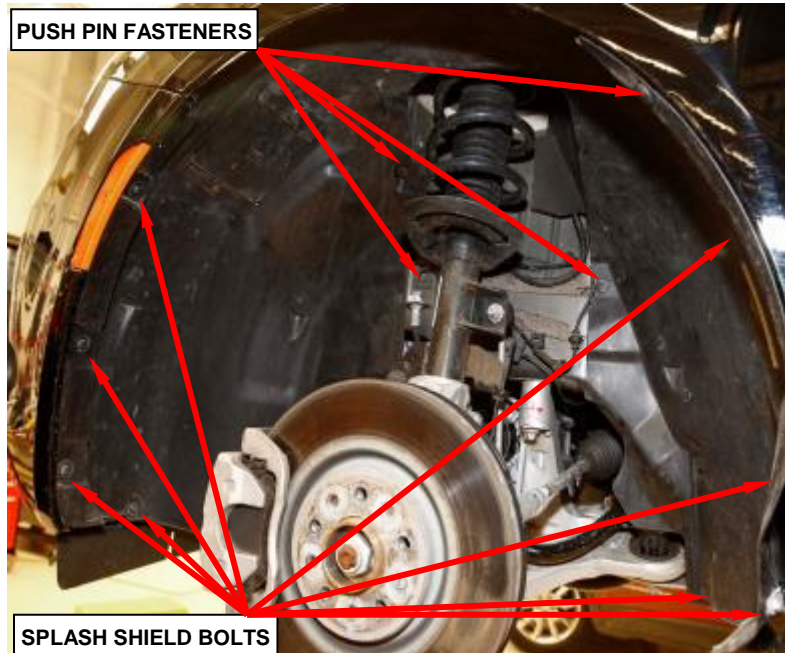
**Figure 3 – Wheelhouse Splash Shield**

- a. Remove and save the push pin fasteners (Figure 3).
- b. Remove and save the front wheelhouse splash shield bolts (Figure 3).

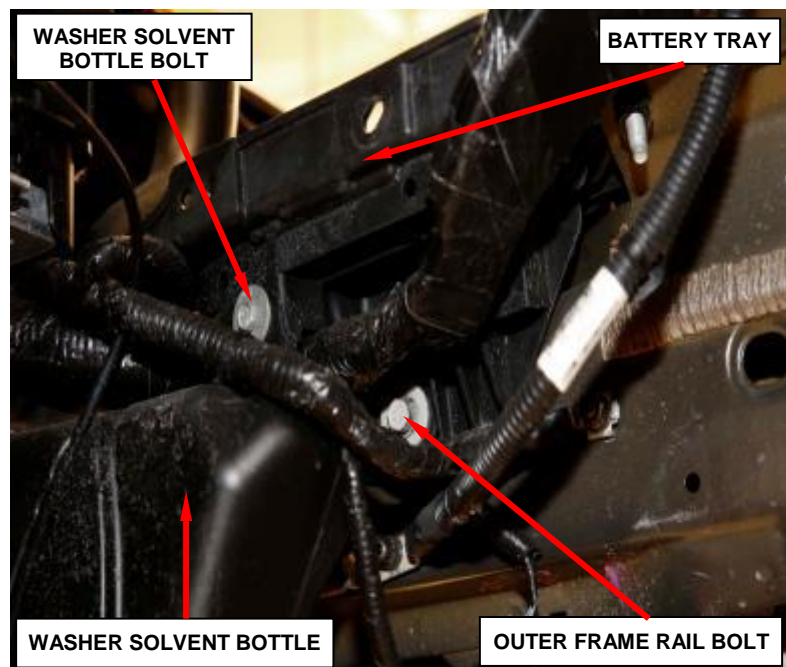
**Figure 4 – Outer Battery Tray Bolts**

- a. Remove and save the bolt that secures the washer solvent bottle to the battery tray (Figure 4).
- b. Remove and save the bolt that secures the battery tray to the outer frame rail (Figure 4).
- c. Remove the wire harness from the lower edge of the battery tray.

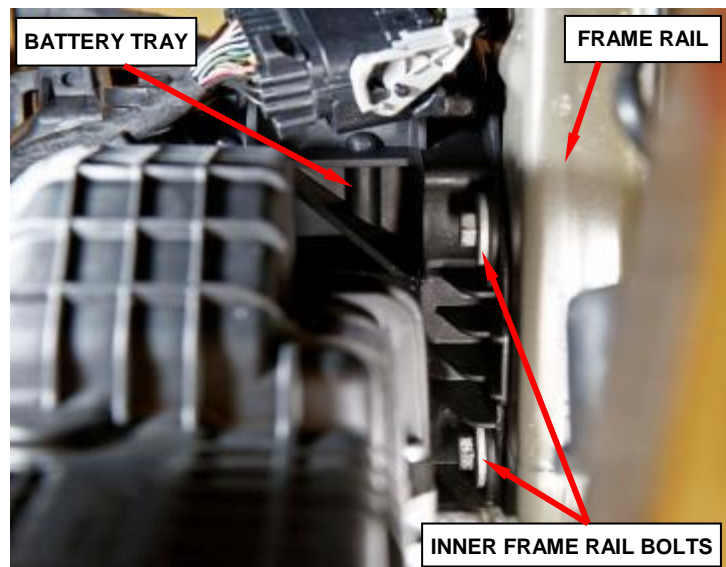
**Figure 5 – Inner Battery Tray Bolts**

- d. Raise the vehicle to an appropriate height.
- e. Remove the lower belly pan and the underbody shield.
- f. Remove and save the two bolts that secure the battery tray to the inner frame rail (Figure 5).
- g. Lower the vehicle and remove the battery tray.

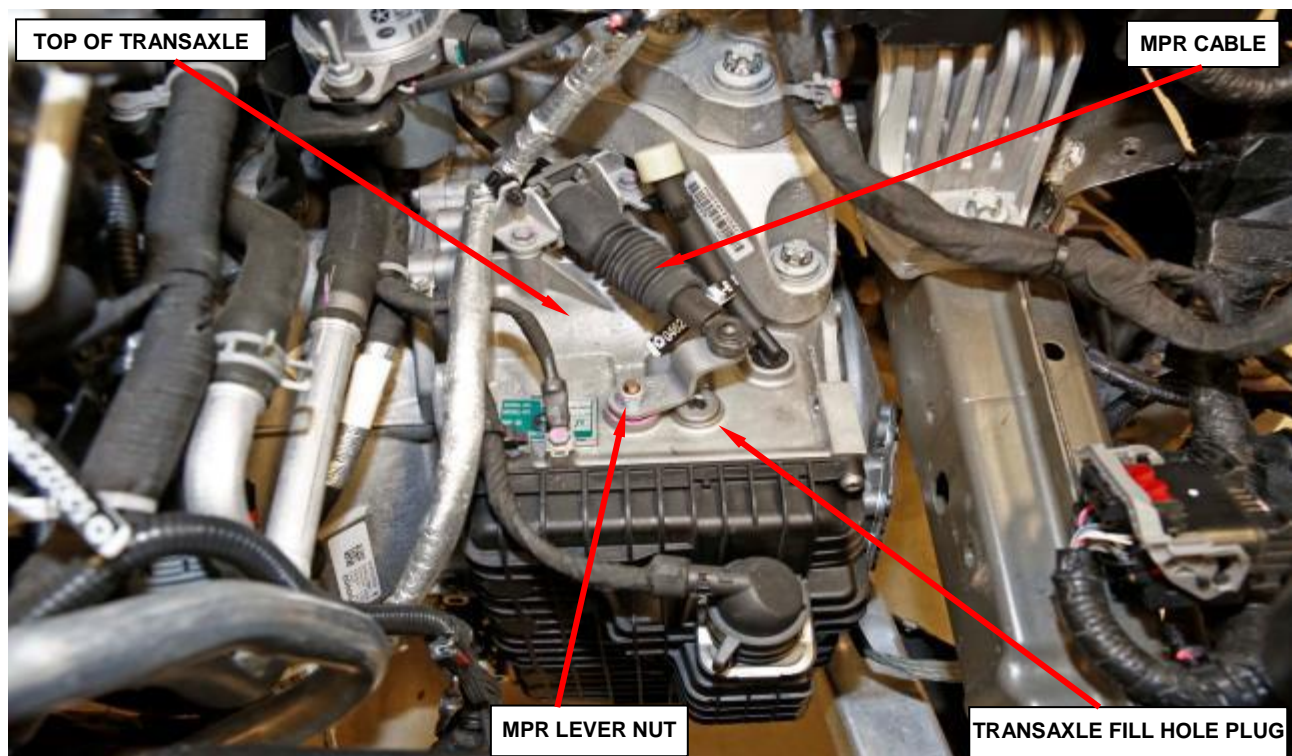
**Figure 6 – Manual Park Release Lever (MPR)**

- 12. Remove and save the nut holding the Manual Park Release (MPR) lever and position the lever and cable assembly to the side (Figure 6).
- 13. Remove and save the transaxle fill hole plug (Figure 6).

18. Install the nut holding the MPR lever and securely tighten to 12 in. lbs. (16 N·m) (Figure 6).

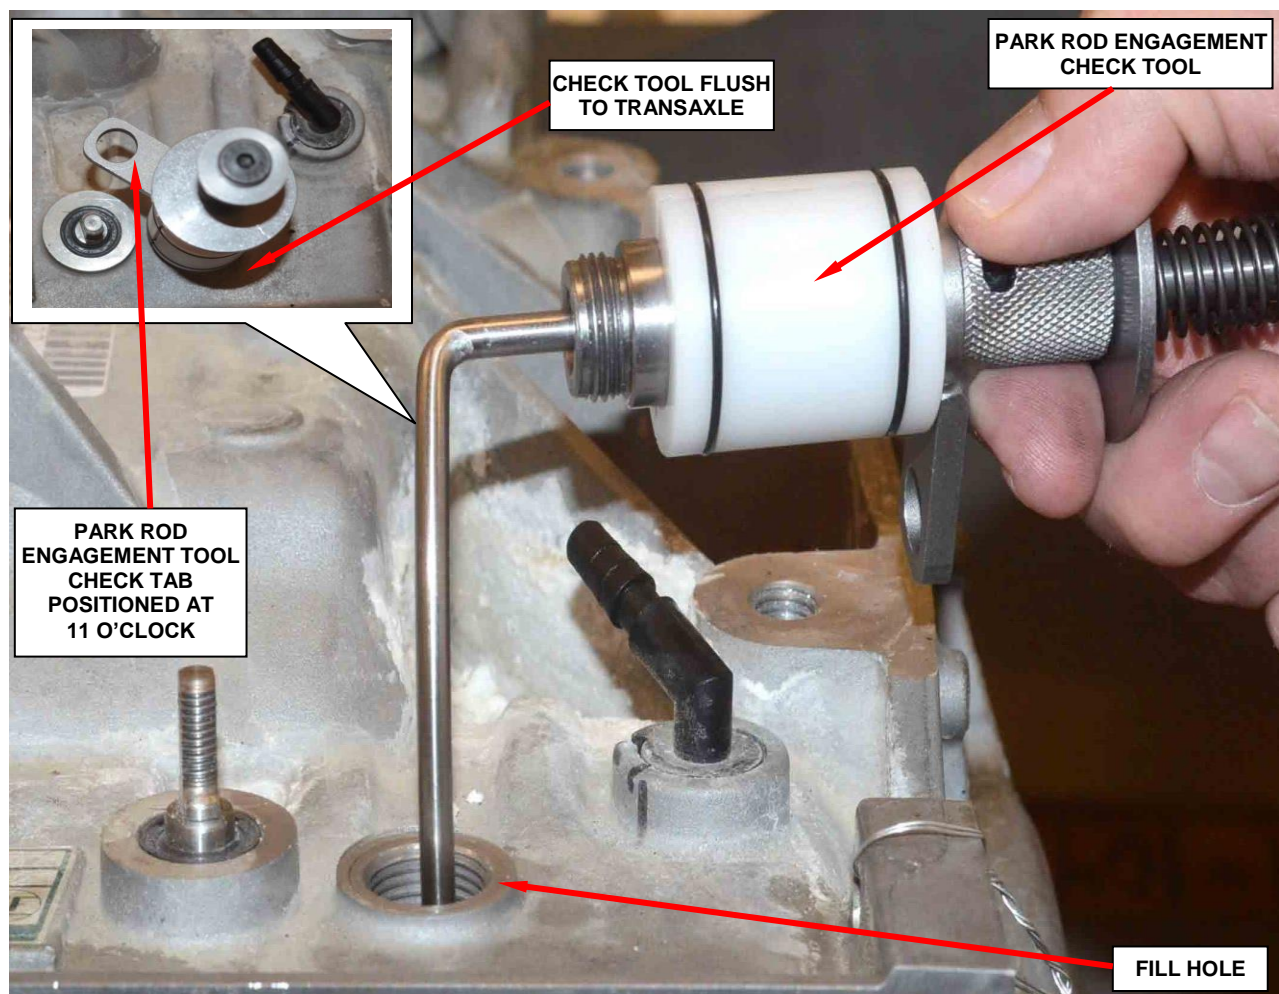
**Figure 7 - Park Rod Engagement Check Tool**

- a. Insert the Park Rod Engagement Check Tool through the fill hole as shown (Figure 7).
- b. Once fully inserted, position the Park Rod Engagement Check Tool check tab at 11 o'clock and tighten the Park Rod Engagement Check Tool until flush to the transaxle case (Figure 7).

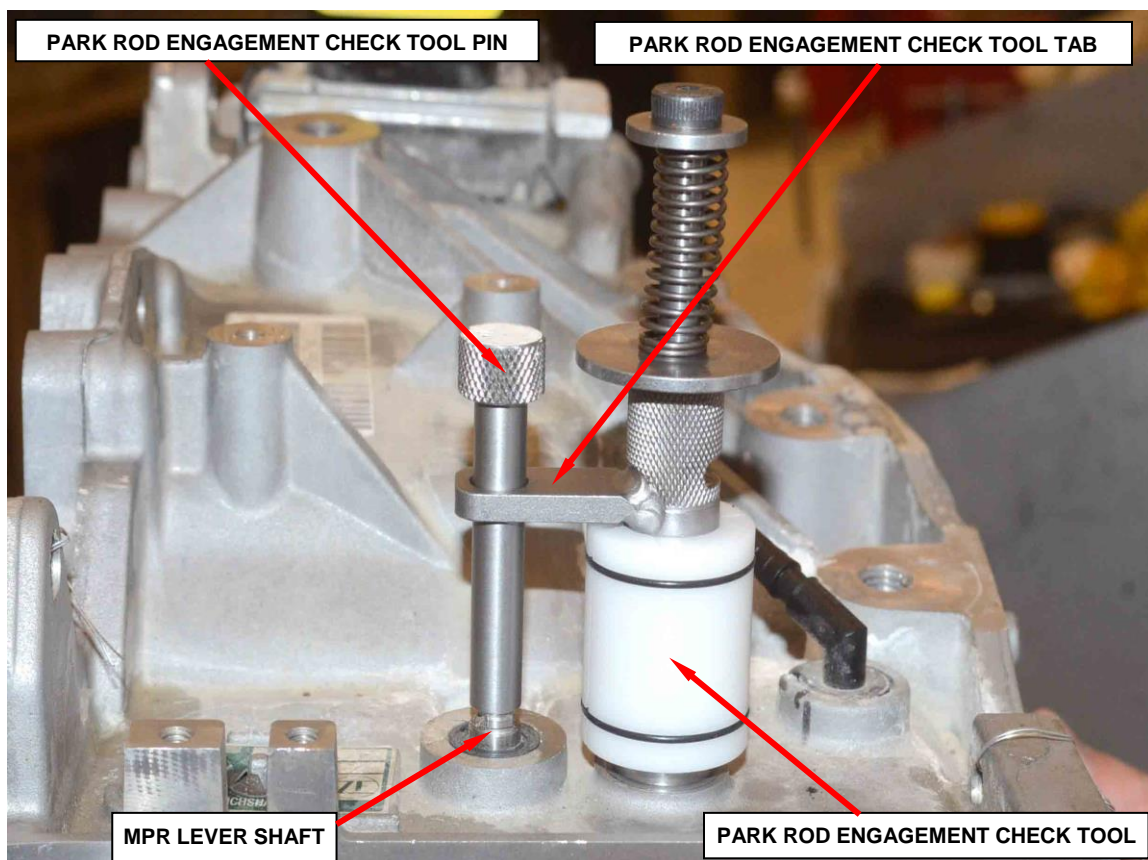
**Figure 8 – Correctly Installed Park Rod Engagement Check Tool**

**NOTE:** The inspection is not valid if the Park Rod Engagement Check Tool pin is not screwed on to the MPR shaft. A false failure could occur if the Park Rod Engagement Check Tool is not properly installed (Figure 8).

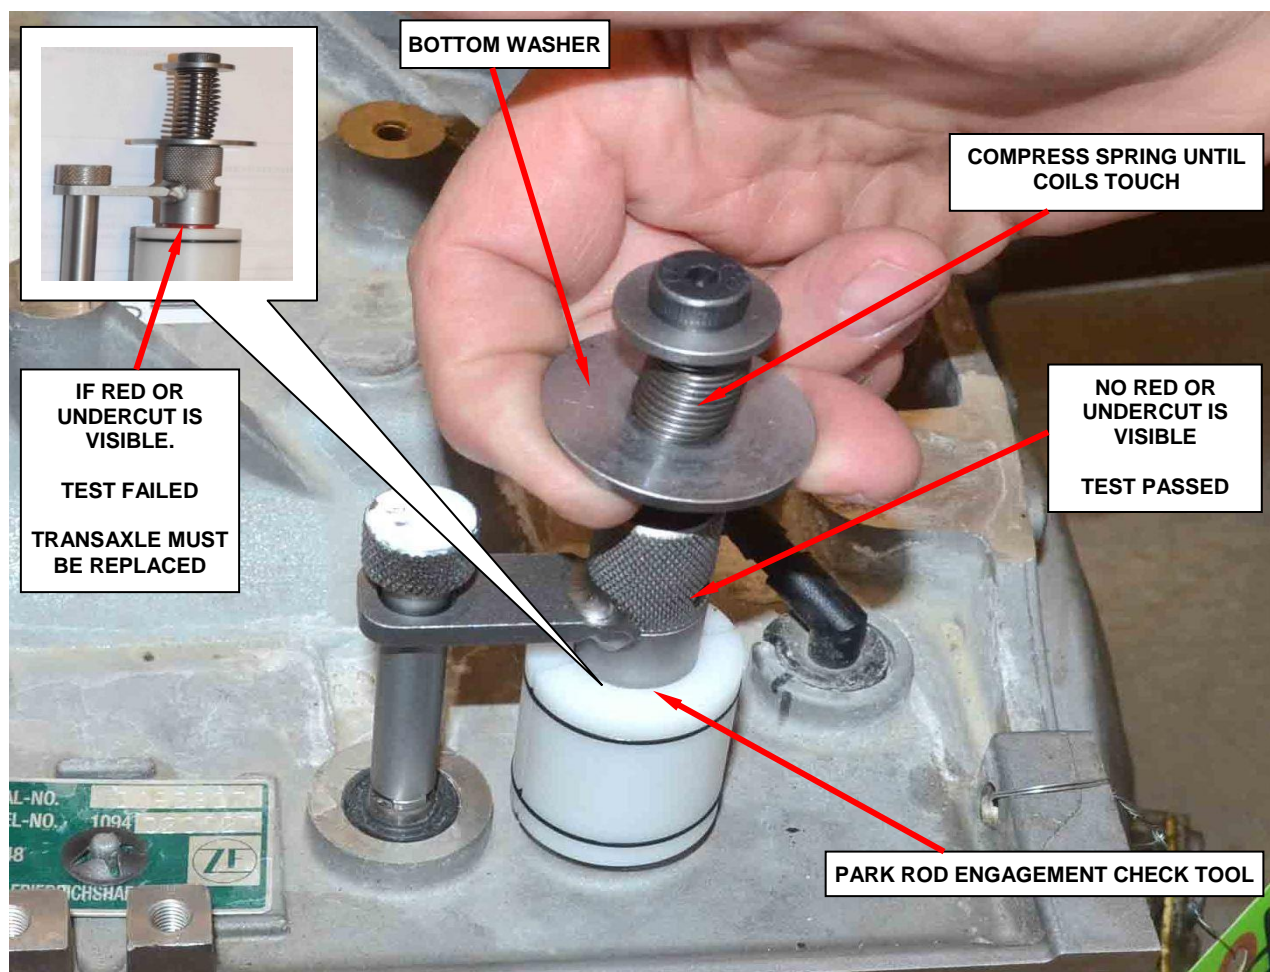
**Figure 9 – Fully Compress Spring**

**NOTE: Once the spring is fully compressed, do not attempt to pull the washer up further. Applying excessive force may cause loss of tool calibration and/or tool breakage.**

- If red or undercut is **not** visible continue with **step 15**.
- If red or undercut is visible the transaxle must be replaced. Continue to **Section B. AWD/FWD Transaxle Removal**.

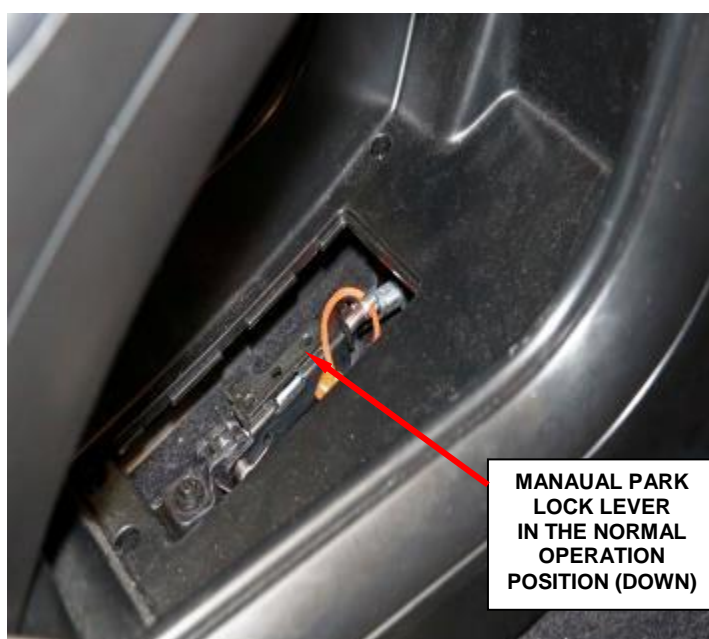
**Figure 11 – Manual Park Lock in Normal Position**

**NOTE:** The manual park lock lever must be in the normal operation position (down) to perform the following inspection (Figure 11).

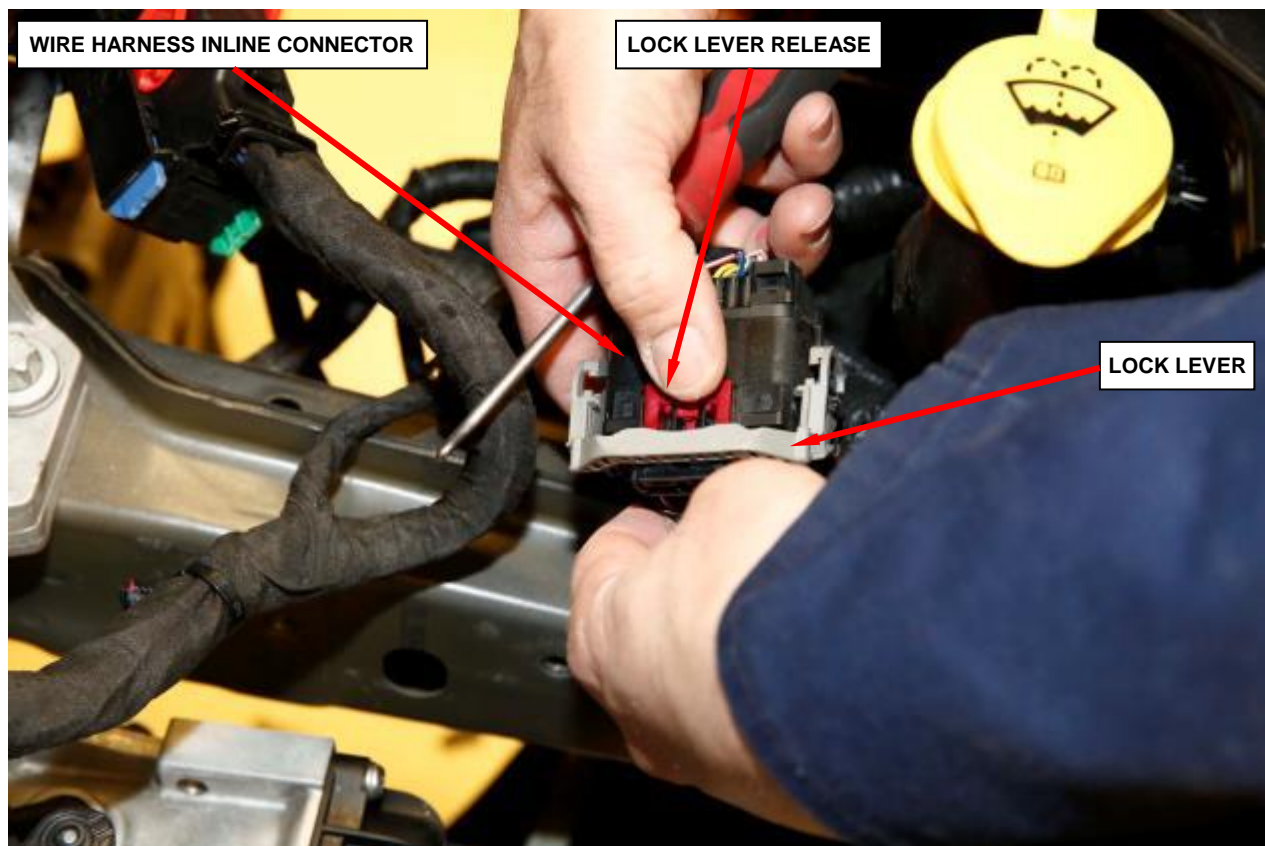
**Figure 12 – Wire Harness Inline Connector**

1. Release the lock lever on the wire harness inline connector on the front of the battery tray and disconnect the wire harness inline connector from the main engine harness (Figure 12).
2. Remove the Power Distribution Center (PDC) cover.

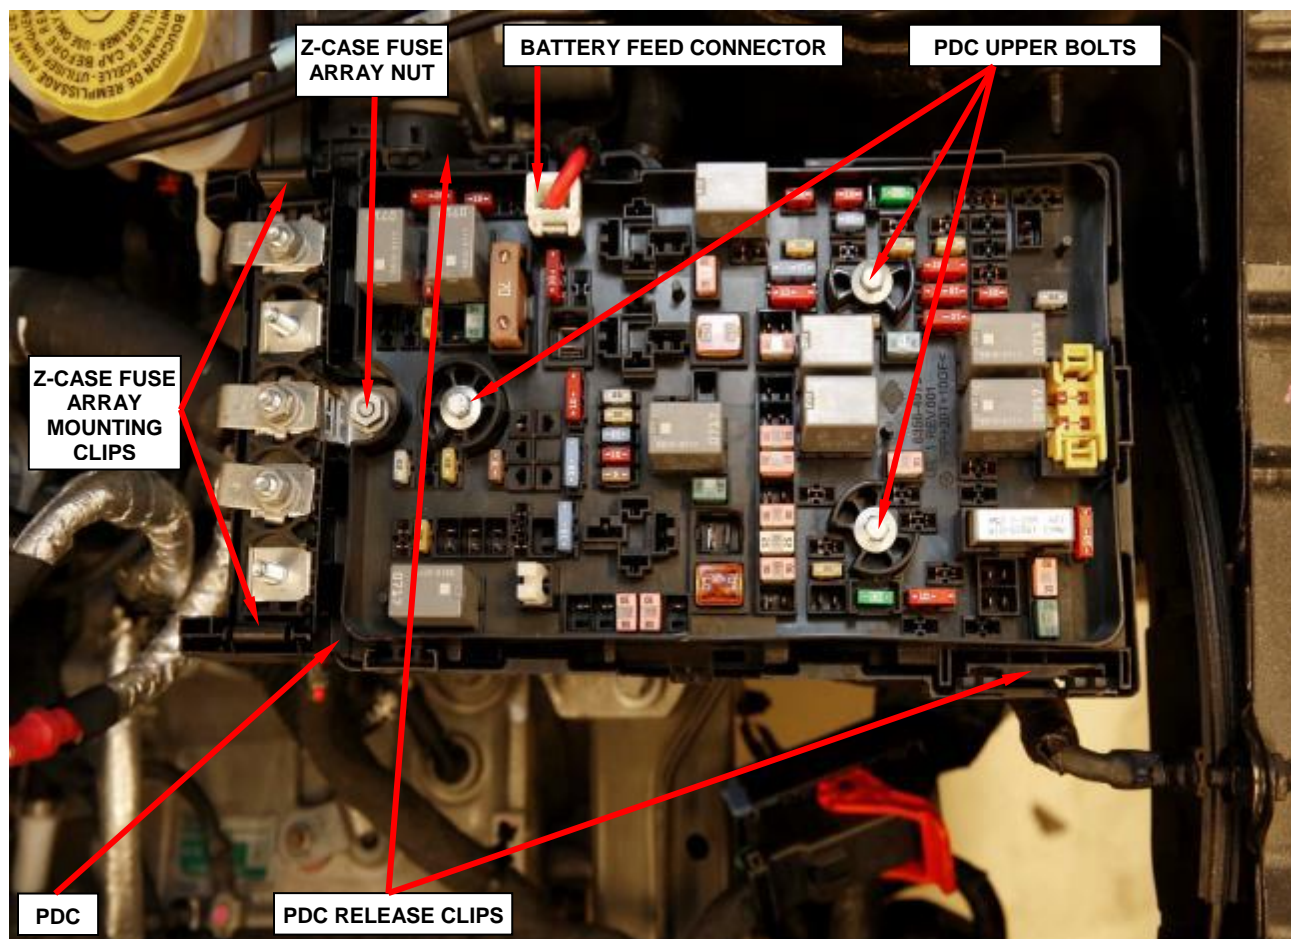
**Figure 13 – PDC Top and Z-Case Fuse Array**

3. Remove and save the nut from the Z-case fuse array (Figure 13).
4. Unclip the two Z-case fuse array mounting clips and set aside (Figure 13).
5. Remove the battery feed connector from the PDC (Figure 13).
6. Loosen the three bolts that secure the PDC upper (Figure 13).

7. Release the clips that secure the PDC upper to the PDC tray (Figure 13).

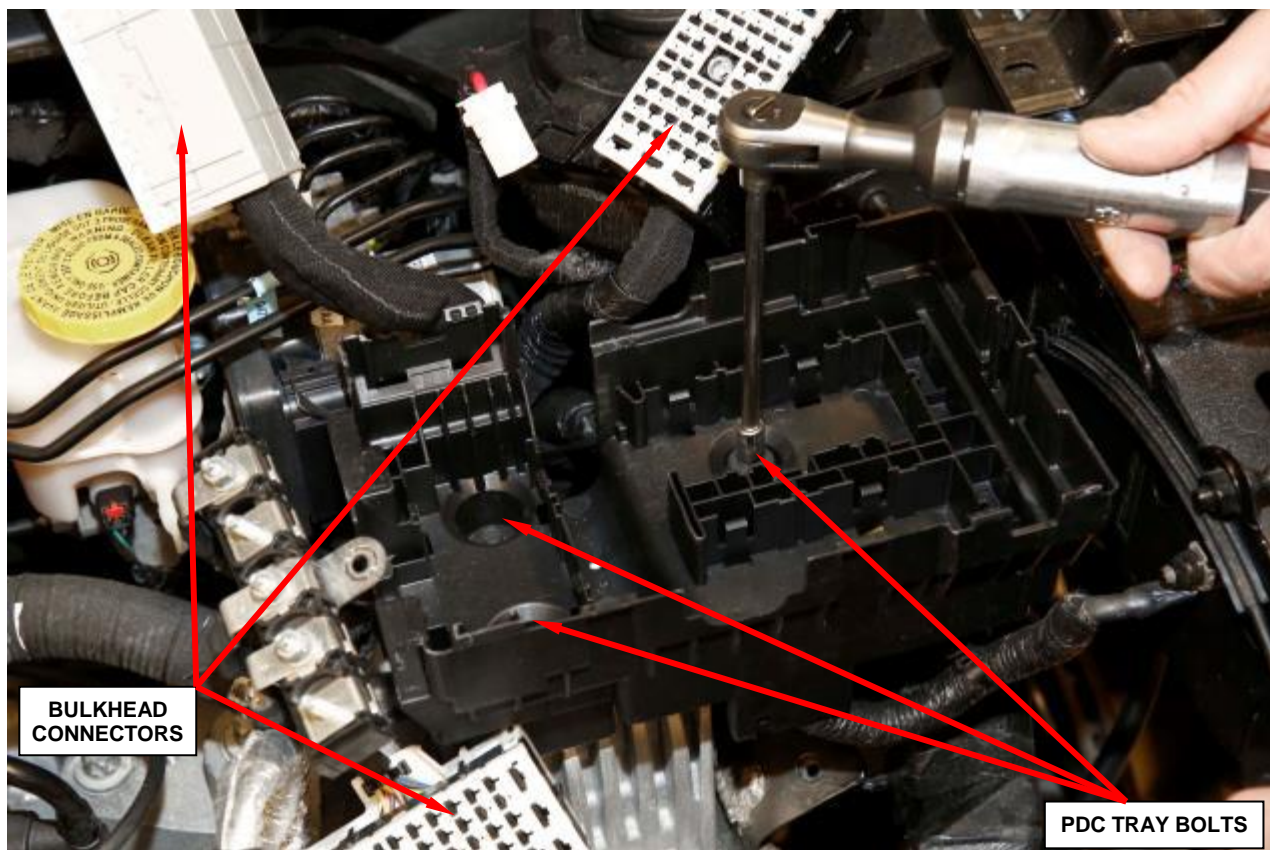
**Figure 14 – PDC Tray**

8. The PDC upper will now lift upward. Carefully lift and disconnect the three bulkhead connectors from the PDC upper.
9. Remove the three bolts securing the PDC tray and remove the PDC tray from the vehicle (Figure 14).

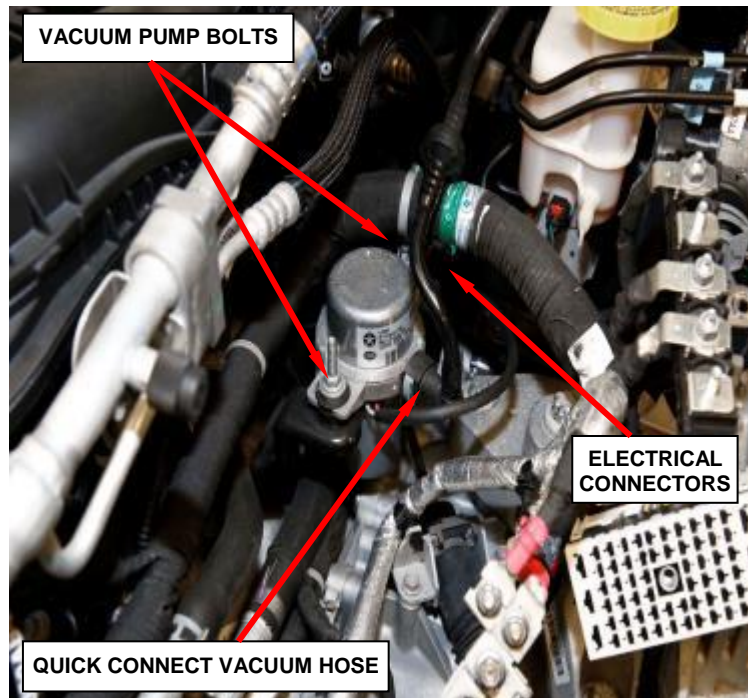
**Figure 15 – Vacuum Pump**

10. Use the following steps to remove the vacuum pump:
  - a. Disconnect the vacuum pump electrical connector and remove the vacuum pump pigtail connector from the mounting bracket (Figure 15).
  - b. Release the locking tab and disconnect the quick connect vacuum hose from the vacuum pump (Figure 15).
  - c. Remove and save the two vacuum pump to bracket bolts, remove the vacuum pump from the vehicle (Figure 15).

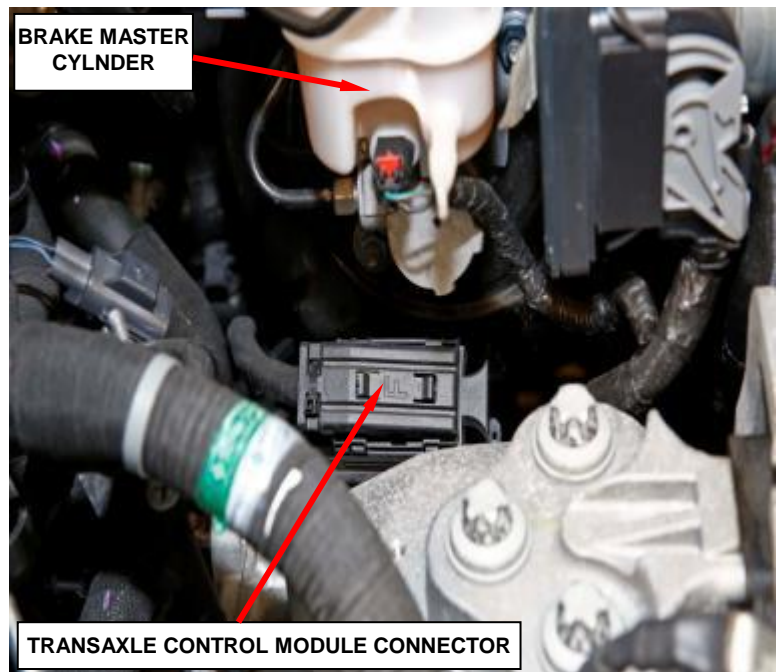
**Figure 16 - Transaxle Control Module Connector**

11. Release the lock on the Transaxle Control Module (TCM) wire harness connector and disconnect the TCM connector (Figure 16).

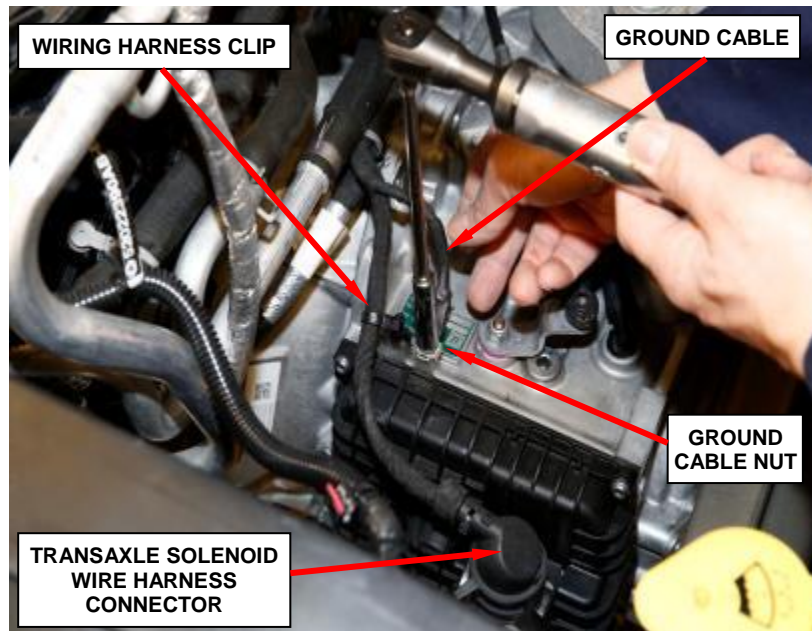
**Figure 17 – Ground Cable**

12. Remove the wiring harness and the nut holding the ground cable from the top of the transaxle (Figure 17).
13. Rotate the lock lever counterclockwise on the transaxle solenoid wire harness connector and disconnect the transaxle solenoid wire harness connector from the transaxle (Figure 17).

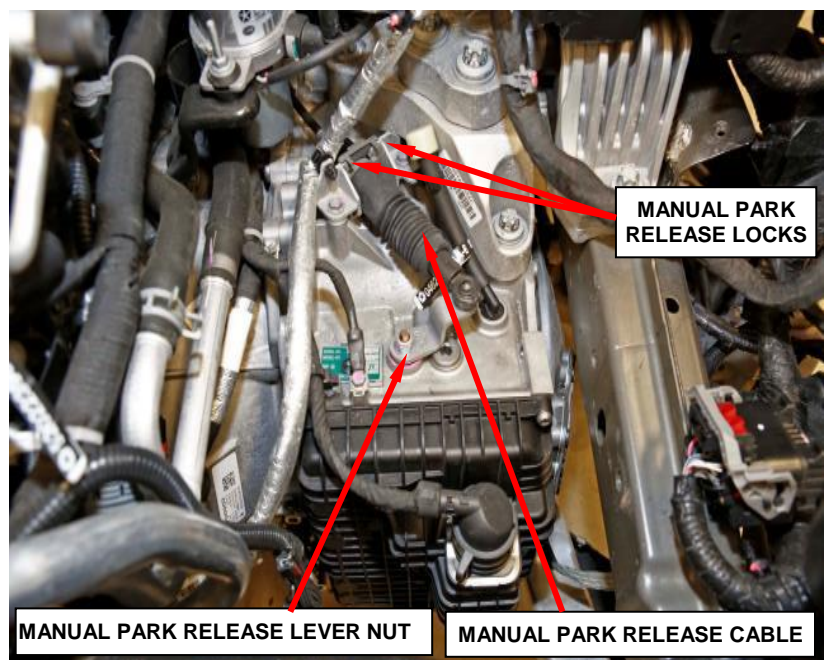
**Figure 18 – Manual Park Release Cable (MPR)**

14. Remove and save the nut holding the Manual Park Release (MPR) lever and position the lever and cable assembly to the side (Figure 18).
15. Release the locks holding the MPR cable to the MPR cable bracket on the transaxle and separate the MPR cable from the MPR bracket (Figure 18).

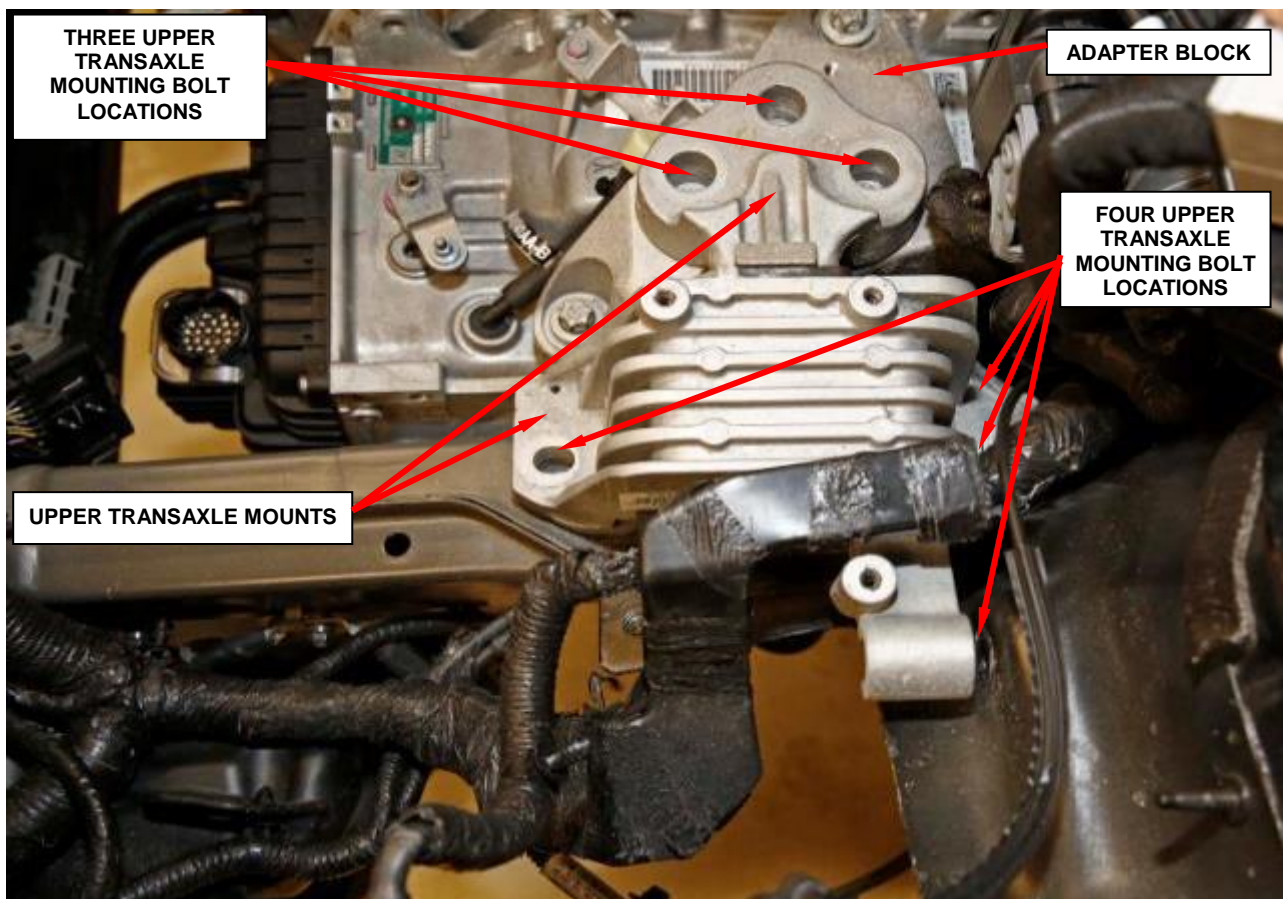
**Figure 19 – Transaxle Mounting Bolt Locations**

16. Disconnect the Power Transfer Unit (PTU) electrical connector located on the top of the PTU.
17. Remove the PTU vent hose from the top of the PTU and unclip it from the coolant line.
18. Position a floor jack under the transaxle and raise the jack enough to relieve tension on the upper transaxle mount.
19. Remove and save the three upper transaxle mounting bolts holding the upper transaxle mount to the adaptor block (Figure 19).
20. Remove and save the four upper transaxle mounting bolts (Figure 19).

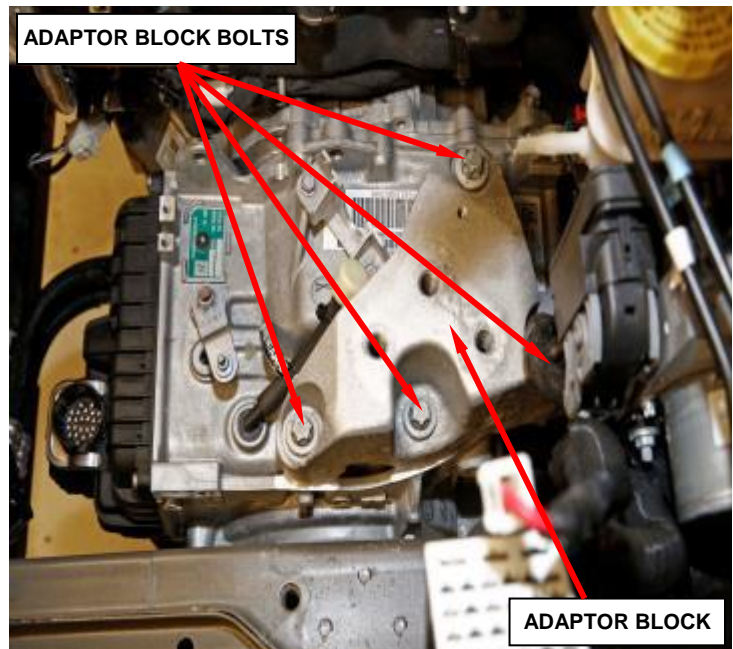
**Figure 20 – Adaptor Block Bolts**

21. Remove and save the four adaptor block bolts and remove the adaptor block from the transaxle (Figure 20).
22. Remove the left front tire and wheel assembly and place a wooden block between the transaxle side cover and the frame rail load beam (Figure 21).

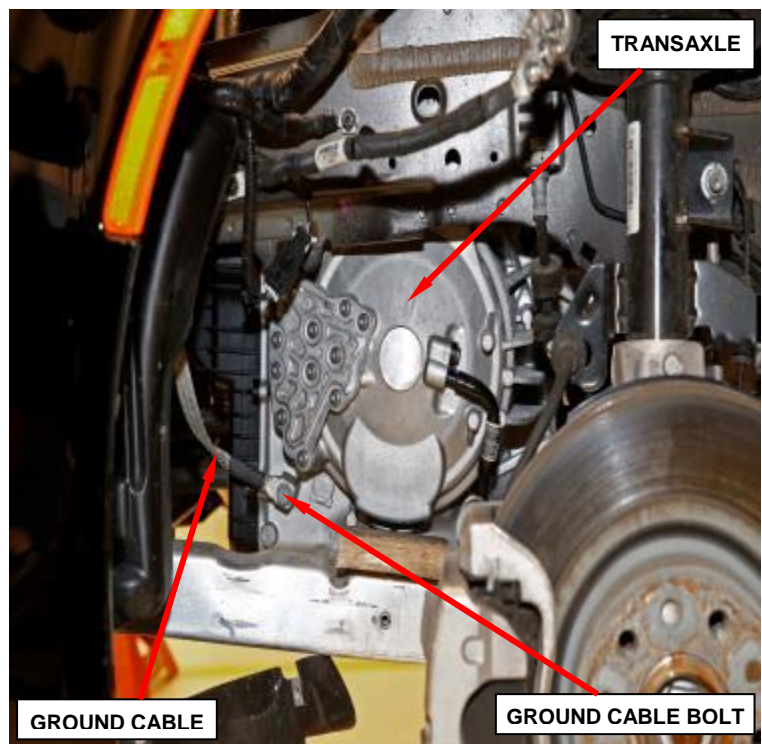
**Figure 21 – Ground Cable Bolt**

23. Lower the floor jack until the wood block supports the transaxle. Remove the floor jack.
24. Remove and save the ground cable bolt holding the ground cable to the transaxle and separate the ground cable from the transaxle (Figure 21).

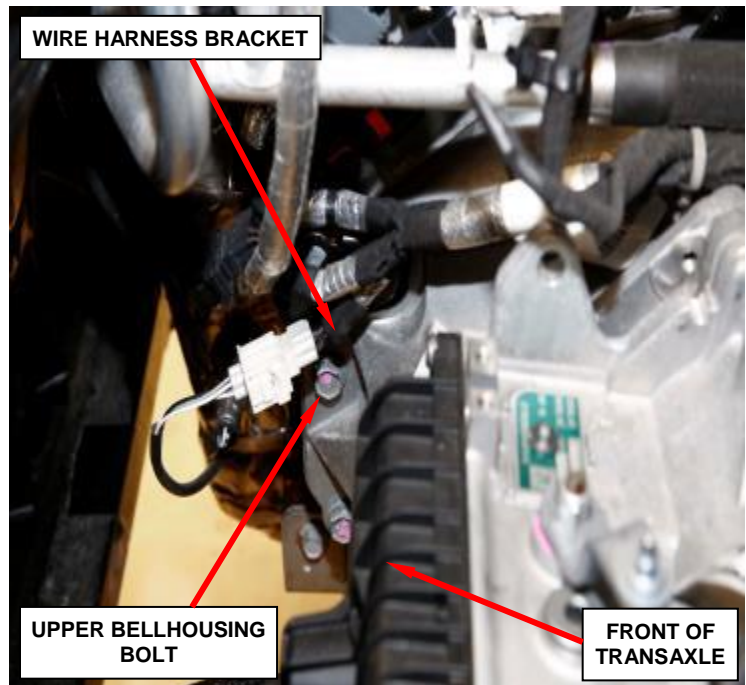
**Figure 22 – Wire Harness Bracket**

25. Remove and save the upper bolt holding the wire harness bracket and transaxle bellhousing to the engine block (Figure 22).
26. Remove and save the two upper bolts holding the transaxle bellhousing to the engine block located behind the main engine wire harness and remove the vacuum pump bracket (Figure 23).

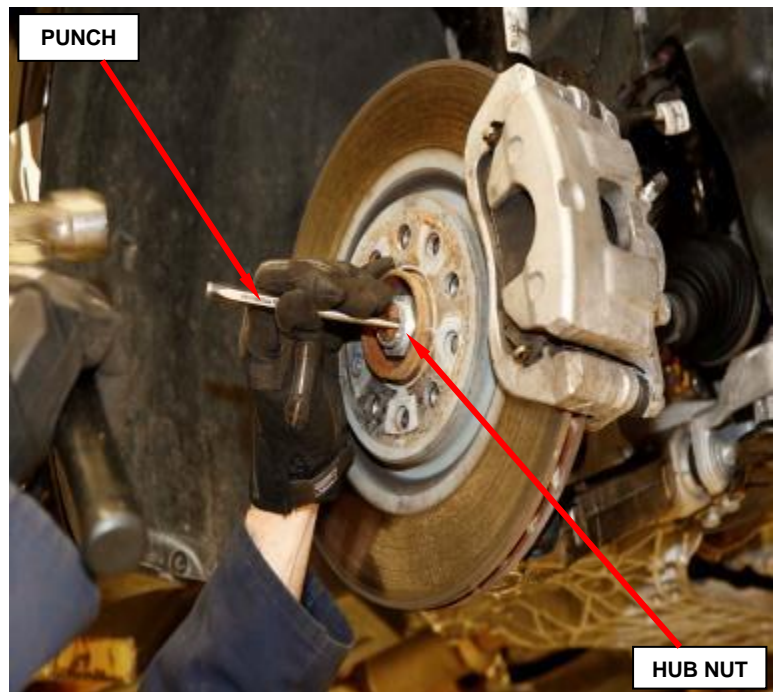
**Figure 28 – Hub Nut**

- a. Using a suitable punch, lift the two staked areas in the hub nut to avoid damaging the half shaft (Figure 28).
- b. While a helper applies the brakes to keep the hub from rotating, **remove and discard** the hub nut from the half shaft and discard. **The used hub nut is not reusable.**

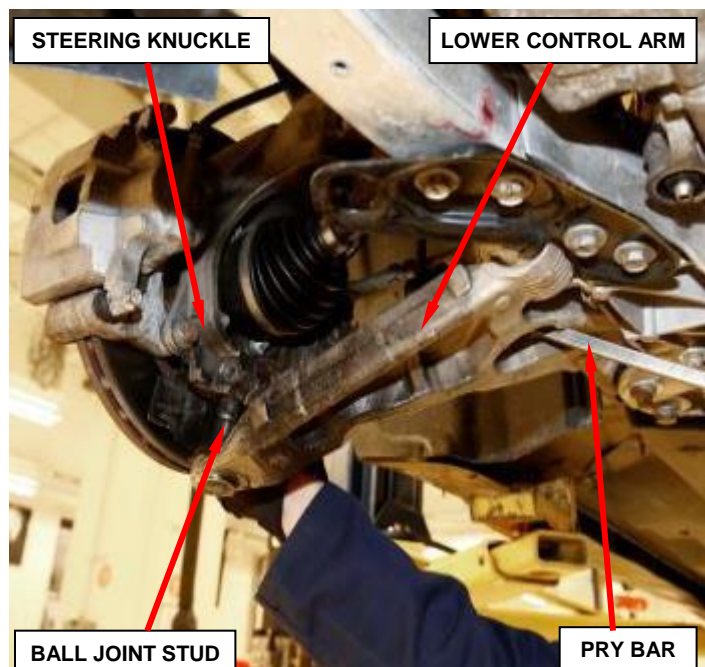
**Figure 30 – Lower Control Arm to Knuckle**

- e. Separate the lower control arm from the steering knuckle by prying down with a pry bar (Figure 30).
- f. Pry down on the lower control arm until the ball joint stud is clear of the steering knuckle. Position the steering knuckle assembly to the side. Slowly release the control arm (Figure 30).

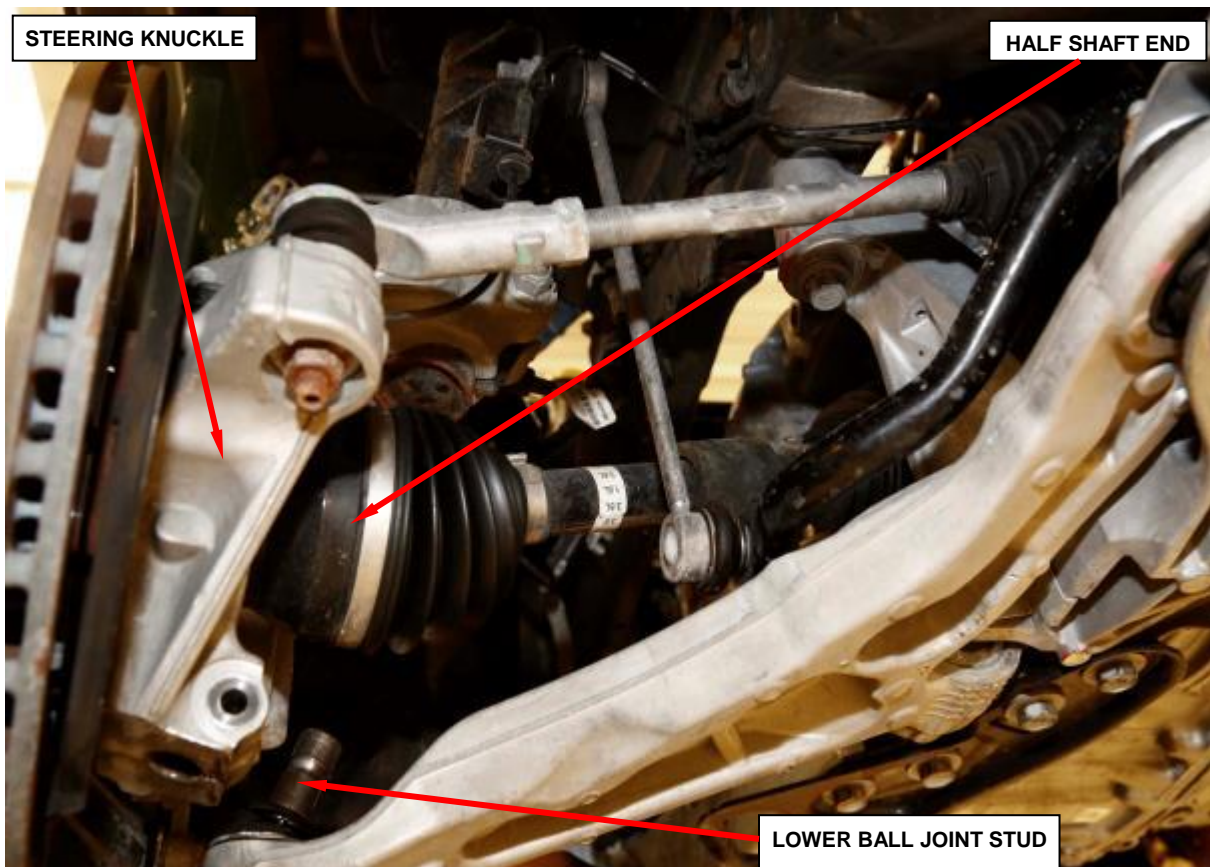
**Figure 31 – Half Shaft Removal (Left Side Shown)**

- g. Swing the steering knuckle outward and off the half shaft end (Figure 31).
- h. Place a drain pan under the transaxle to catch fluid that may spill from the transaxle when the half shaft is removed.
- i. Remove the half shaft from the vehicle.

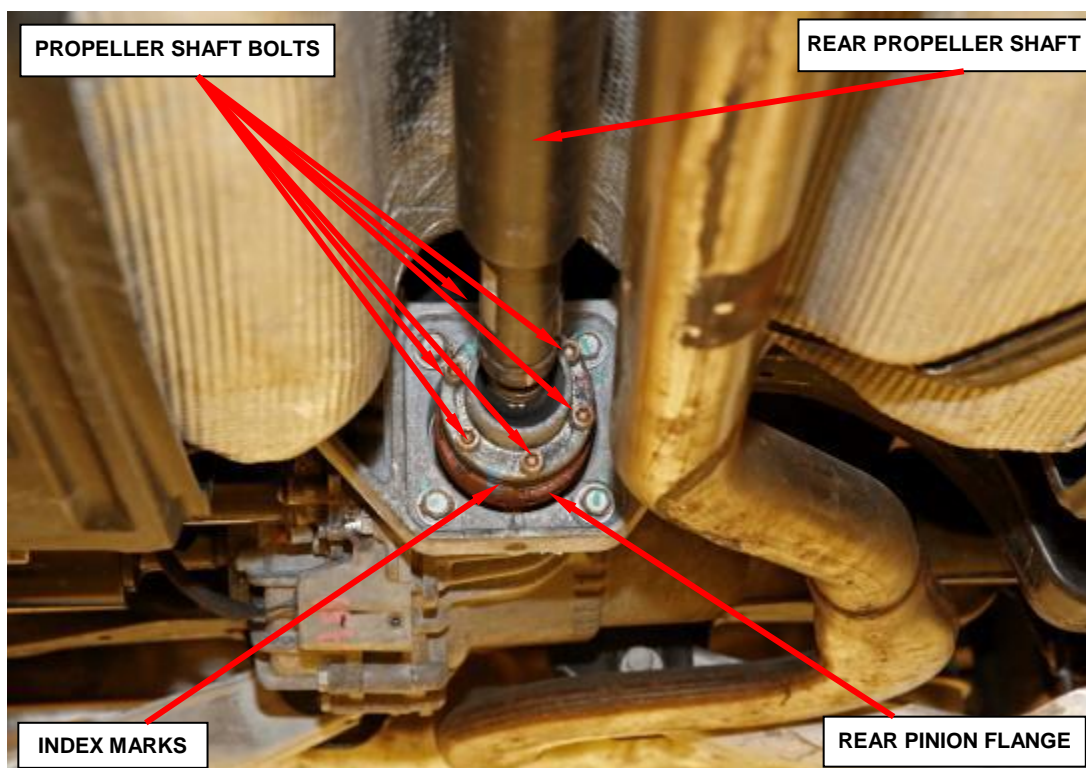
**Figure 32 - Propeller Shaft Bolts**

- a. Apply index marks on the rear pinion flange and the rear propeller shaft flange (Figure 32).
- b. **Remove and discard** the six propeller shaft bolts at the rear pinion flange (Figure 32).
