Dealer Service Instructions for:

## **Safety Recall R08 / NHTSA 15V-090**

### **Transaxle Park Rod**

**2015 (UF) Chrysler 200**

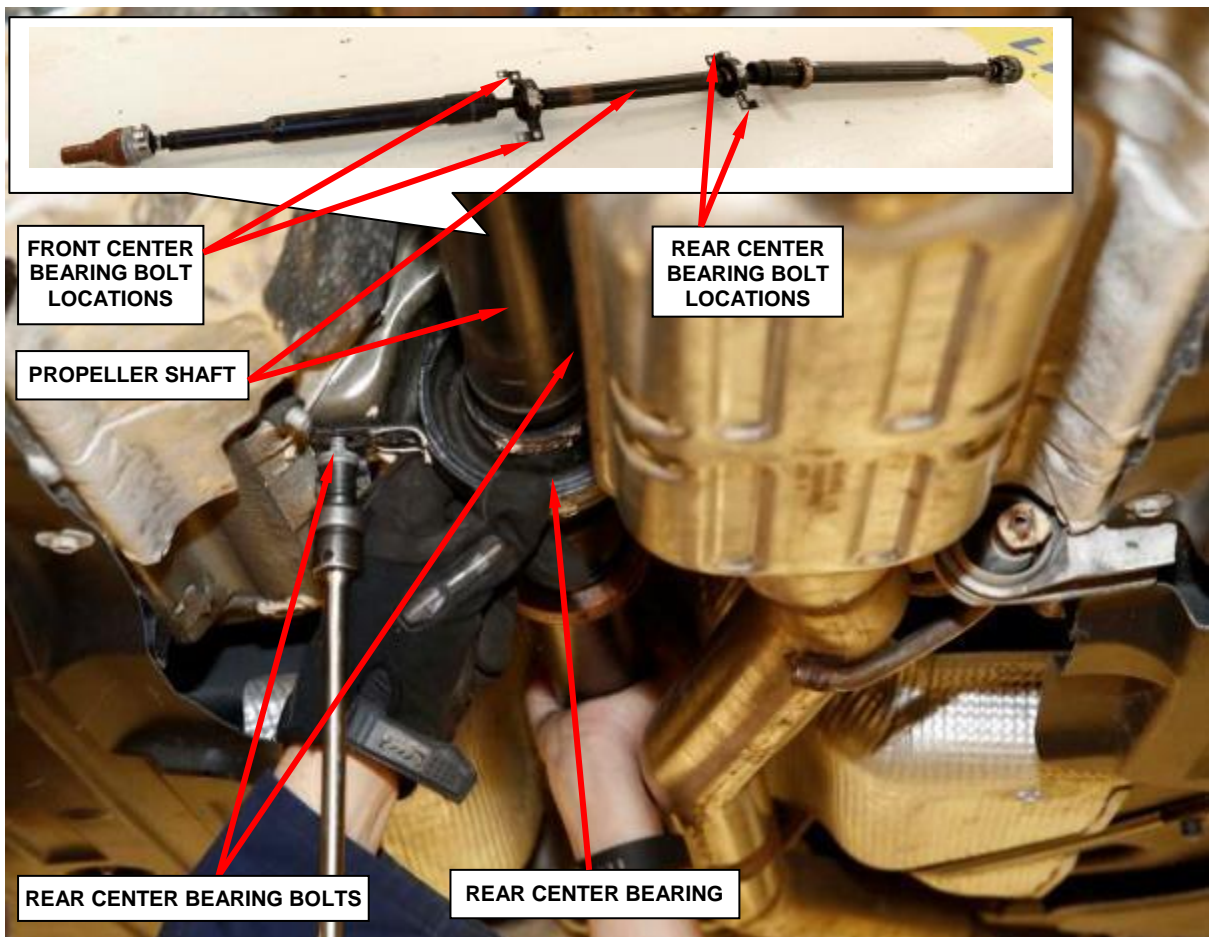
**Figure 33 – Center Bearing Bolts**

- c. Remove and save the two front center bearing bolts (Figure 33).
- d. Remove and save the two rear center bearing bolts (Figure 33).
- e. Slide the propeller shaft off the Power Transfer Unit (PTU) and remove the propeller shaft from the vehicle.

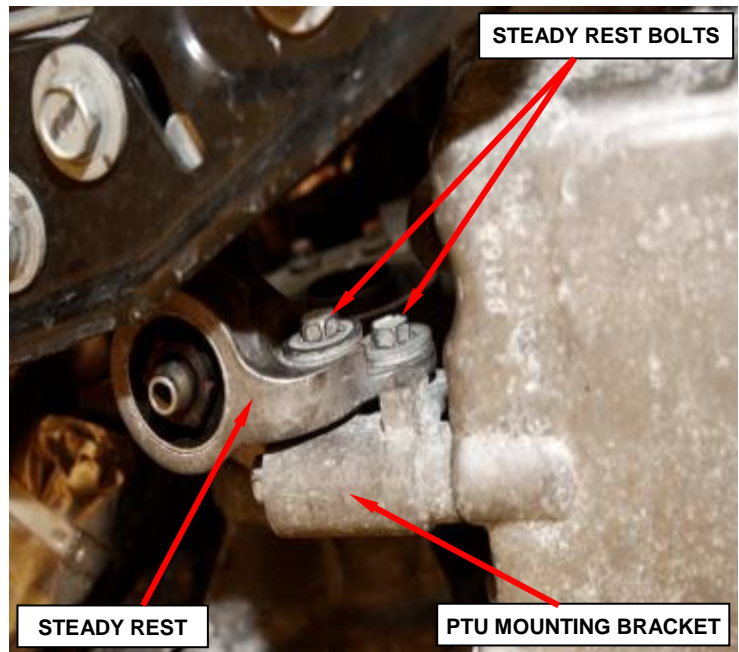
**Figure 34 – Steady Rest Bolts**

- f. Remove and save the two steady rest bolts from the PTU mounting bracket and remove the steady rest bracket (Figure 34).
- g. Remove and save the two upper PTU mounting bracket-to-PTU bolts (Figure 35).
- h. Remove and save the lower PTU mounting bracket-to-PTU bolt (Figure 35).
- i. Remove and save the additional four PTU mounting bracket-to-PTU bolts (Figure 35).

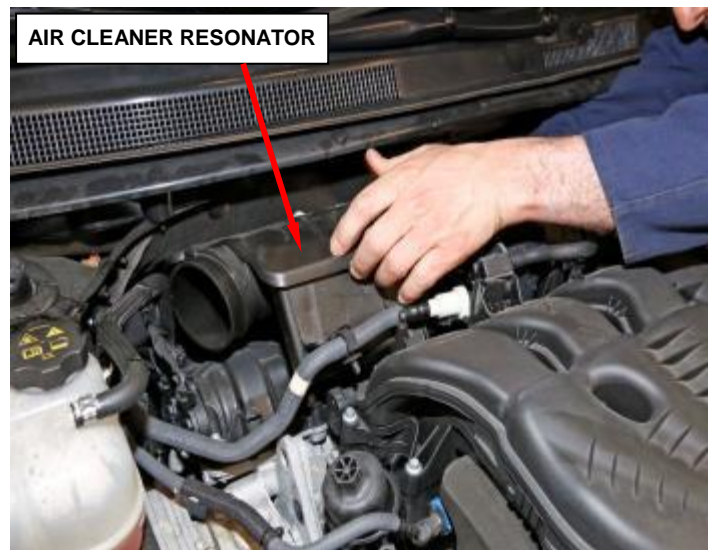
**Figure 36 – Air Cleaner Resonator**

- j. Remove the air cleaner resonator (Figure 36).

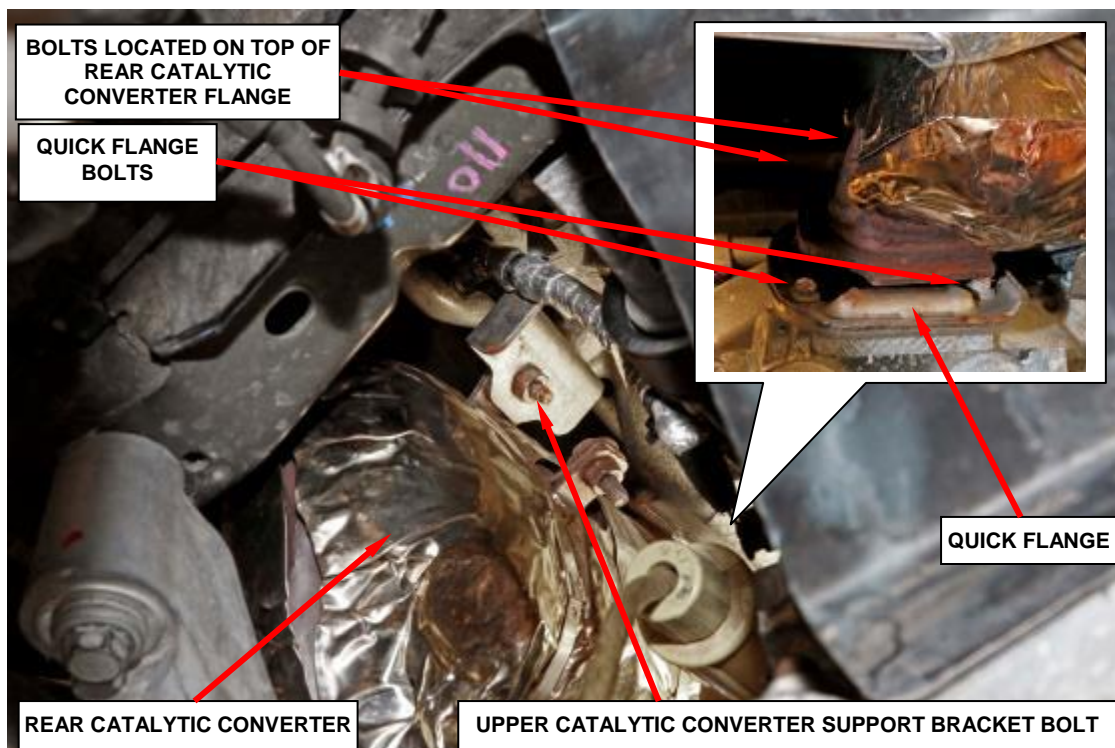
**Figure 37 – Catalytic Converter Mounting (Viewed from Under the Vehicle)**

- k. Remove and save the upper catalytic converter support bracket bolt (Figure 37).
- l. Remove and save the two bolts holding the rear catalytic converter to the cylinder head (Figure 37).

- m. Install the upper catalytic converter support bracket bolt and tighten to 21 ft. lbs. (28 N•m) (Figure 37).

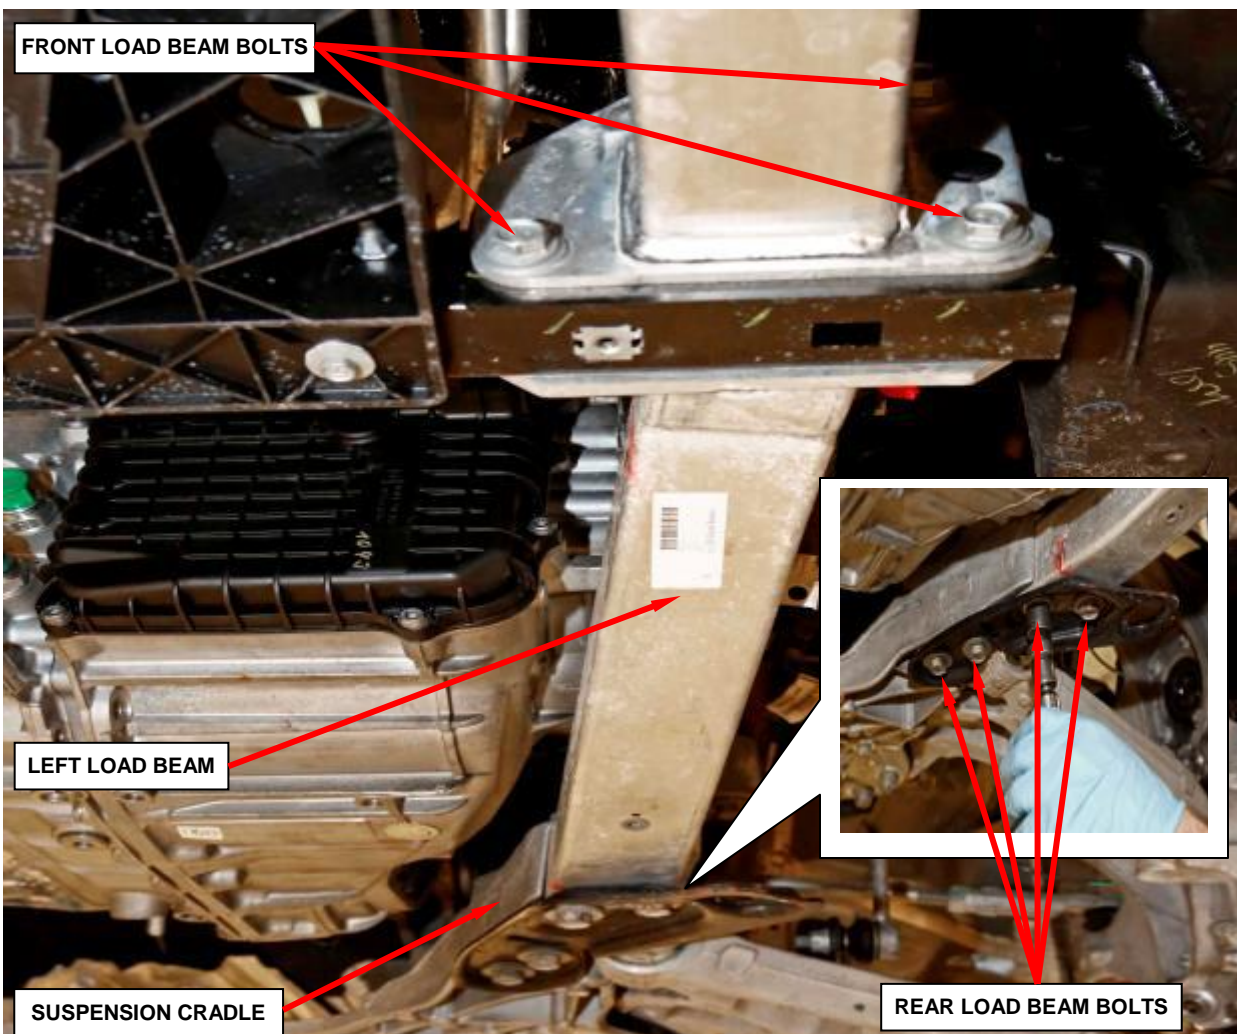
**Figure 42 – Left Load Beam**

45. Remove and save the four bolts holding the rear end of the left load beam to the suspension cradle (Figure 42).
46. Remove and save the three bolts holding the front of the left load beam to the radiator support panel (Figure 42).
47. Separate the left load beam from the vehicle.

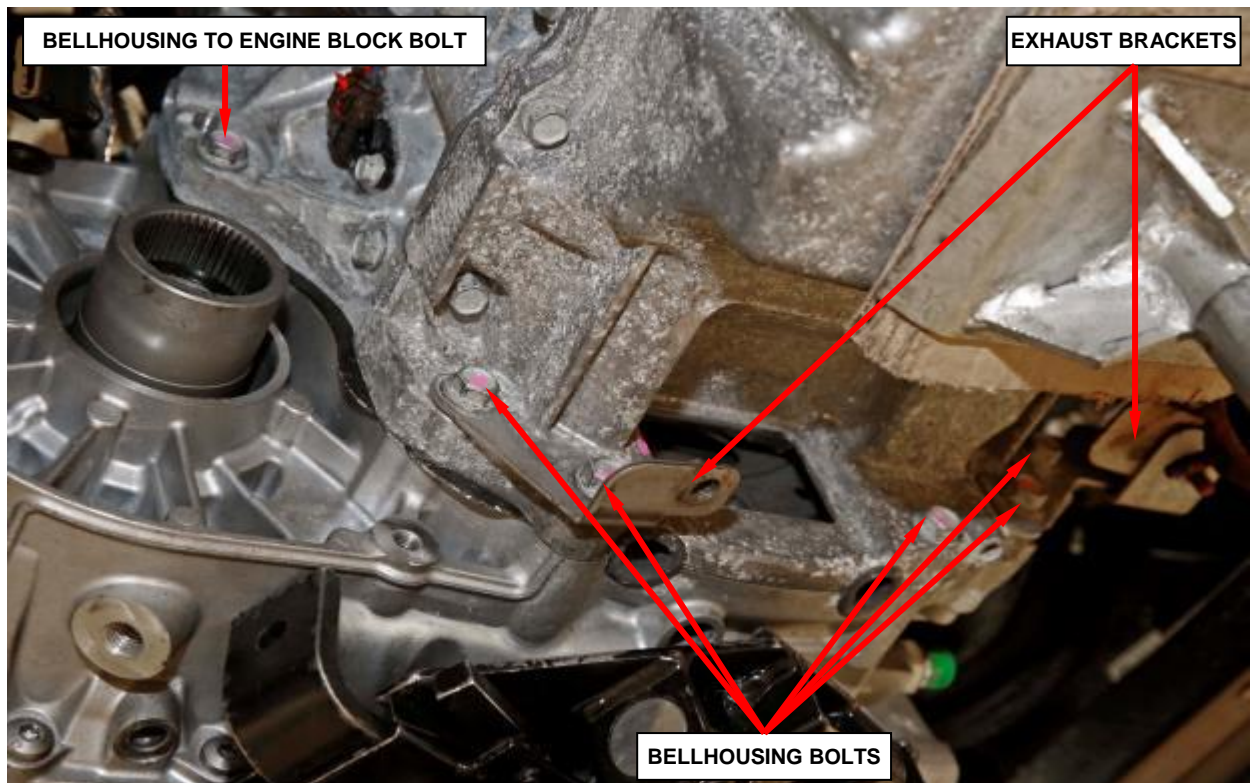
**Figure 44 – Lower Bellhousing Bolts**

48. Disengage the quick couplings and remove the cooler lines from the transaxle. If accessible, install suitable cap-plugs in the male and female ends of the cooler lines to prevent leakage (Figure 43).
49. Remove and save the bolt holding the transaxle bellhousing to the engine block from above the differential housing (Figure 44).
50. Remove and save the five bolts holding the exhaust brackets, engine block and oil pan to the bellhousing (Figure 44).

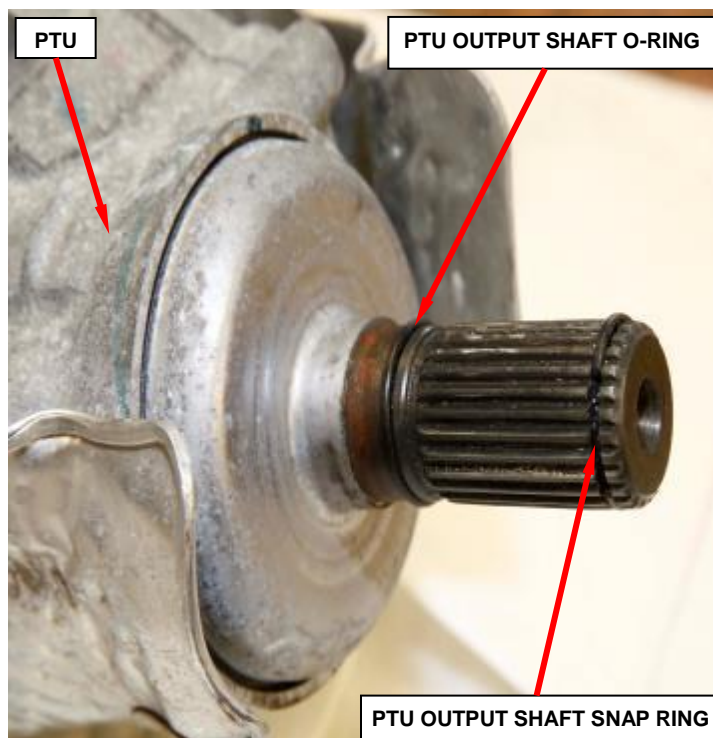
**Figure 45 – PTU Snap Ring and O-Ring**

- d. Replace the Power Transfer Unit (PTU) output shaft snap ring and O-ring before the PTU is reinstalled (Figure 45).

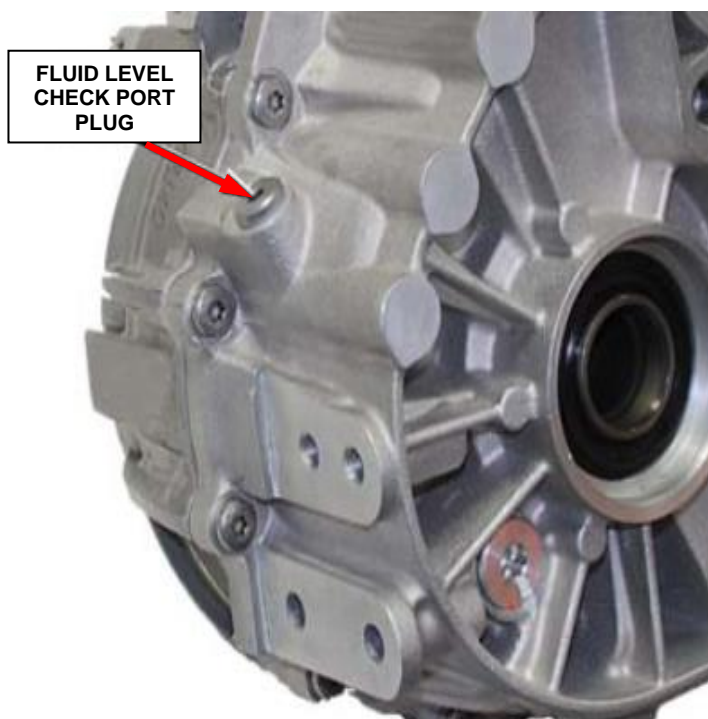
**Figure 47 – Fluid Level Check Port**

**NOTE:** Checking the fluid level in the automatic transmission is to measure the distance from the upper lip of the fluid level check port, located on top of the transmission housing above the differential, down to the surface of the fluid. Tool 10323A fluid level indicator is marked in 5 mm increments. The engine must be running at idle with the transmission in park and the vehicle in a level position.

- a. With the wiTECH scan tool, view Data Display and read the transmission Fluid Temperature.
- b. Start the engine and allow it to run at idle with the transmission in Park.
- c. Verify that the fluid temperature is above 50 °C.
- d. Remove the plug from the fluid level check port (Figure 47).
- e. Insert Special Tool Transmission Dipstick 10323A (Figure 48) into the fluid level check port and allow the handle of the 10323A – Transmission Dipstick to rest on the flat surface of the transmission housing around the check port.
