Dealer Service Instructions for:

Safety Recall R14 / NHTSA 15V-178 Outside Door Handle Switch

2013 – 2014 (ZD) Dodge Viper

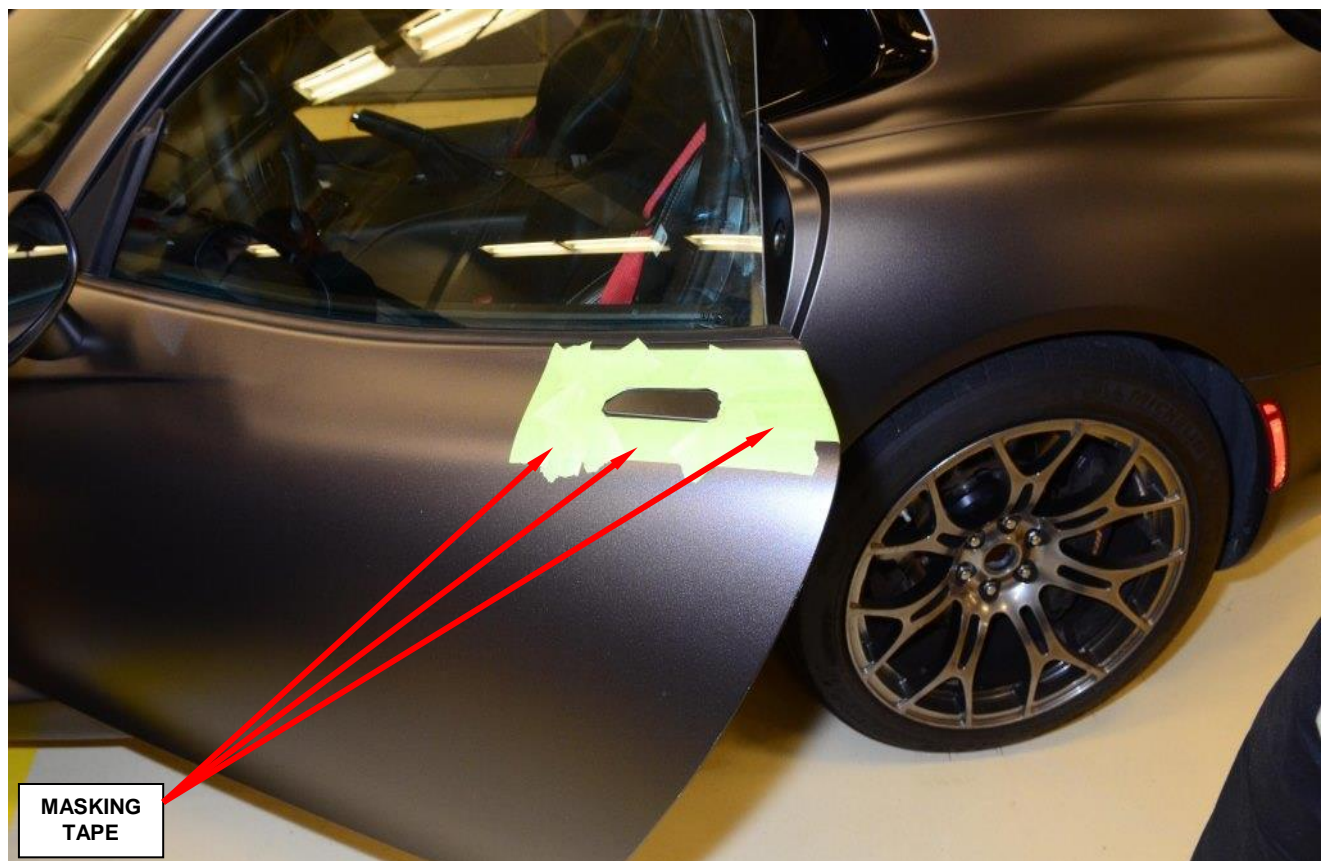
Figure 1 – Apply Masking Tape to Protect Paint

1. Open the liftgate.
2. Place the door glass for both doors in the full up position.
3. Apply masking tape around the door handle to protect the paint during door handle replacement (Figure 1).
4. Open both doors.
5. Disconnect and isolate the negative battery cable.

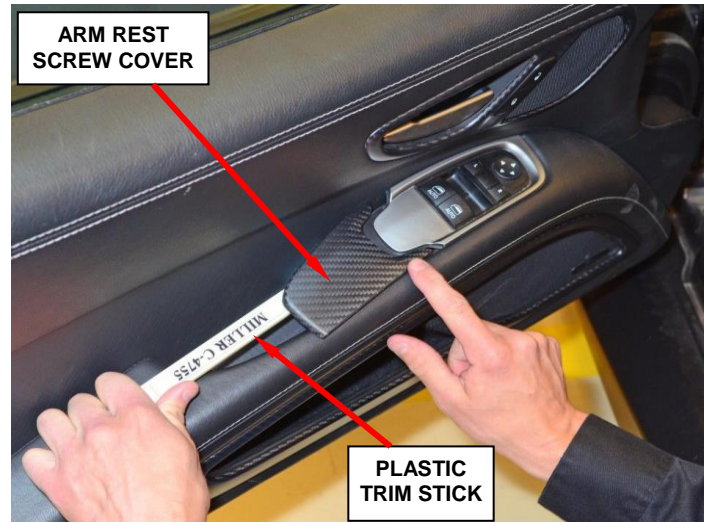
Figure 2 – Arm Rest Screw Cover

6. Use the following procedure to remove the interior door panel:
 - a. Remove and save the arm rest screw cover and screw (Figure 2).

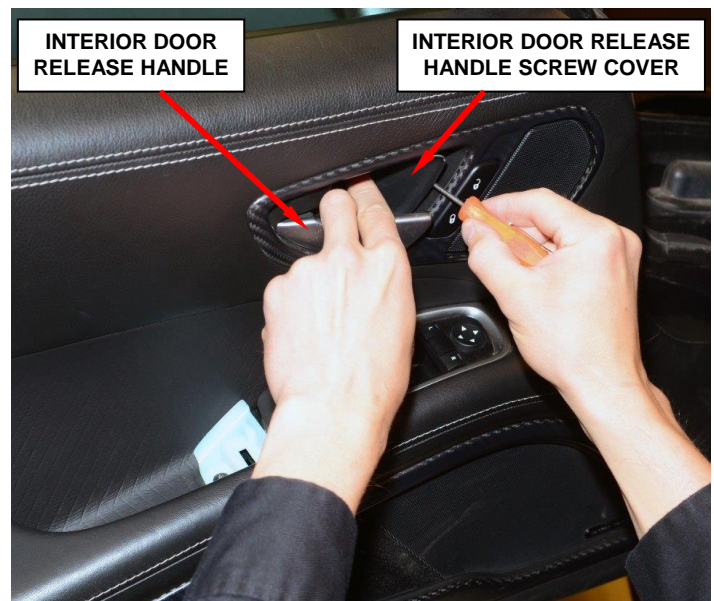
Figure 3 – Interior Door Release Handle Screw Cover

- b. Remove and save the interior door release handle screw cover and screw (Figure 3).

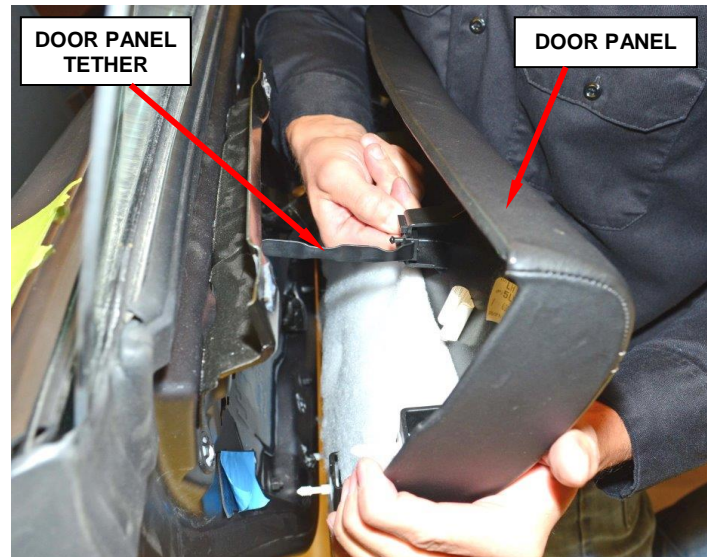
Figure 4 – Interior Door Panel Tether

- d. Disconnect the interior door panel tether (Figure 4).
- e. Disconnect all interior door panel electrical connectors.
- f. Disconnect the interior door handle release cable.
- g. Carefully remove and save the interior door panel.
- h. Carefully pull back the door shell water shield to gain access to the outside door handle electrical connector (Figure 5).

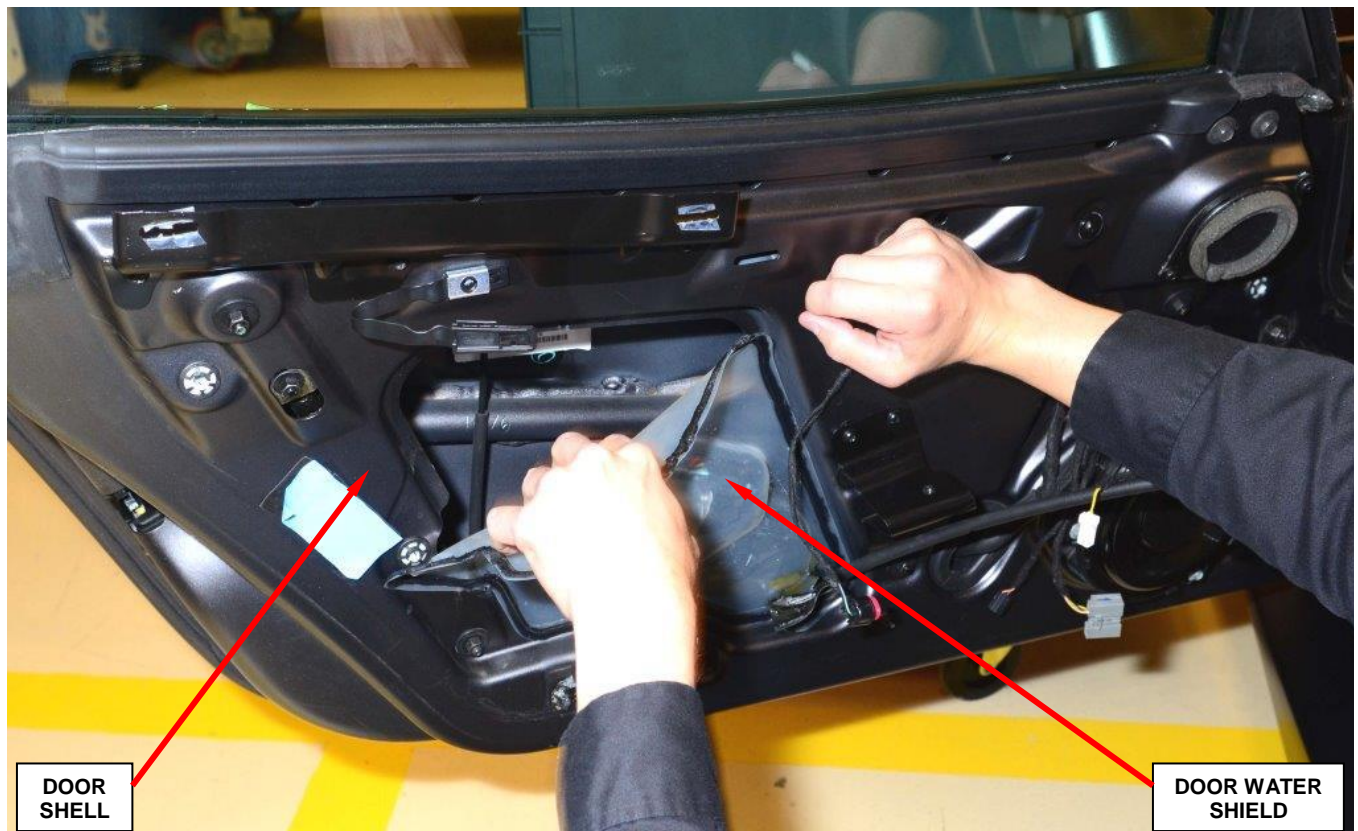
Figure 5 – Partially Remove the Door Shell Water Shield

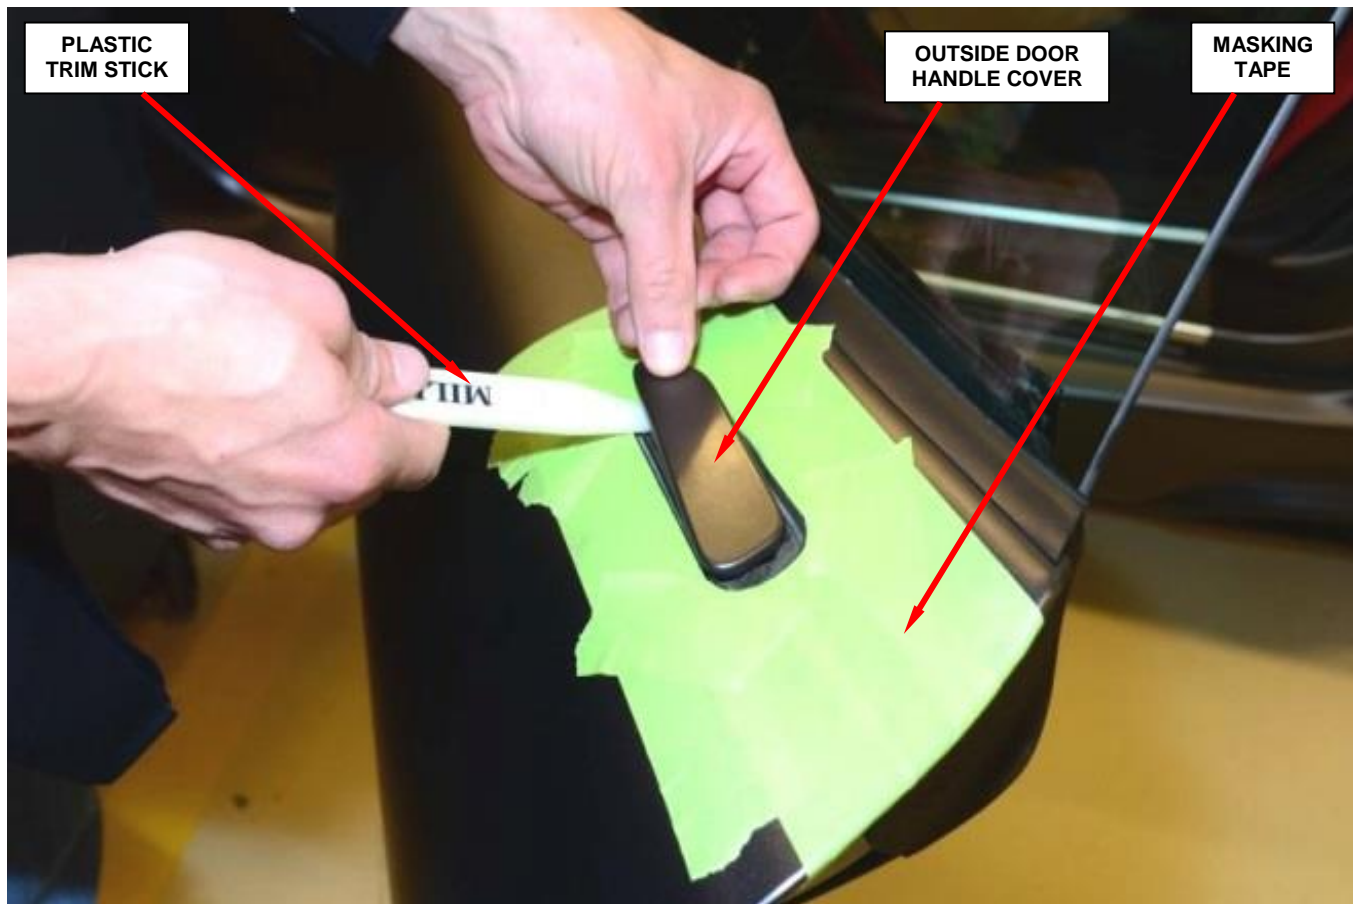
Figure 6 – Remove and Discard the Outside Door Handle Cover

7. Reaching inside the door, unfasten the outside door handle wiring connector from the door.
8. Disconnect the outside door handle electrical connector from the door wire harness electrical connector.
9. Reposition the end of the weatherstrip to access the door handle cover access holes.
10. Using a plastic trim stick, or equivalent, release the door handle cover from the door handle (Figure 6).

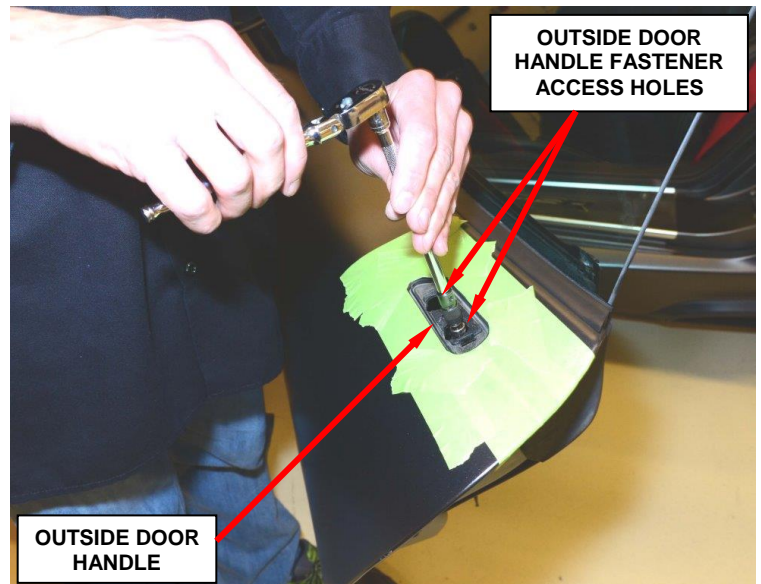
Figure 7 – Outside Door Handle Fasteners

11. Remove and save the two fasteners from the outside door handle assembly (Figure 7).
12. Push the door handle down fully.
13. While holding the door handle down, back the “lock” screw out just far enough to lock the door handle in the down position (Figure 8).
14. Remove and discard the original outside door handle assembly from the door.

17. Place the outside door handle in the correct position by aligning the opening in the door for the handle with the ridge on top of the outside door handle assembly.
18. Install the original outside door handle fasteners and tighten to 45 in. lbs. (5 N·m).
19. From inside the door, connect the outside door handle electrical connector to the door wire harness electrical connector.
20. Insert the outside door handle electrical connector retainers into the door tab holes.

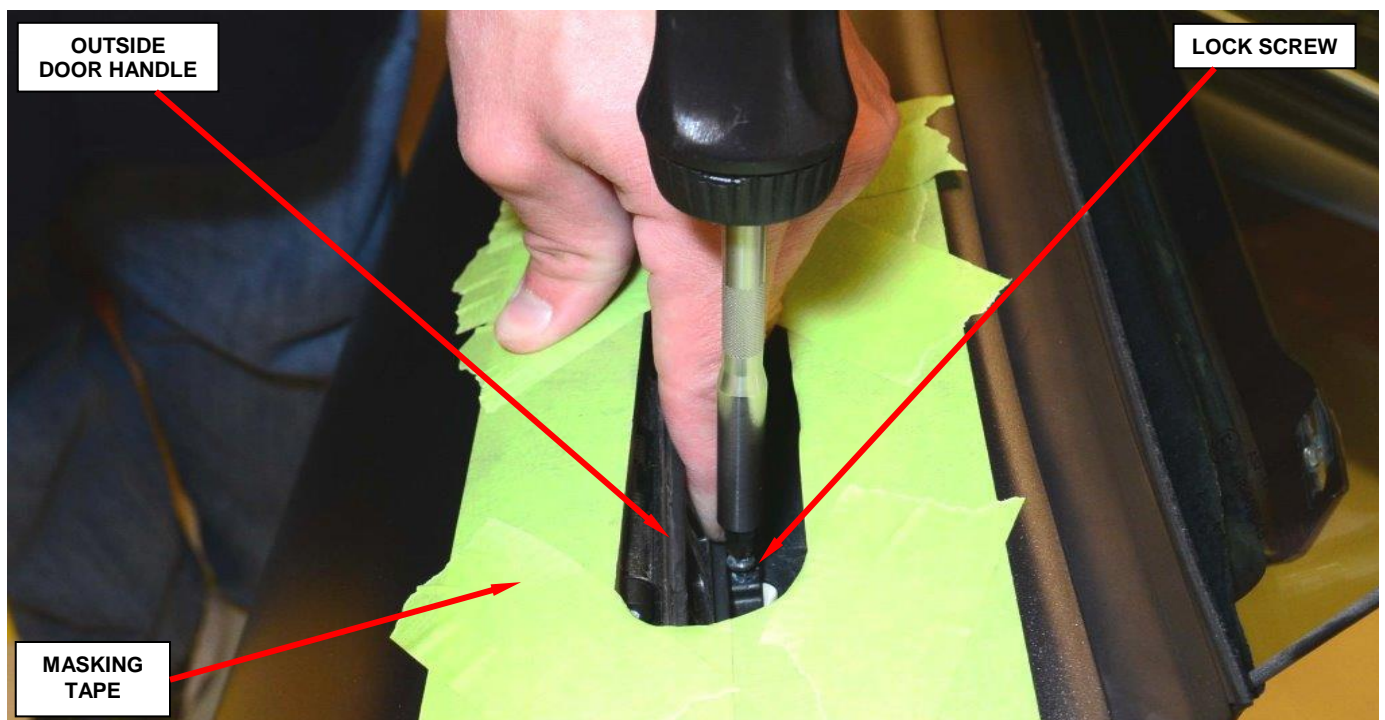
Figure 8 – Door Handle Lock Screw

NOTE: If the new door handle is not in the down position, push the handle down fully and back out the “lock” screw far enough to hold the handle down.

16. Tighten the “lock” screw securely, unlocking the door handle (Figure 8).
