Dealer Service Instructions for:

Safety Recall R34 / NHTSA 15V-468

Front Suspension Upper Control Arms

2015 (DP) RAM Truck (4500 and 5500 series)

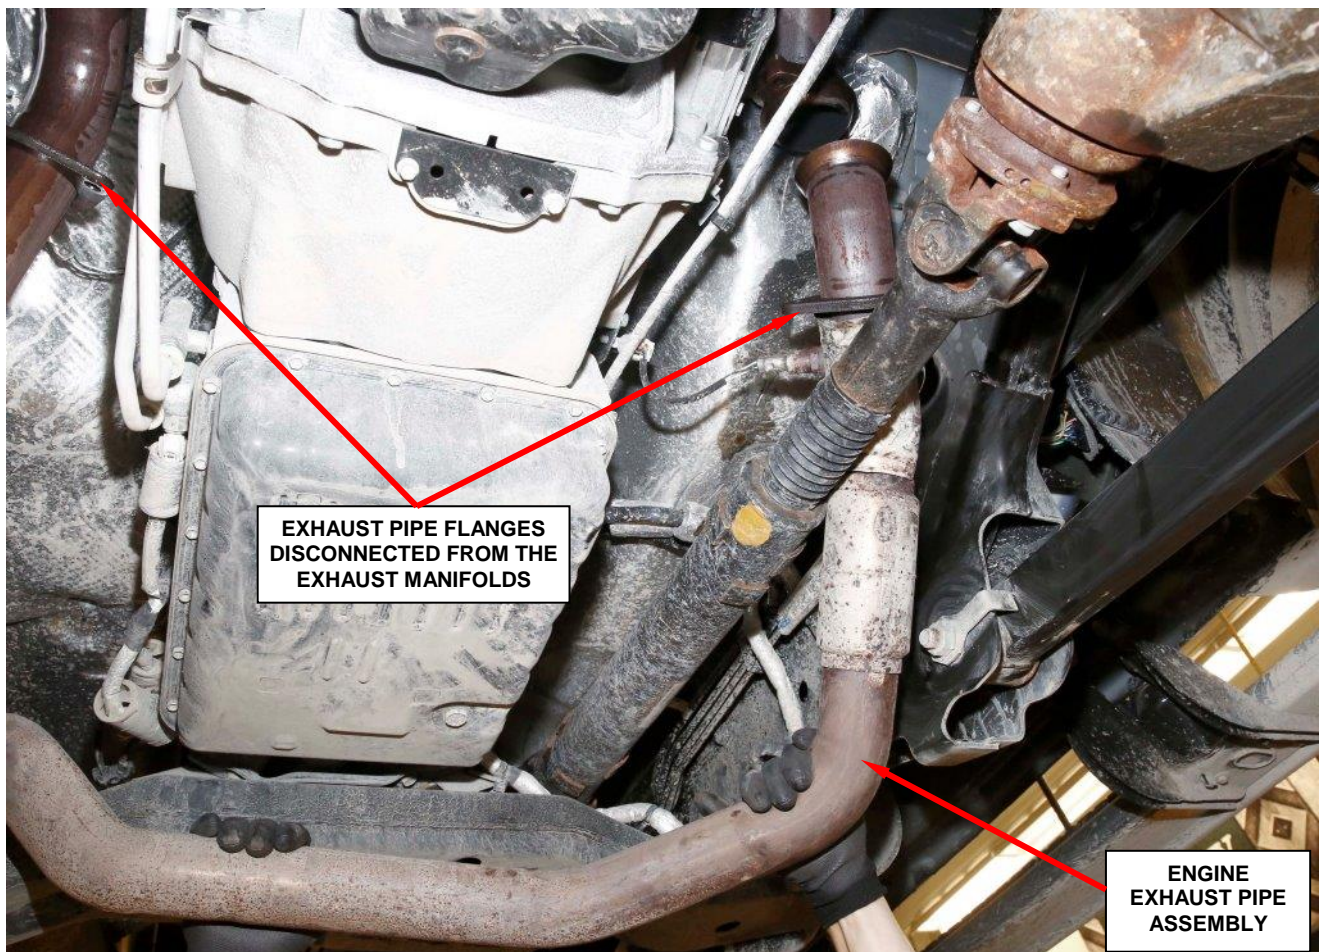
Figure 3 – Exhaust System

4. Use the following procedure to replace the left side front suspension upper control arm:
 - a. Disconnect the exhaust system at the engine exhaust manifolds (Figure 3).
 - b. Carefully reposition the exhaust system as required to gain access to the front suspension upper control arm bolt (Figure 3).

CAUTION: Use extreme care not to damage the oxygen sensor wires when relocating the exhaust pipe.

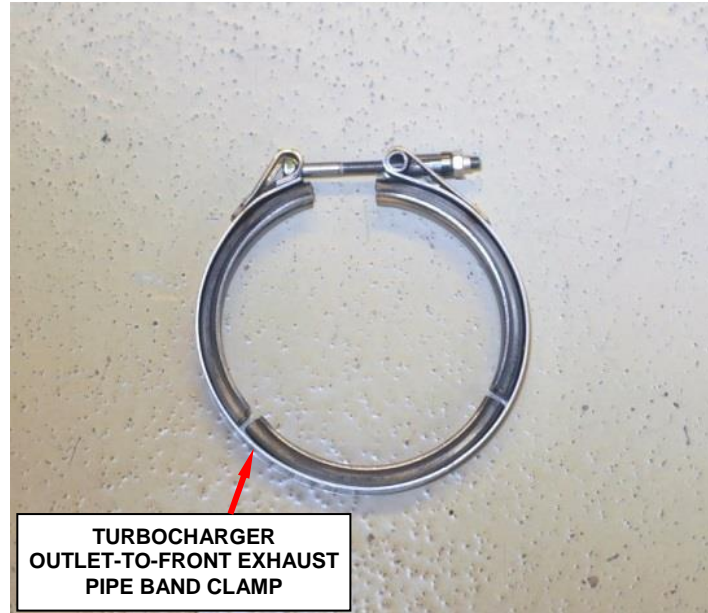
Figure 10 – Turbocharger Outlet-to-Front Exhaust Pipe Band Clamp

- j. Install the new bolts, then finger tighten the new nuts.
- k. With full vehicle weight on the suspension, tighten the upper control arm nuts at the axle bracket and frame bracket to 185 ft. lbs. (250 N·m).
- l. Remove and discard the original turbocharger outlet-to-front exhaust pipe band clamp (Figure 10).
- m. Install the new turbocharger outlet-to-front exhaust pipe band clamp into position (Figure 10).

w. Tighten the turbocharger outlet-to-front exhaust pipe band clamp to 13 ft. lbs. (18 N·m).

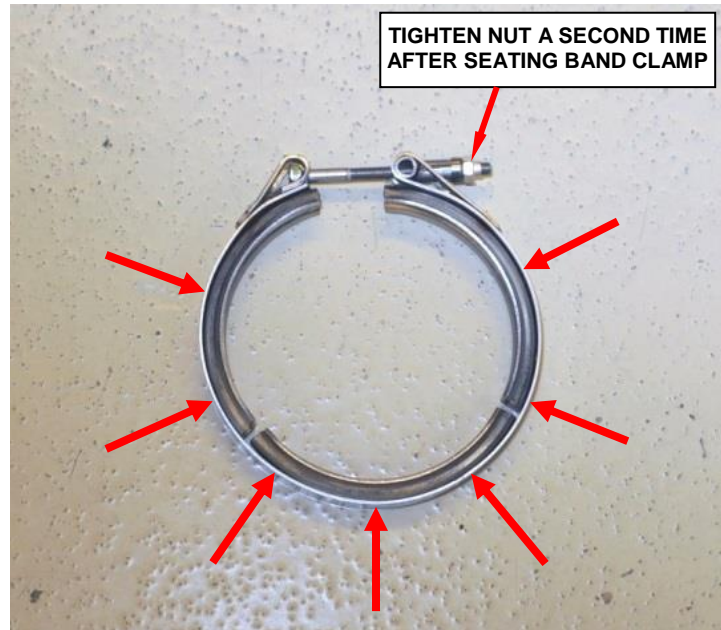
Figure 12 – Tap Around the Clamp with a Hammer to Seat Band Clamp

x. Using a small hammer, lightly tap around the outside diameter of the turbocharger outlet-to-front exhaust pipe band clamp to seat the clamp (Figure 12).

y. Tighten the turbocharger outlet-to-front exhaust pipe band clamp again to 13 ft. lbs. (18 N·m).

CAUTION: Failure to seat the band clamp and tightening the nut a second time could result in an exhaust leak.
