Dealer Service Instructions for:

Safety Recall S22 / NHTSA 16V-253 Trailer Tow Lighting Control Module

2014-2016 (VF) RAM ProMaster

2015-2016 (VM) RAM ProMaster City

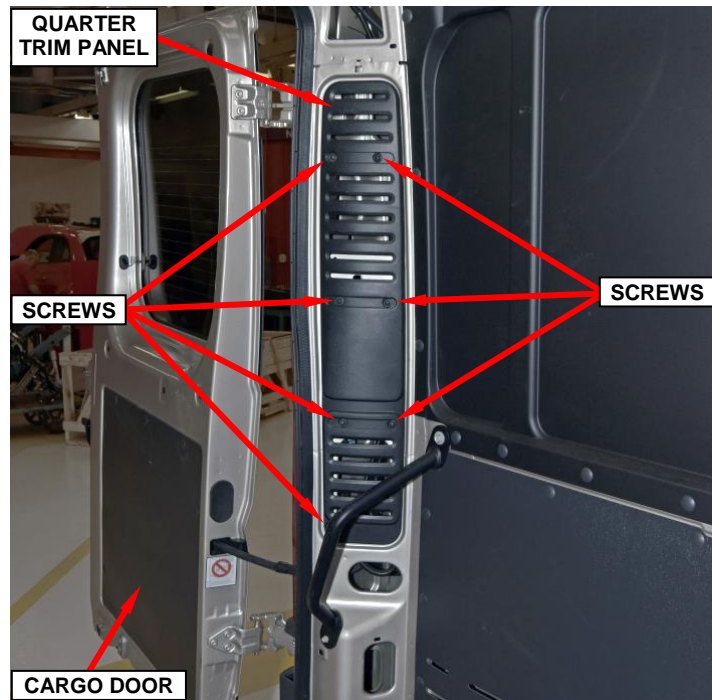
**Figure 1 – Quarter Trim Panel**

1. Disconnect the negative battery cable terminal from the battery.
2. Open the rear cargo doors (Figure 1).
3. Remove and save the seven screws and the quarter trim panel from the left rear corner (Figure 1).
4. Disconnect the electrical connector from the trailer tow lighting control module (Figure 2).
5. Twist / rotate the trailer tow lighting control module both clockwise and counter-clockwise to separate the foam adhesive patch securing the module. A plastic non-marring trim stick or equivalent may also be used to assist with module removal. Remove and discard the trailer tow lighting control module (Figure 2).

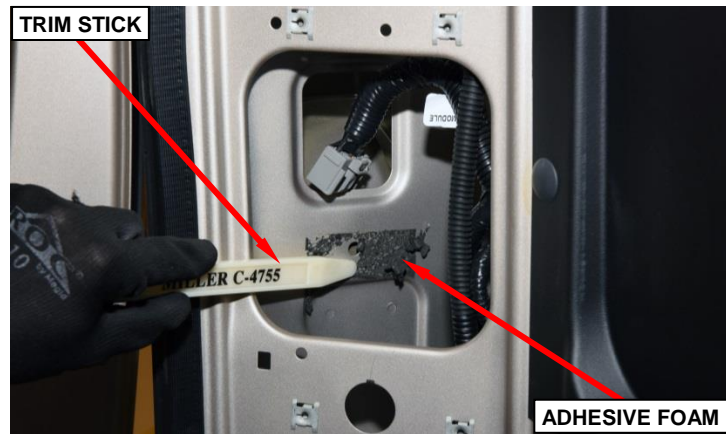
**Figure 3 – Remove Foam Pieces**

6. Remove any large adhesive foam backing pieces using a plastic scratch resistant tool such as a trim stick or equivalent (Figure 3).

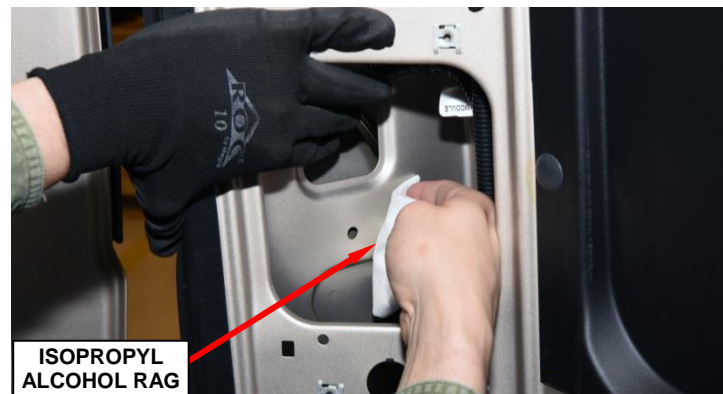
**Figure 4 – Remove Residual Adhesive**

7. Use a clean rag and isopropyl alcohol to remove any residual adhesive from the module mounting area (Figure 4). Allow 60 seconds to dry before installing the new module.

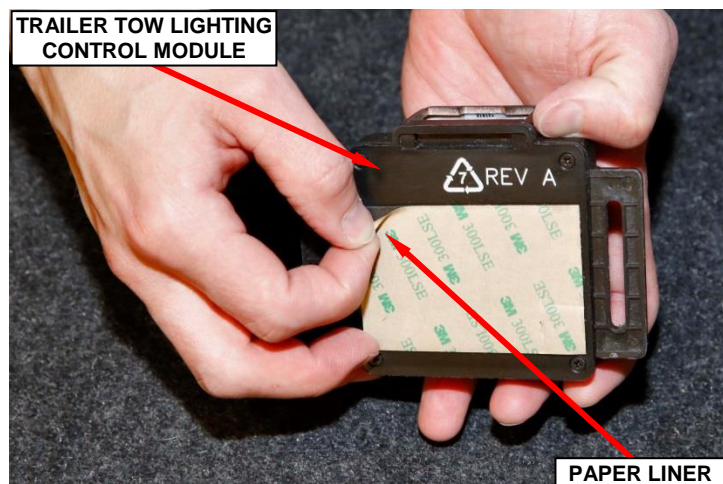
**Figure 5 – Remove Paper Liner**

8. Remove the paper liner from the foam adhesive patch on the new trailer tow lighting control module (Figure 5).

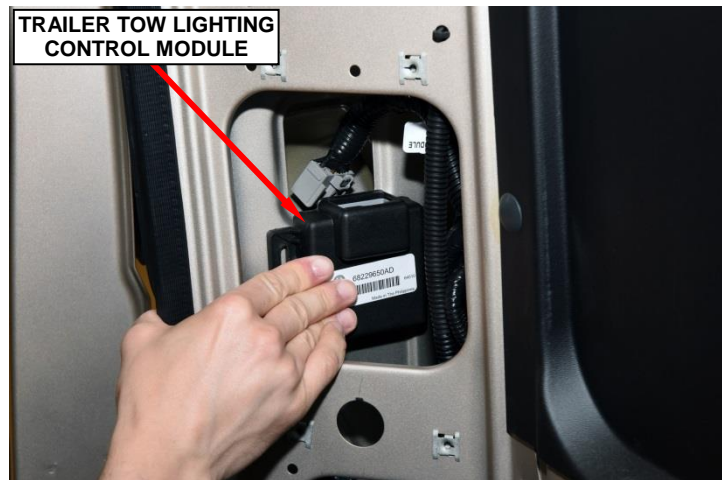
**Figure 6 – Press And Hold New Module**

9. Place the new trailer tow lighting control module in the in the same location as the old module (Figure 6).
10. Press and hold the new trailer tow lighting control module in place applying constant pressure to for 30 seconds to ensure proper adhesion of the foam patch to the vehicle (Figure 6).
11. Connect the electrical connector to the trailer tow lighting control module (Figure 7).
12. Install the quarter trim panel and seven screws (Figure 1).
13. Close the rear cargo doors (Figure 1).
14. Connect the negative battery cable terminal to the battery.
15. Connect the wiTECH scan tool and clear all Diagnostic Trouble Codes (DTCs).
16. Disconnect the wiTECH scan tool from the vehicle.

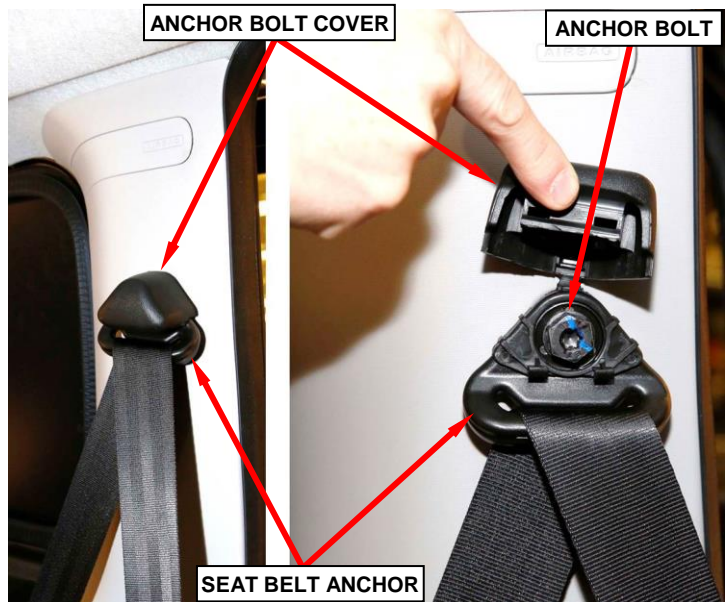
Figure 8 – C-Pillar Seat Belt Upper Anchor

3. Lift up the left C-pillar seat belt upper anchor bolt cover (Figure 8).

4. Remove the left C-pillar seat belt upper anchor bolt (Figure 8).

45. Ensure the seatbelt webbing is properly aligned and then install the left C-pillar upper seat belt anchor bolt (Figure 8). Tighten the bolt to 30 ft. lbs. (40 N·m).

46. Close and secure the left C-pillar upper seat belt anchor bolt cover (Figure 8).
47. If equipped, place the rear seat in the customer preferred position as it was prior to service.

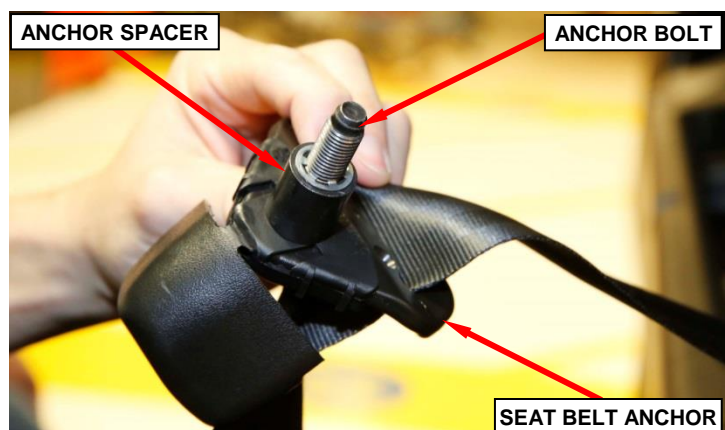
Figure 9 – Seat Belt Anchor Spacer

5. Ensure the black spacer remains on the seat belt anchor bolt (Figure 9).

43. Install the cover on the left C-pillar lower seat belt anchor bolt (Figure 10).
44. Ensure the black spacer is on the left C-pillar upper seat belt anchor bolt (Figure 9).

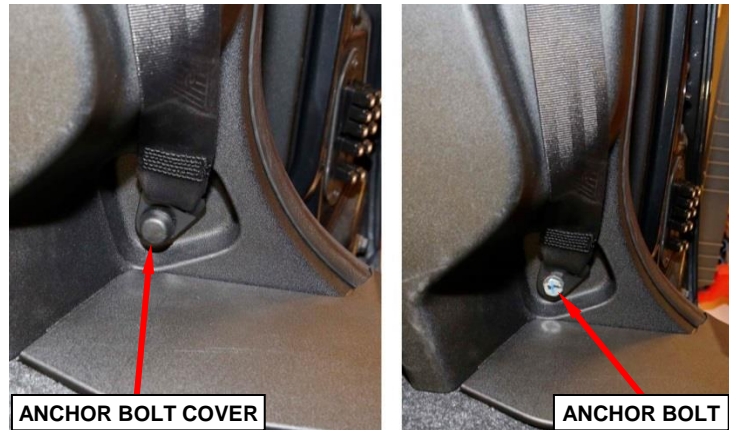
Figure 10 – C-Pillar Seat Belt Lower Anchor

6. Remove and save the cover from the left C-pillar lower seat belt anchor bolt (Figure 10).

7. Remove and save the left C-pillar lower seat belt anchor bolt (Figure 10).

42. Ensure the seatbelt webbing is properly aligned and then install the left C-pillar lower seat belt anchor bolt (Figure 10). Tighten the bolt to 30 ft. lbs. (40 N·m).

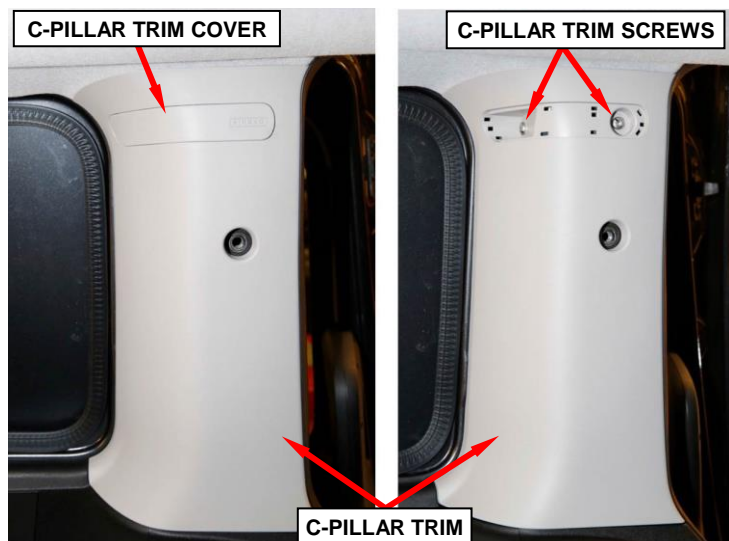
Figure 11 – C-Pillar Trim

8. Remove and save the trim cover from the top of the left C-pillar trim (Figure 11).

9. Remove and save the two screws from the top of the left C-pillar trim (Figure 11).

10. Remove and save the left C-pillar trim (Figure 11).

39. Install the left C-pillar trim (Figure 11).
40. Install the two screws to the left C-pillar trim (Figure 11).
41. Install the trim cover at the top of the left C-pillar trim (Figure 11).

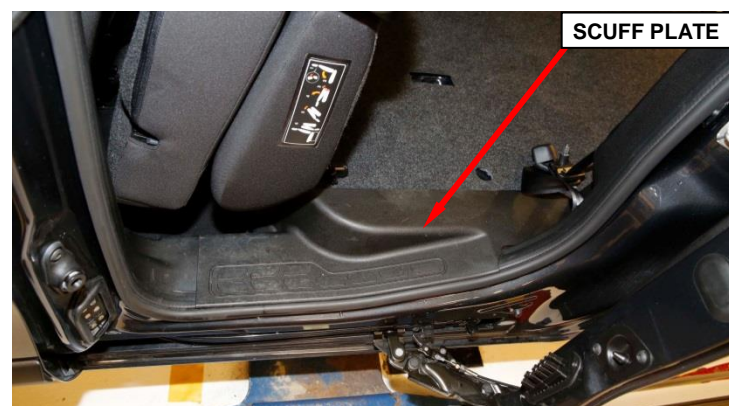
Figure 12 – Door Sill Scuff Plate

11. Remove and save the door sill scuff plate from the left rear sliding side door opening (Figure 12).

37. Install the two screws securing the bin storage tray to the left rear quarter trim panel (Figure 13).
38. Install the door sill scuff plate to the left rear sliding door opening (Figure 12).

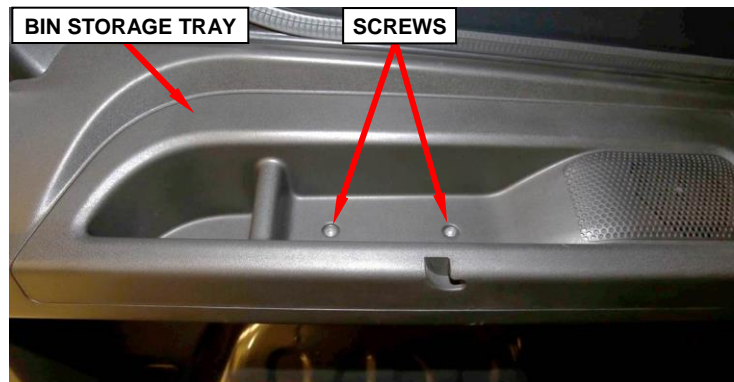
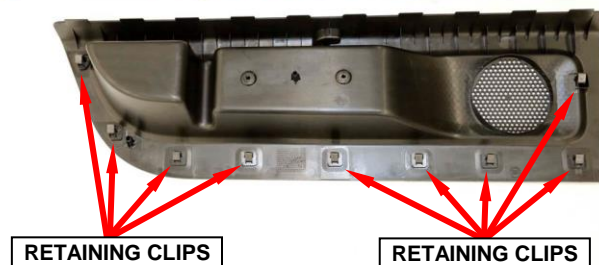
Figure 13 – Bin Storage Tray

12. Remove and save the two screws from the left rear quarter trim panel bin storage tray (Figure 13).

13. Remove and save the left rear quarter trim panel bin storage tray. Ensure the nine retaining clips remain on the storage tray during removal. Reinstall any missing clips (Figure 13).

35. Install the two screws securing the speaker to the left rear quarter trim panel (Figure 14).
36. Install the bin storage tray to the left rear quarter trim panel. Ensure that all nine retaining clips are installed on the storage tray before installation. Reinstall any missing clips (Figure 13).

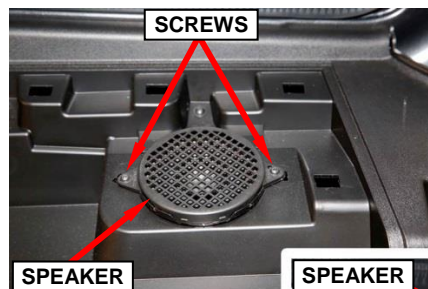
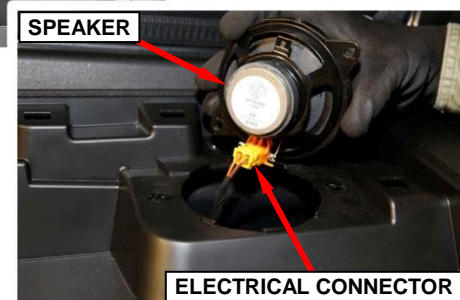
Figure 14 – Speaker

14. Remove and save the two screws securing the speaker to the left rear quarter trim panel (Figure 14).

15. Disconnect the electrical connector from the speaker then remove and save the speaker (Figure 14).

33. Connect the electrical connector to the interior lamp then install the interior lamp housing to the left rear quarter trim panel (Figure 15).
34. Connect the electrical connector to the speaker then install the speaker to the left rear quarter trim panel (Figure 14).

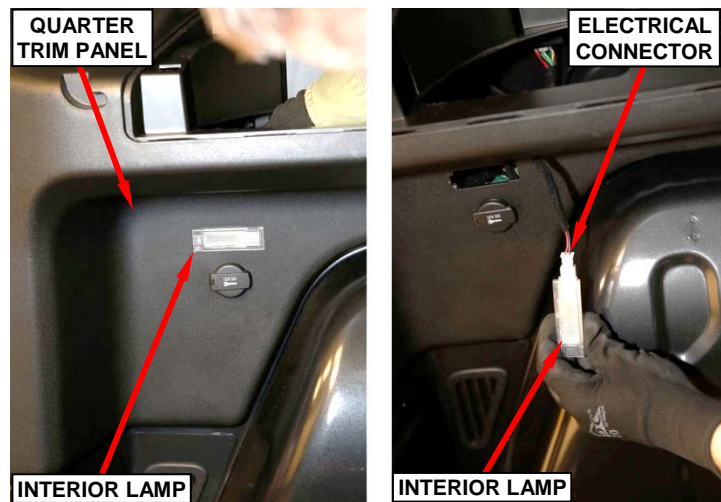
Figure 15 – Interior Lamp

16. Reach in behind the left rear quarter trim panel to release the interior lamp housing from the quarter trim panel (Figure 15).

17. Disconnect the electrical connector from the interior lamp then remove and save the interior lamp (Figure 15).

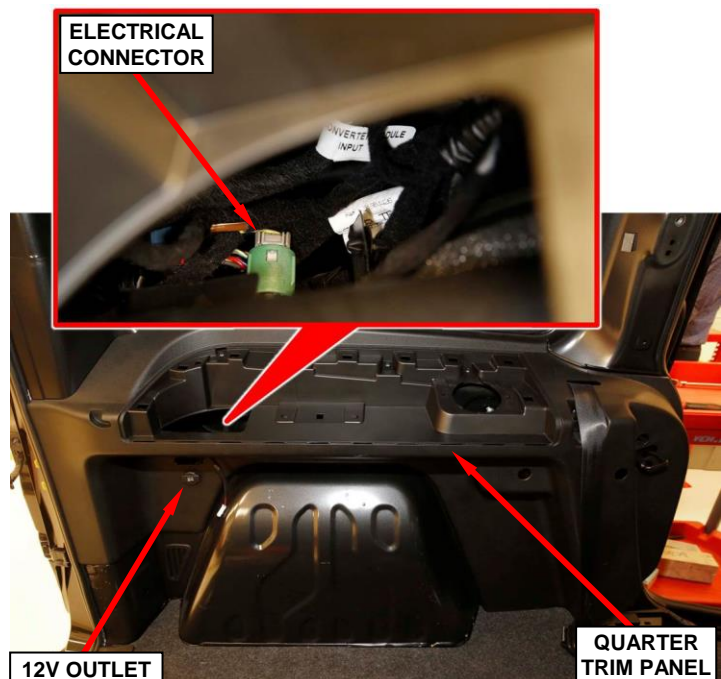
Figure 16 – 12V Outlet

18. Reach in behind the left rear quarter trim panel to disconnect the electrical connector from the green 12V outlet (Figure 16).

31. Install the seven screws securing the left rear quarter trim panel (Figure 17).
32. Reach in behind the left rear quarter trim to connect the electrical connector to the green 12V outlet (Figure 16).

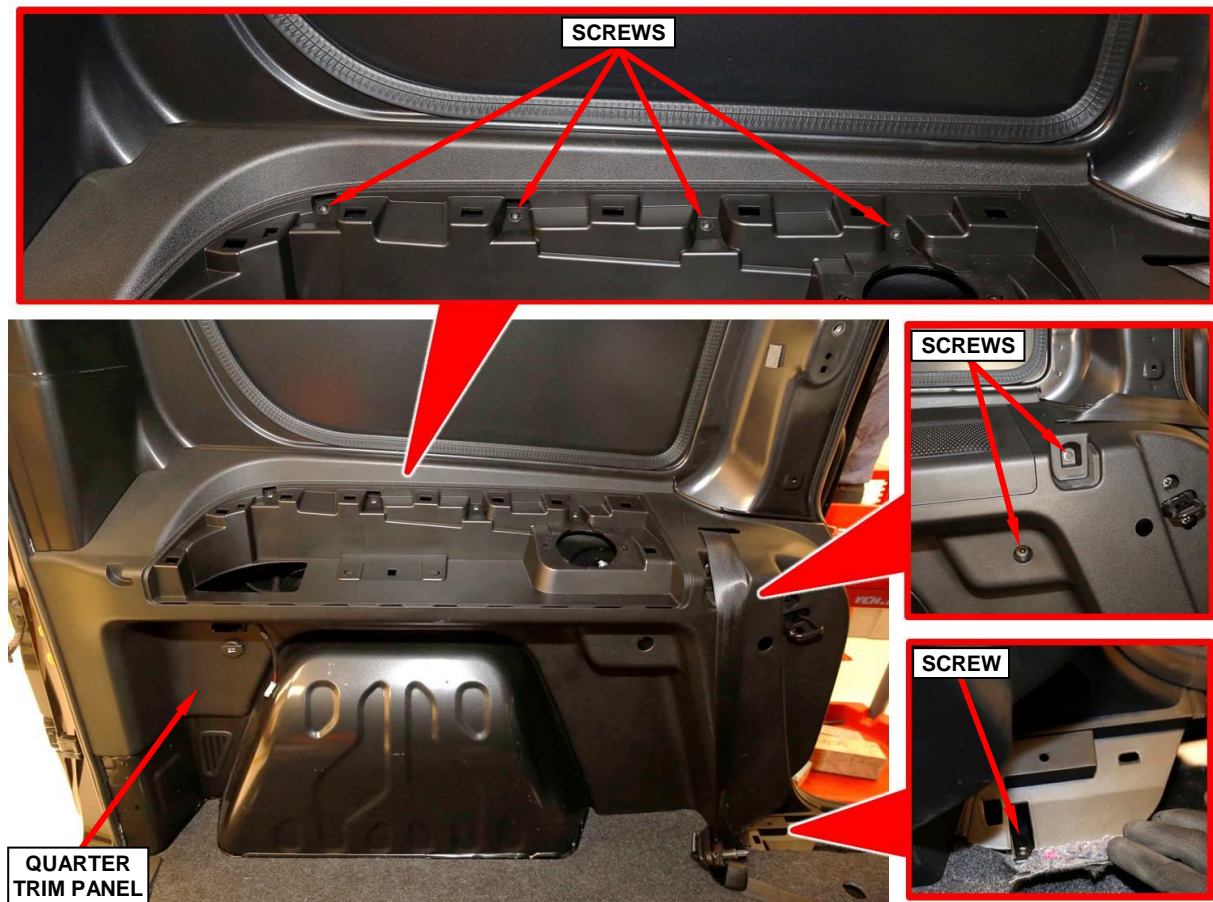
**Figure 17 – Quarter Trim Panel**

19. Remove and save seven screws from the left rear quarter trim panel (Figure 17).
20. Remove and save the left rear quarter trim panel while routing the seatbelt webbing through the slot in the trim panel (Figure 17).

30. Route the seatbelt webbing through the slot in the left rear quarter trim panel then install the trim panel (Figure 17).

NOTE: Ensure the body door opening seals at forward and rearward edges of the left rear quarter trim panel properly overlay the trim panel.

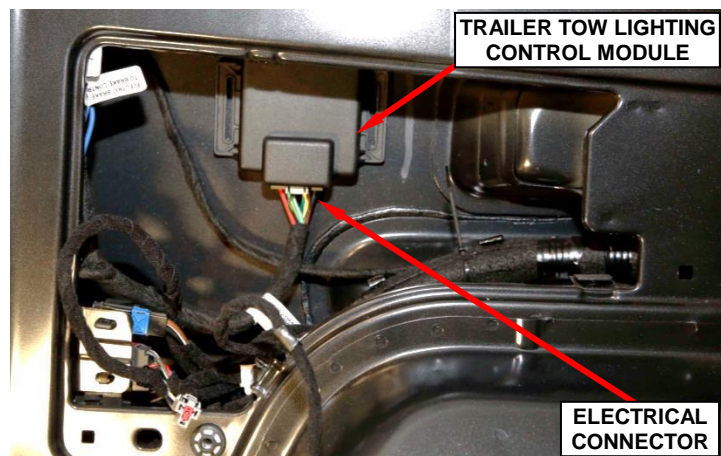
Figure 18 – Module Electrical Connector

21. Disconnect the electrical connector from the trailer tow lighting control module (Figure 18).
22. Using a grease pencil or equivalent, mark the module location (Figure 19).

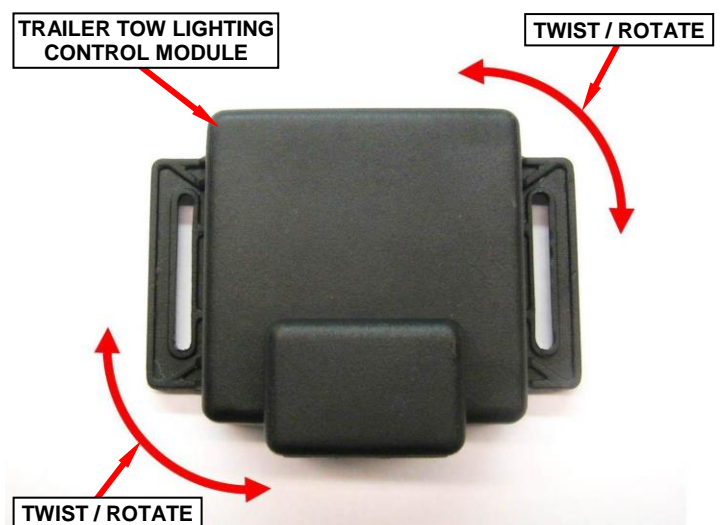
Figure 20 – Twist / Rotate Module To Release

CAUTION: The module is mounted on the back side of a visible exterior body panel. Do NOT use tools of any type for prying the module. Use of tools may cause damage to the exterior appearance of the vehicle.

23. Use hands ONLY to twist/rotate the trailer tow lighting control module both clockwise and counter-clockwise to separate the foam adhesive patch securing the module to the body panel. Remove and discard the trailer tow lighting control module (Figure 20).

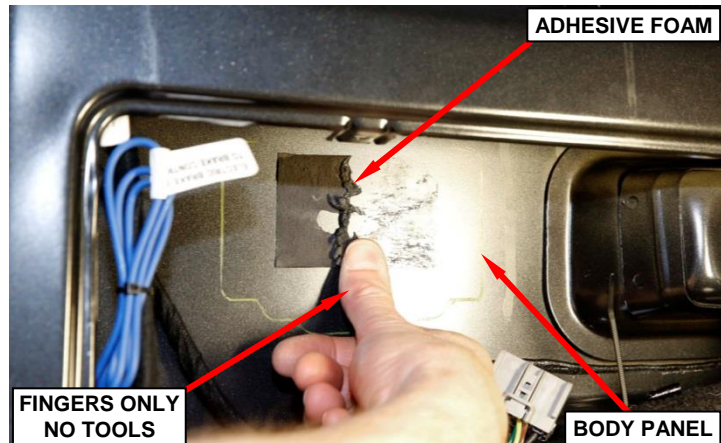
Figure 21 – Remove Foam Pieces

24. Use fingers ONLY to rub away any large adhesive foam backing pieces (Figure 21).

CAUTION: Do NOT use tools of any type for foam removal. Use of tools may cause damage to the exterior appearance of the vehicle.

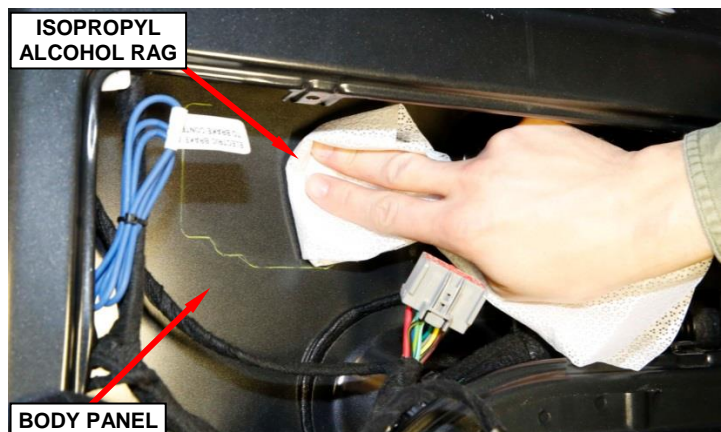
Figure 22 – Remove Residual Adhesive

25. Use a clean rag and isopropyl alcohol to remove any residual adhesive from the module mounting area (Figure 22). Allow 60 seconds to dry before installing the new module.

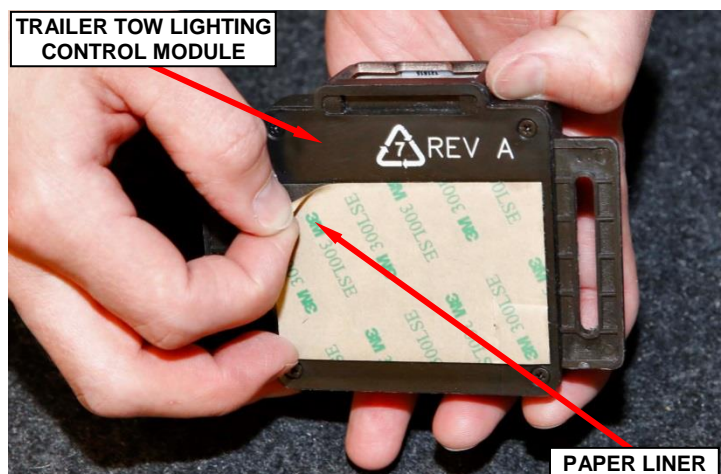
Figure 23 – Remove Paper Liner

26. Remove the paper liner from the foam adhesive patch on the new trailer tow lighting control module (Figure 23).

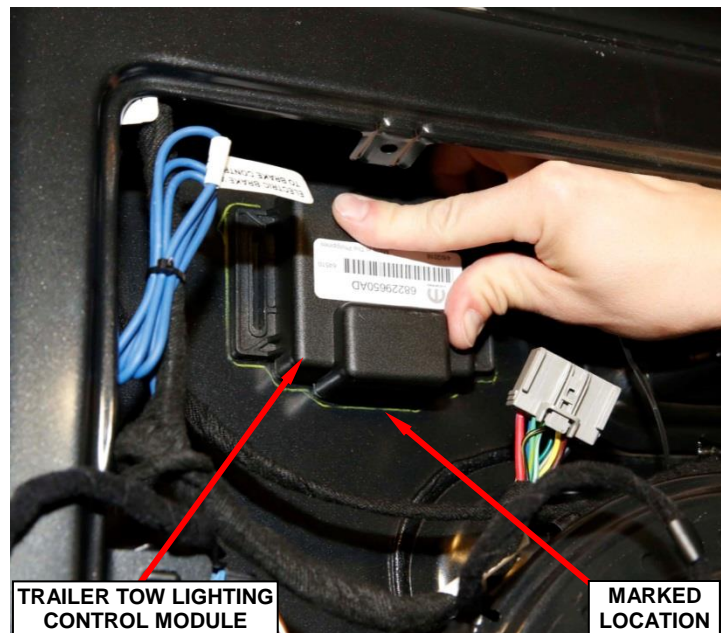
Figure 24 – Press And Hold New Module

27. Place the new trailer tow lighting control module in the previously marked location (Figure 24).

28. Press and hold the new trailer tow lighting control module in place applying constant pressure to for 30 seconds to ensure proper adhesion of the foam patch to the vehicle (Figure 24).

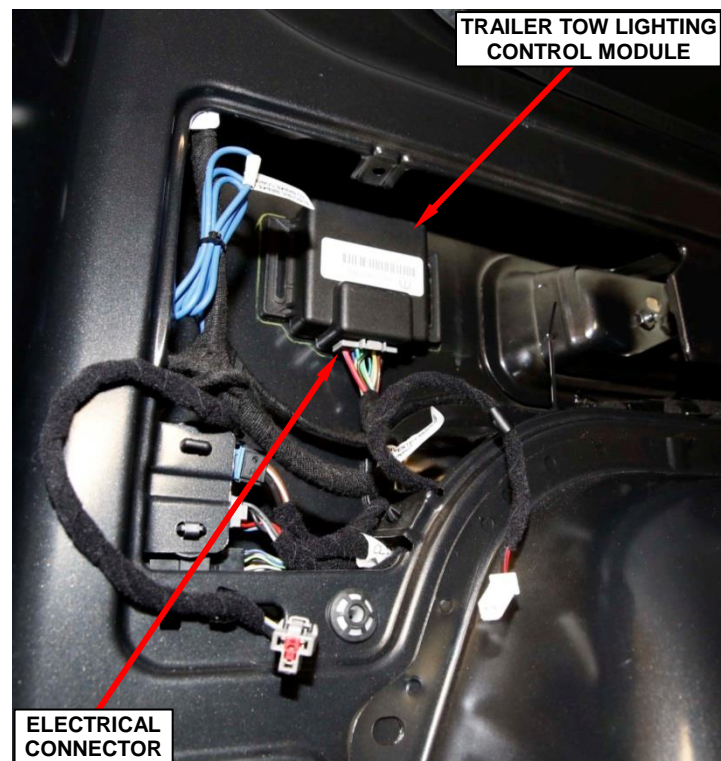
Figure 25 – Connect Electrical Connector

29. Connect the electrical connector to the trailer tow lighting control module (Figure 25).
