Dealer Service Instructions for:

# **Safety Recall T73 / NHTSA 17V-732 Passenger Airbag Module**

**2018 (MP) Jeep® Compass**

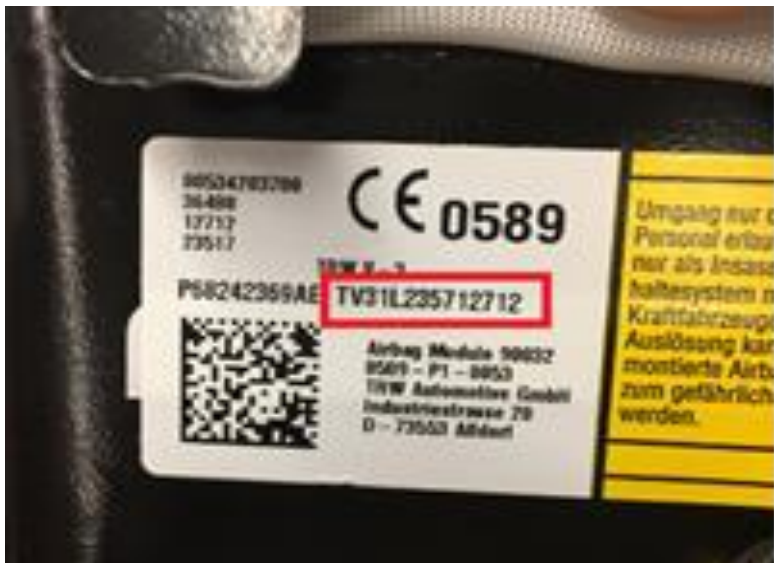
- 3. Please return suspect parts back to your facing PDC using MRA Code 02 and refer to special packaging requirements from your PDC.
- 4. Dealers are to add the PAB serial number in the comments section of the MRA. Serial number starts with TV as highlighted below.

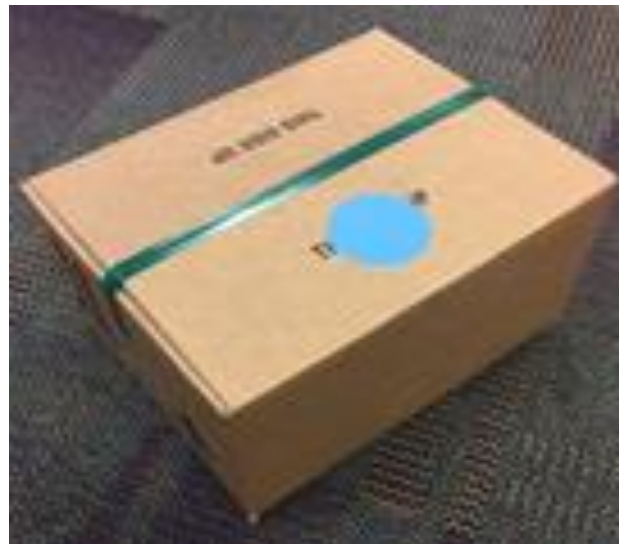
5. Please securely place this label on the top of PAB box being returned to the PDC. The PDC will supply the label with the PAB exchange box.

## MP Airbag Campaign

Please attach to each box prior to return. Also, attach to the cage that the airbags are loaded into.

6. The returned suspect Passenger Airbag (PAB) will be inspected at the facing PDC by a 3rd Party prior to return. The box of each PAB passing inspection will be marked with a sticker and green tape.

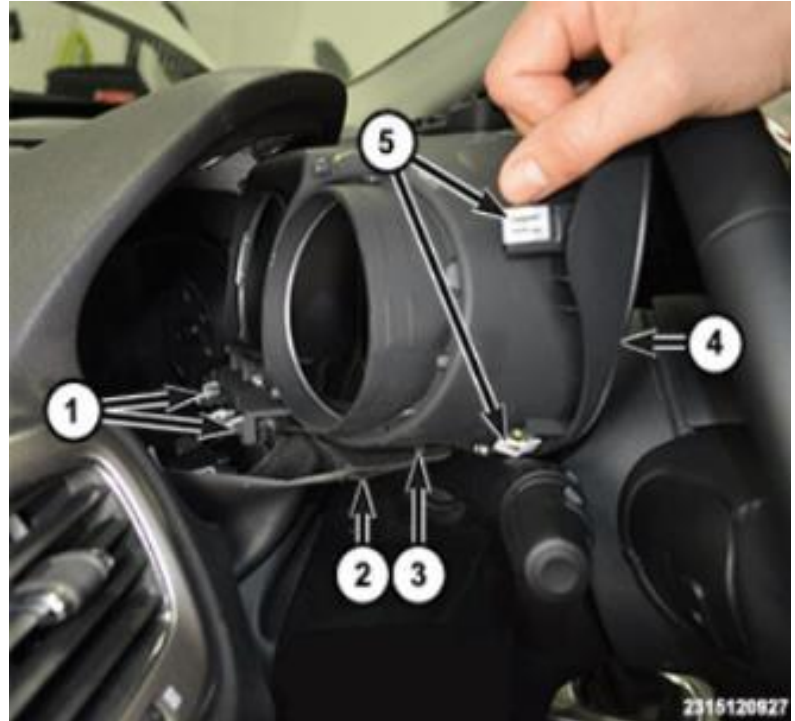
**Figure 7 – Instrument Cluster Bezel**

14. With a trim stick or equivalent, using extreme care not to damage the bezel, release the clips (5) on both sides and bottom of the instrument cluster bezel (4) and pull the outboard side rearward to access the gap hider (Figure 7).

15. Remove the gap hider flap (2) from the retainers (3), on both sides of the instrument cluster bezel (Figure 7).

16. Using a trim stick or equivalent, release the two clips (1) and separate the gap hider from the instrument cluster bezel. Remove the instrument cluster bezel (Figure 7).

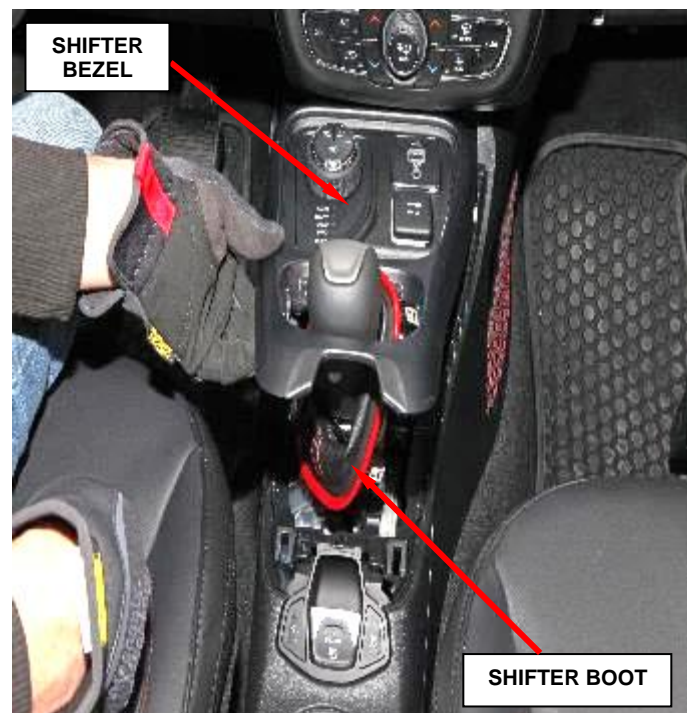
Figure 9 – Shifter Bezel

**NOTE: Do not lift the shifter bezel too high. The wire harness for the gear indicator is short. If you pull too hard on the shifter bezel, the shift indicator may get pulled out of its clips and become damaged.**

21. Using a trim stick, release the shifter boot from the shifter bezel and lift slightly (Figure 9).

22. Using a trim stick, loosen the shifter bezel. Disconnect the wire harness connectors and remove (Figure 9).

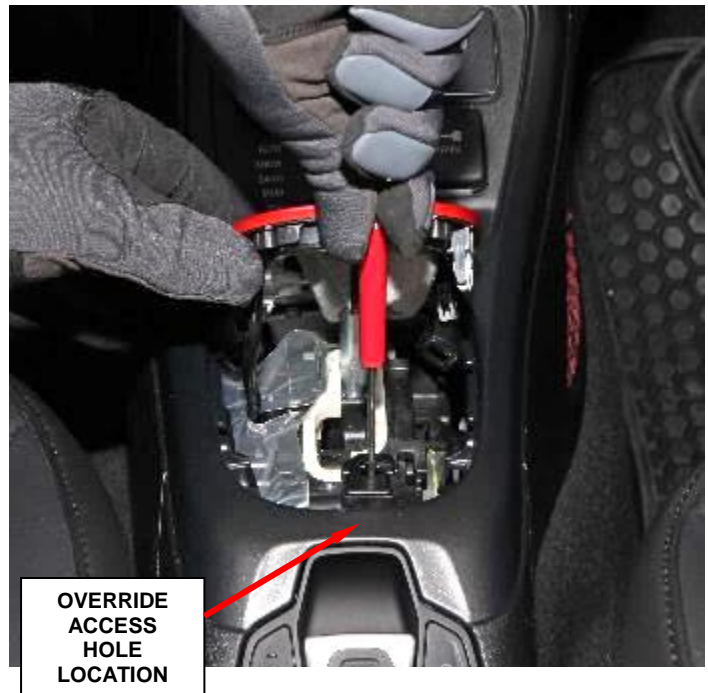
**Figure 10 – Override Release Lever**

24. Insert a small screwdriver or similar tool down into the shift lever override access hole and push and hold the override release lever down and place the shifter in the drive (D) position (Figure 10)

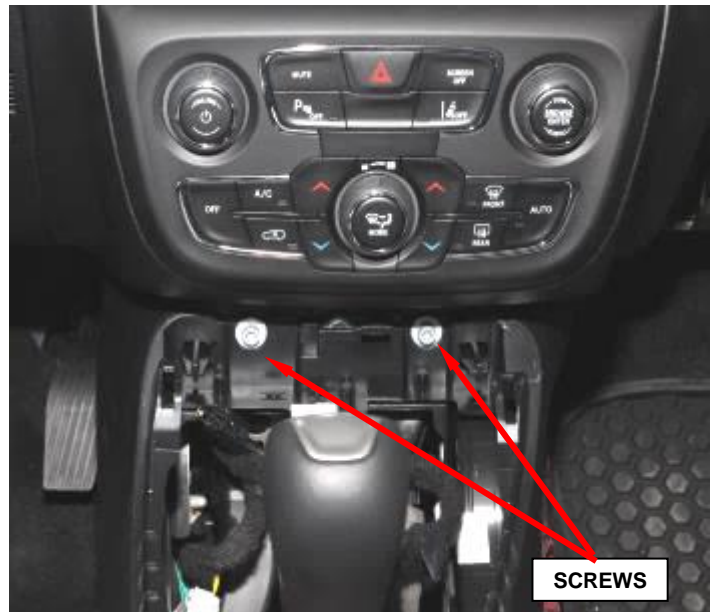
Figure 12 – Center Console Mounting Screws

26. Remove the two screws from the center console (Figure 12).

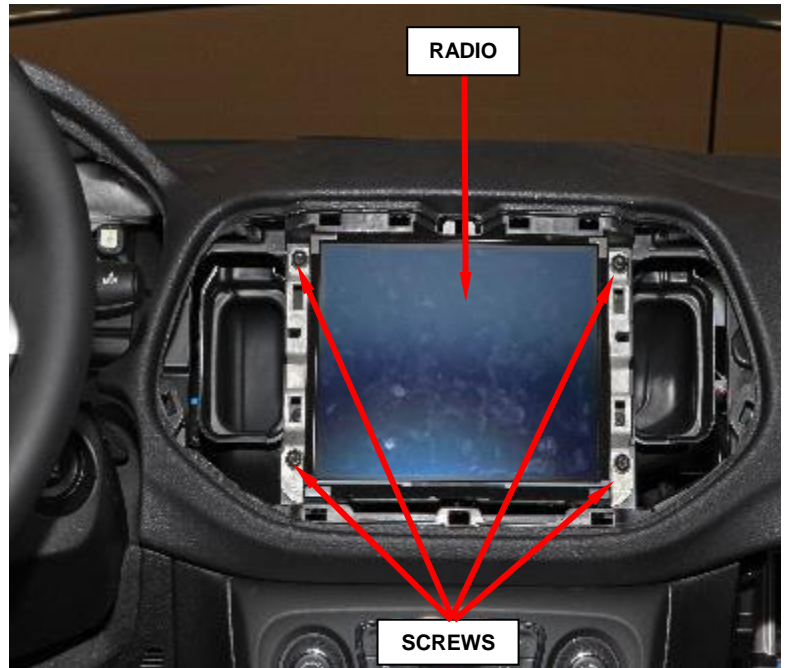
**Figure 15 – Radio**

34. Remove the four screws securing the radio to the instrument panel (Figure 15).
35. Pull the radio out far enough to access the back of the radio.
36. Disconnect the antenna cables, and radio wire harness connector.
37. If equipped, disconnect the USB connector.
38. Remove the radio from the instrument panel.
39. Using a trim stick C-4755 or equivalent, remove the Vehicle Feature Controls Center Stack (VFCCS) from the instrument panel (Figure 16).
40. Disconnect the VFCCS wire harness connector from the VFCCS.
41. Remove the VFCCS from the vehicle.

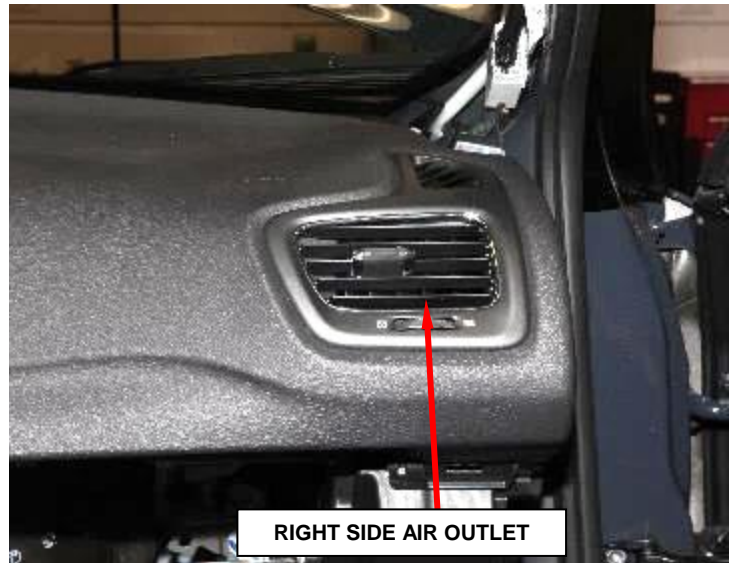
**Figure 17 – Right Side Air Outlet Shown**

- 42. Using a trim stick, remove the left and right air outlets (Figure 17).

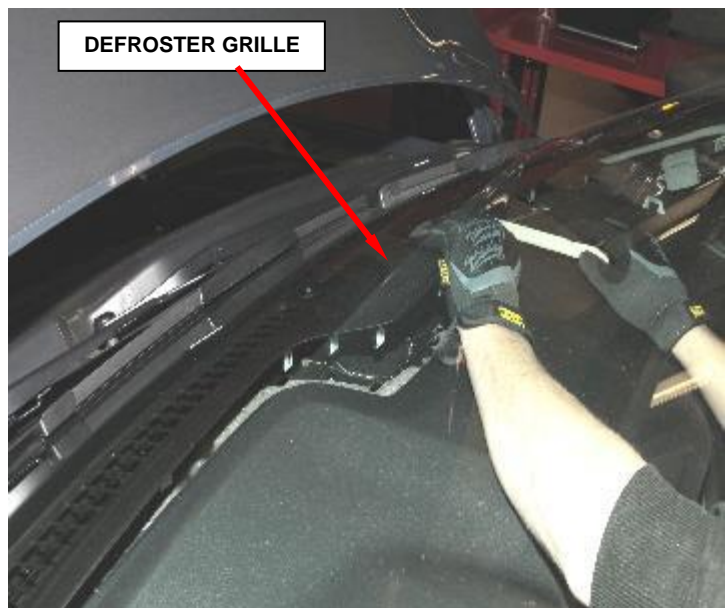
**Figure 21 – Defroster Grille**

- 52. Using a trim stick or equivalent, lift the rear of the defroster grille to release the retaining clip (Figure 21).
- 53. Lift the defroster grille and disconnect the sun sensor, then remove.

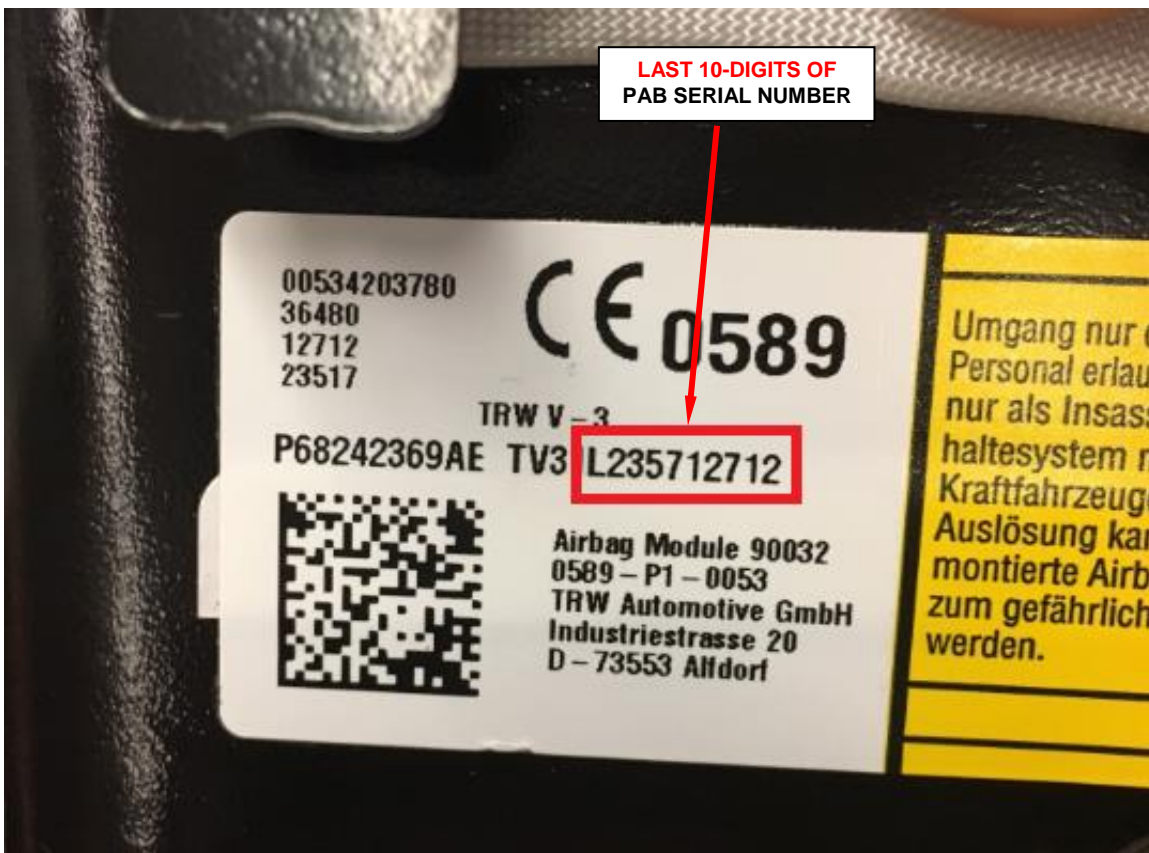
For Unsold Vehicles with a part that passed inspection (Green Tape & Sticker): Record the Last 10-Digits of The Serial Number (Starting With “L”) Of the New Airbag on The Repair Order Prior To Installing. The Serial Number Will Also Need to Be Entered in The Part Number Field on The Claim with A \$0.01 Allowance for Successful Reimbursement. This is in Addition to CSEJT731AA, Which Must Also Be Entered on the Claim.

1. Place the instrument panel trim cover on a suitable work surface with the PAB chute receptacle facing up. Be certain to take the proper precautions to prevent the instrument panel cover from receiving cosmetic damage during the following procedures.
2. Carefully position the **NEW** PAB module to the PAB chute. The side of the PAB module with six hooks faces forward in the vehicle.
3. Engage all the hooks on one side of the PAB module through the windows on the same side of the PAB chute, then rotate the opposite side of the PAB module downward into the chute.
4. Inspect around the perimeter of the PAB making certain each of the hooks on the PAB module is fully engaged through the windows in the forward and rearward vertical walls of the PAB chute.
