RECALL CAMPAIGN "VZ"
Technical Service BulletinFebruary 27, 2017
Bulletin No. TS 07 02037**(Service Campaign Bulletin SC-74)**

SAFETY RECALL CAMPAIGN "VZ"

2009-2013 GRAND VITARA MANUAL TRANSMISSION GEAR SHIFT REAR SHAFT

Affected Models: Certain 2009 - 2013 Grand Vitara (JB424W) Models**Affected Departments:** Management, Service, Warranty, Sales, Parts, Accessories

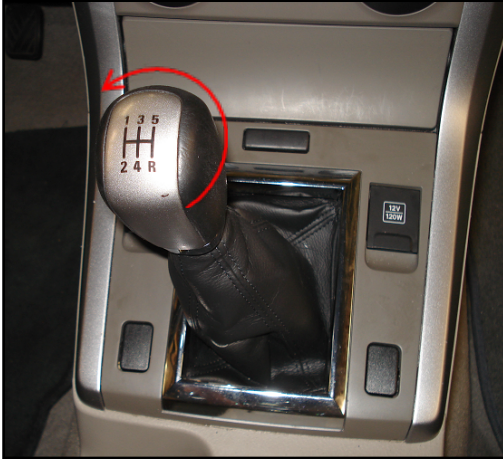
1A) Remove the shift knob by turning it counterclockwise.

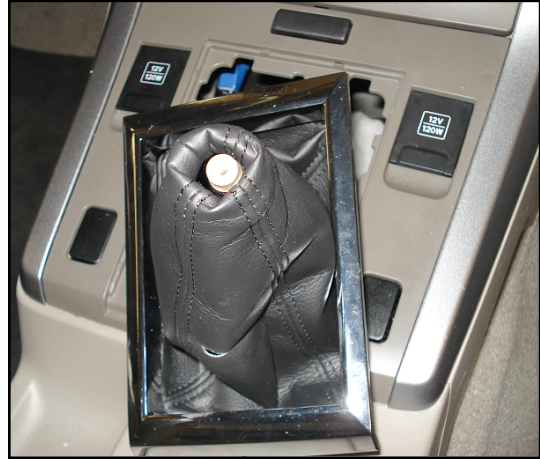
1B) Remove the chrome shift ring and shift boot by lifting them up.

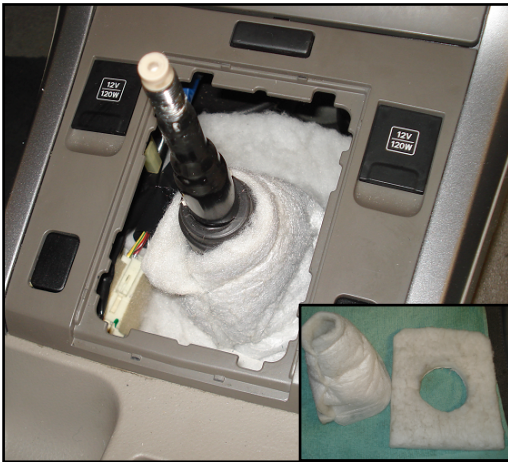
1C) Remove the upper and lower silencer boot and mat (if equipped).

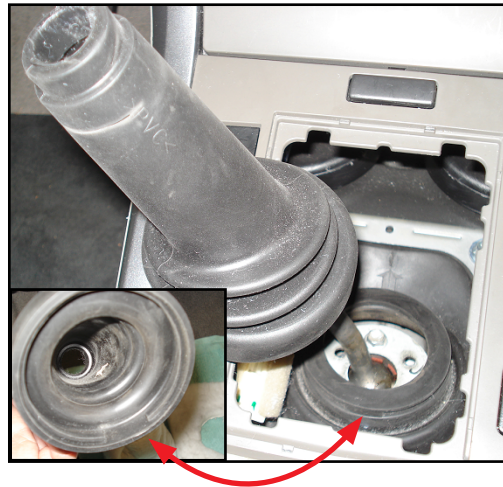
1D) Remove the upper rubber shift boot. Note the indexing tab on the underside of the boot.

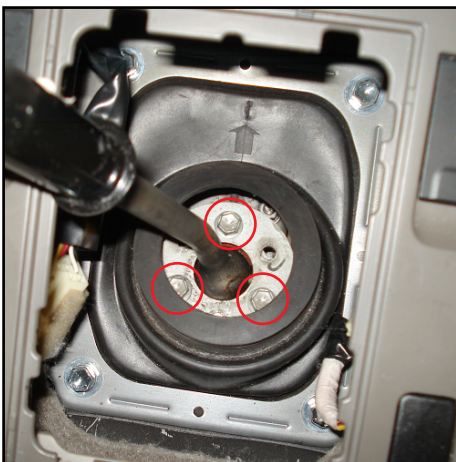
1E) Remove the three bolts securing the shift control lever cover to the shift control arm.

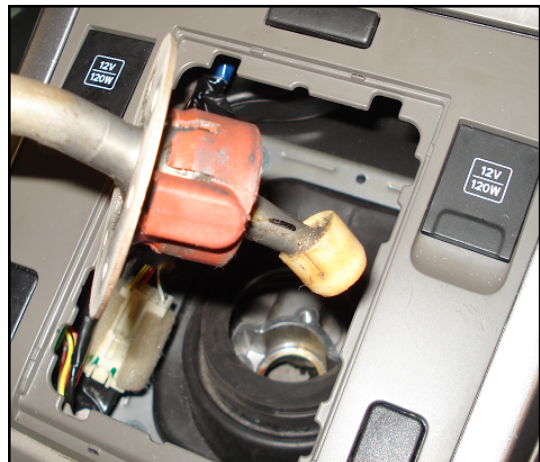
1F) Remove the shift control lever.

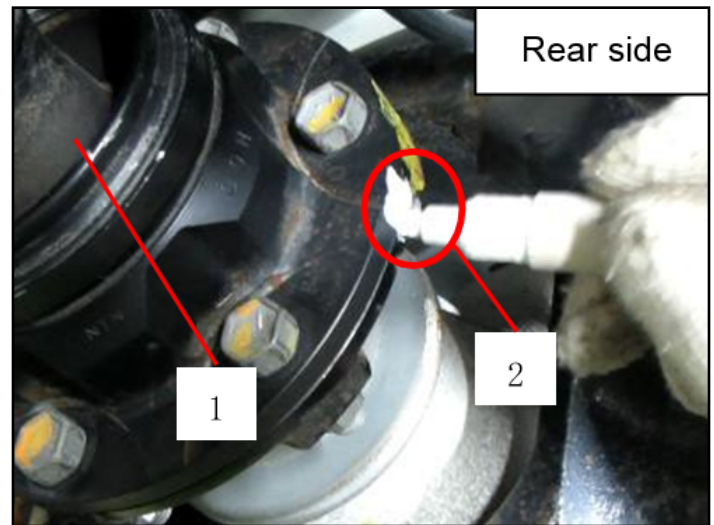
- 2) Remove exhaust pipe No. 2 and the exhaust center pipe. Refer to Service Manual **Section 1K Exhaust System**.
- 3) Mark the joint flange (2) and propeller shaft (1) as shown.

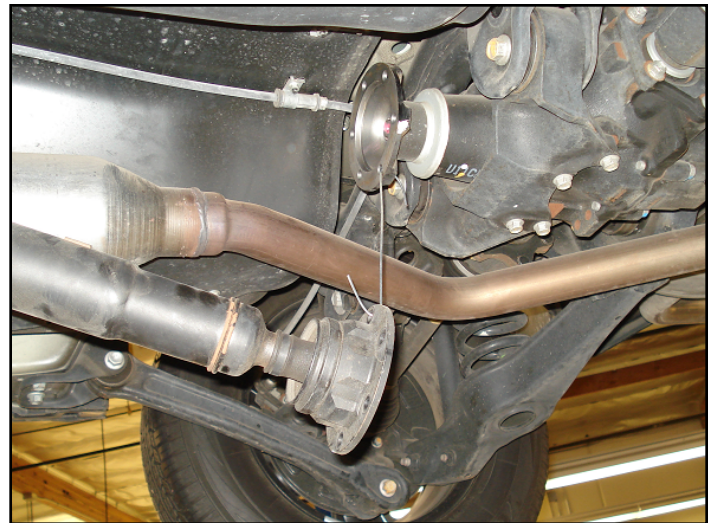
- 4) Remove rear propeller shaft at the rear axle and suspend the propeller shaft from the rear axle as shown.

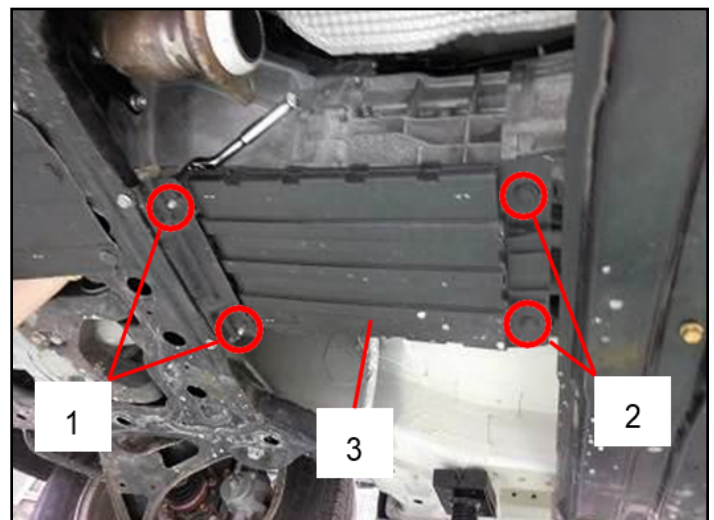
- 5) Remove the bolts (1) and clips (2), then remove the engine splash cover (3).

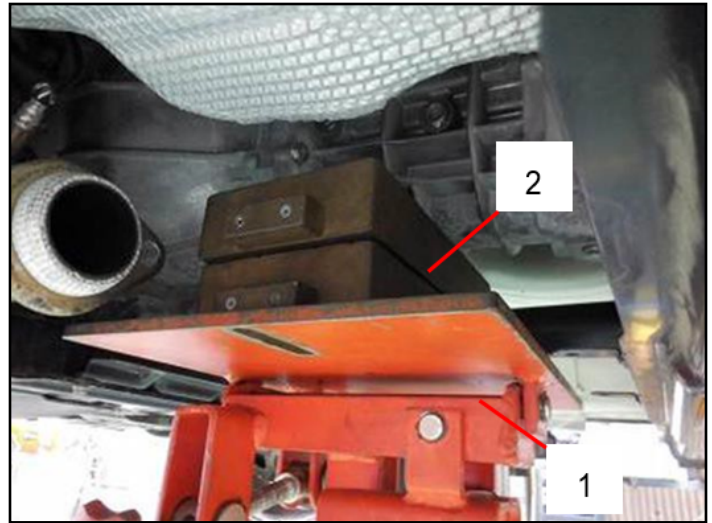
- 6) Support the transmission using a transmission jack (1) and wood block (2).

If available, use a rubber block or lift pad instead of a wood block.

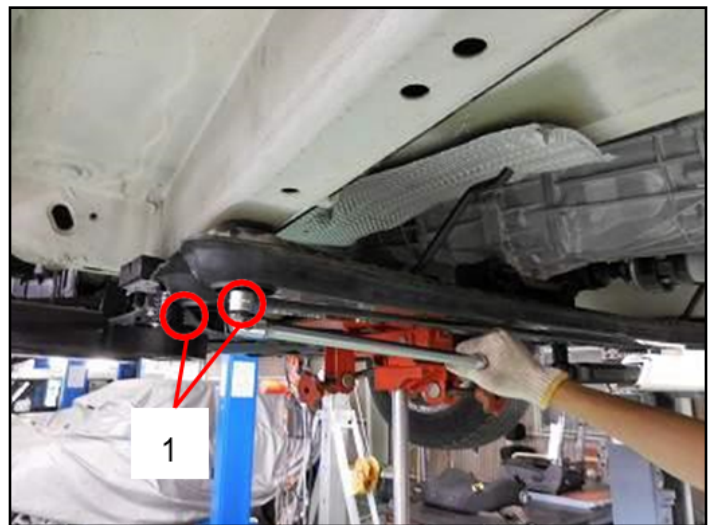
- 7) Remove the rear engine mounting member bolts (1).

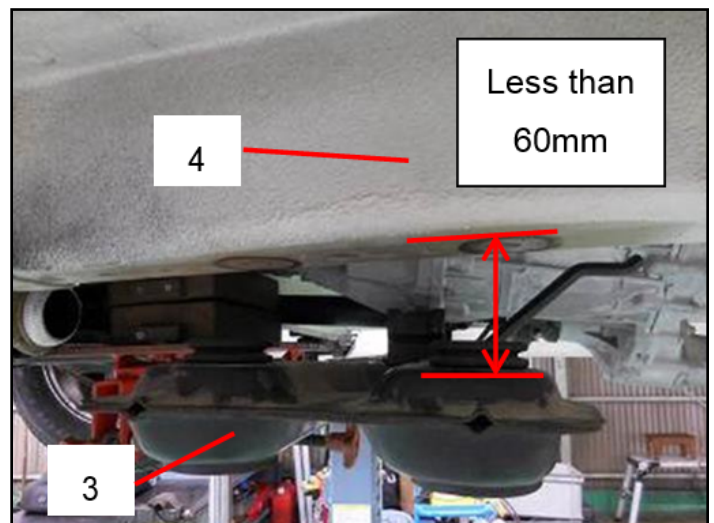
- 8) Lower the jack gradually to tilt the transmission rearward until the clearance between the engine rear mounting member (3) and chassis frame (4) is 60mm.

Be careful not to let the exhaust No. 1 pipe (1) come into contact with the suspension frame (2).
(See image and NOTICE on following page.)

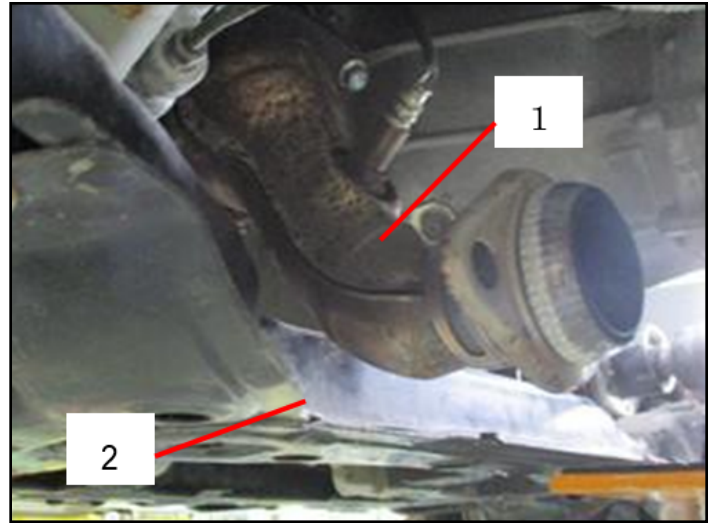
NOTICE

If the transmission is tilted more than specified, it may damage exhaust pipe No. 1 and the suspension frame, etc.

Do not tilt the transmission more than specified above.

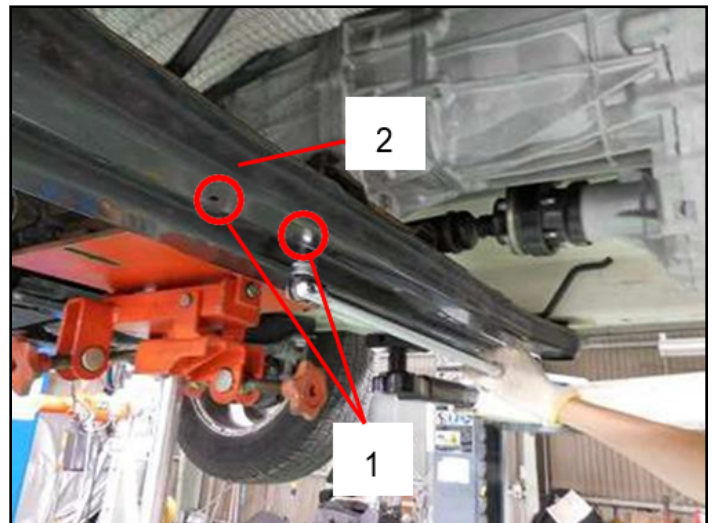
- 10) Remove the engine rear mounting No. 2 bolts (1), then remove the engine rear mounting member (2).

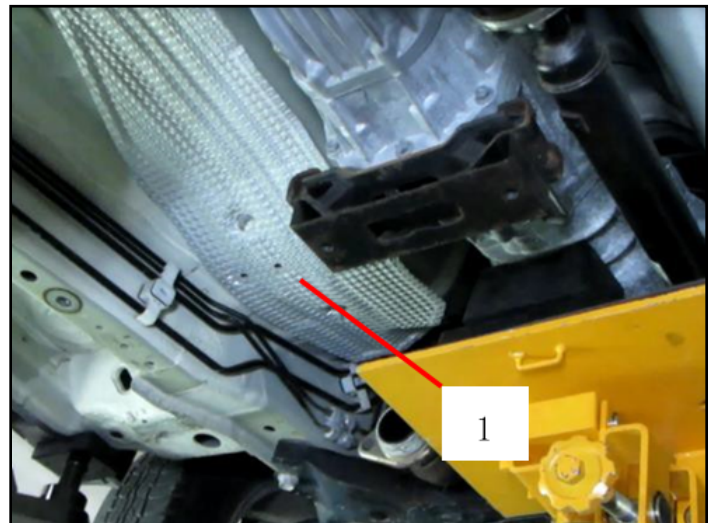
- 11) Remove the heat protector panel (1).

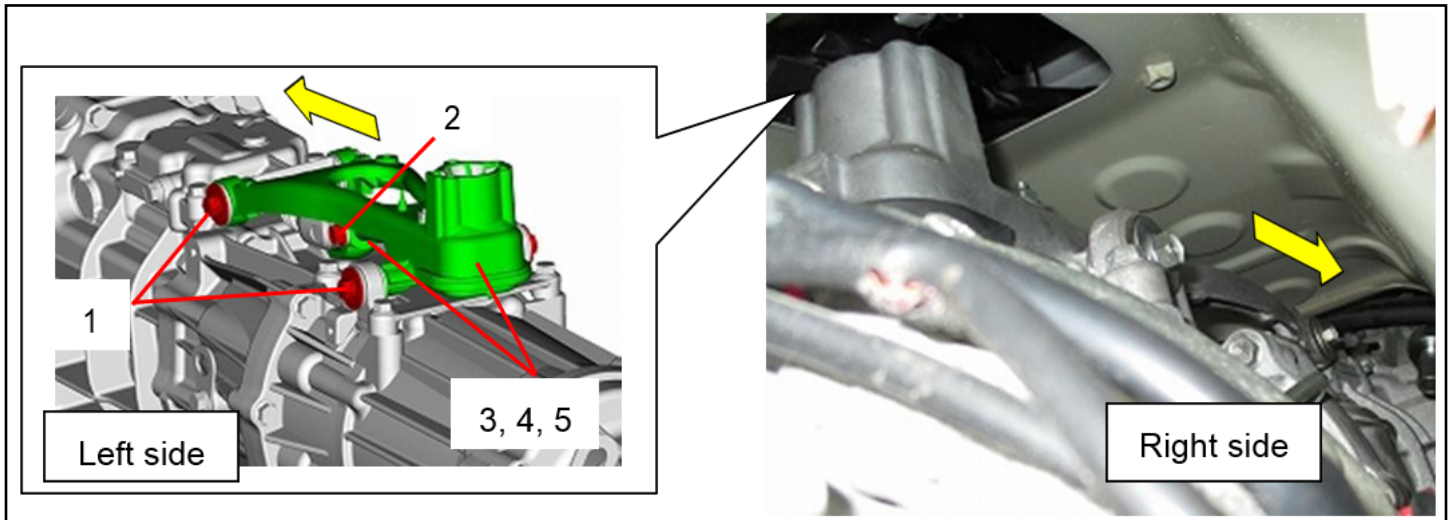
- 12) Remove bolts (1, 2), then remove the gear shift control arm assembly (3), gear shift rear shaft assembly (4) and gear shift control shaft boot (5).

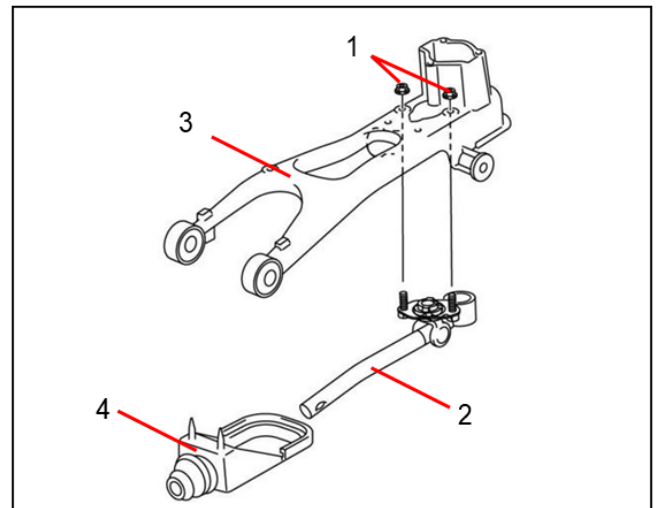
- 13) Remove the gear shift stopper plate nuts (1), then remove gear shift control arm (3) and gear shift control shaft boot (4) from the gear shift rear shaft assembly (2).

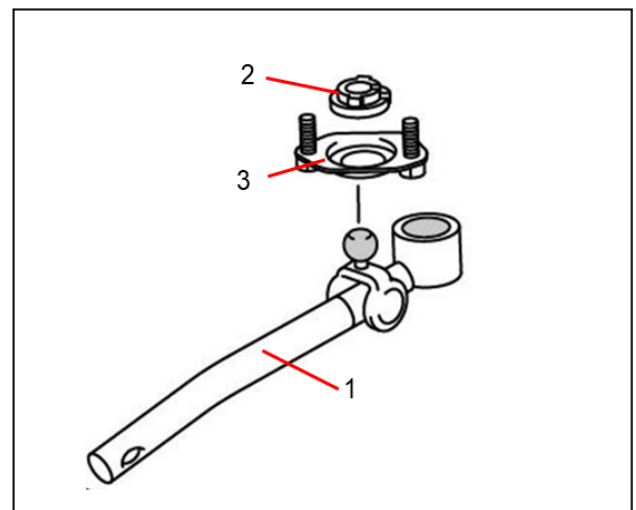
- 14) Remove the gear shift control shaft bushing (2) and gear shift stopper plate (3) from the gear shift rear shaft assembly (1).

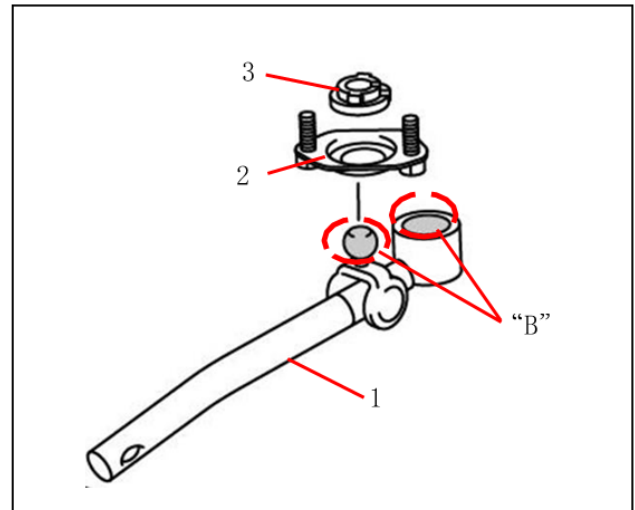
- 1) Replace the gear shift rear shaft assembly (1) with new one and apply grease to areas B as shown, then install the stopper plate (2) and gear shift control bushing (3) in the gear control shaft.

**B: Grease 99000–25011
(SUZUKI Super Grease A)**

Install the gear shift control shaft bushing so that the surface with the key is facing up.

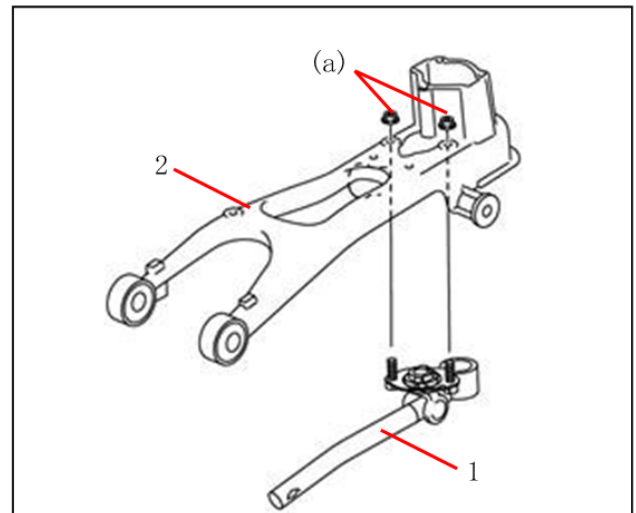
- 2) Install gear the shift rear shaft assembly (1) in gear shift control arm (2) and tighten the gear shift stopper plate nuts to the specified torque.

Tightening Torque:
**Gear shift stopper plate nut (a): 10N·m
(1.0 kgf-m, 7.3 lbf-ft)**

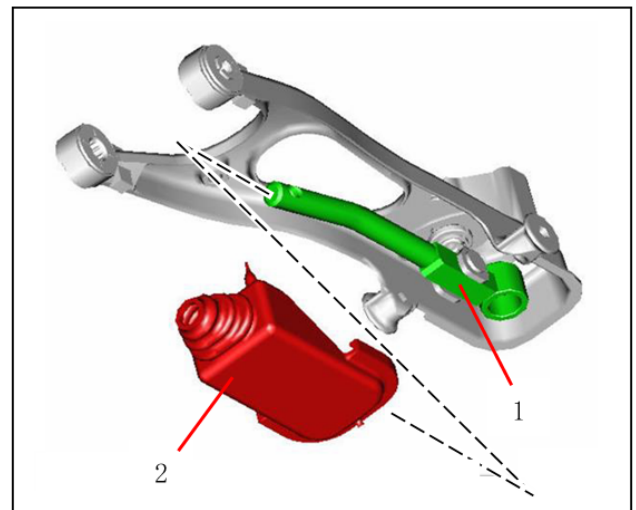
- 3) Install the gear shift control shaft boot (2) in the gear shift rear shaft assembly (1).

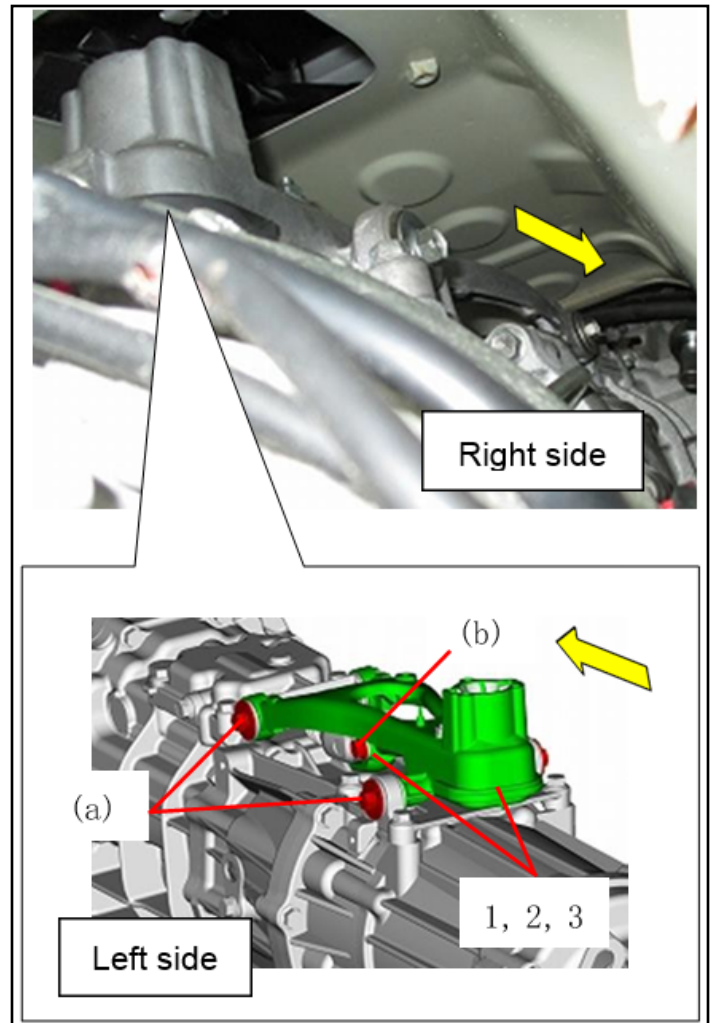
- 4) Install the gear shift control arm assembly (1), gear shift rear shaft (2) and gear shift control shaft boot (3), then tighten bolts in specified torque.

Bolt (a): 13N·m (1.3 kgf-m, 9.5 lbf-ft)

Gear Shift Control Joint Bolt (b): 33N·m (3.3 kgf-m, 24.3 lbf-ft)

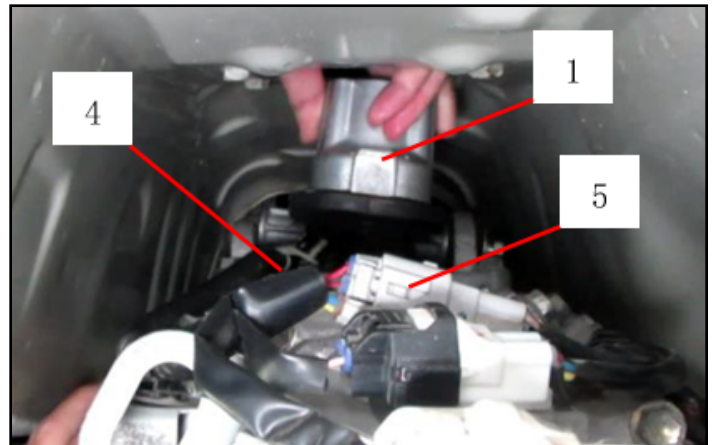
Pinching the wiring harness (4) when installing the gear shift control arm (1) can damage the wires.

Be careful not to pinch the wiring harness (4), and do not forget to reconnect the connector (5) if it is disconnected during the repair.

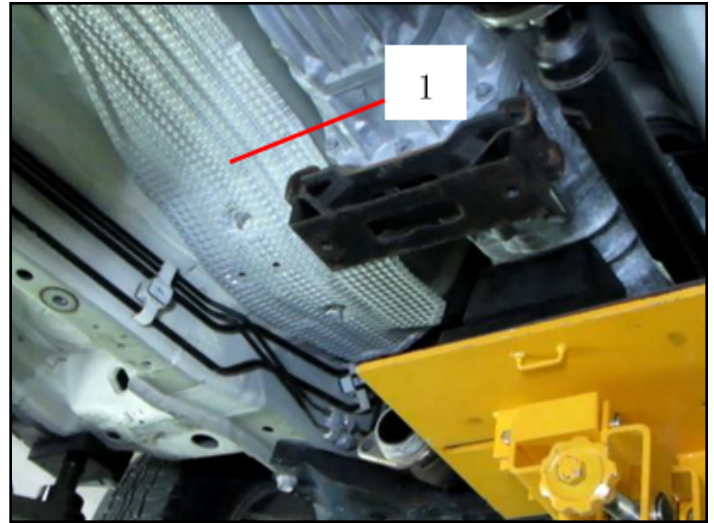
- 5) Install the heat protector panel (1).

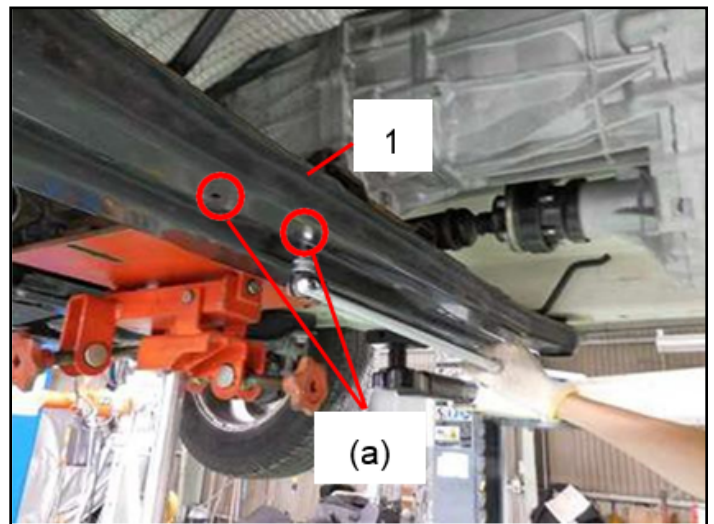
- 6) Install the engine rear mount member (1) onto the transmission and tighten the bolts (a) to the specified torque.

**Engine Rear Mounting No. 2 Bolt (a): 55N·m
(5.6 kgf-m, 40.5 lbf-ft)**

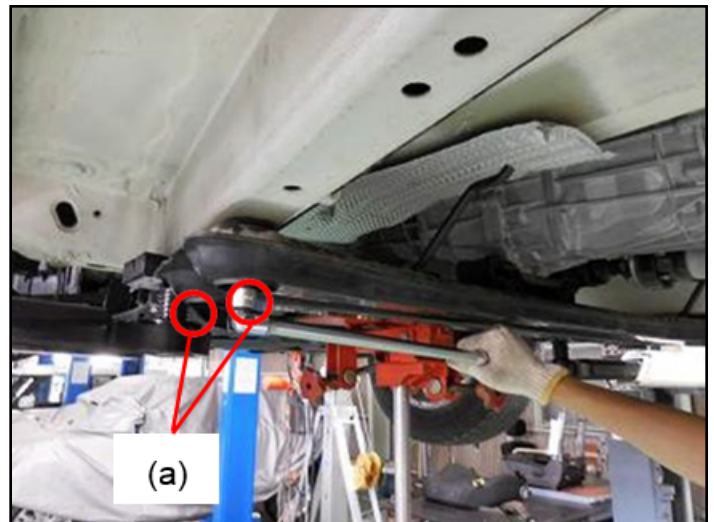
- 7) Raise the transmission gradually with a jack and tighten the engine rear mount member bolts (a) to the specified torque.

**Engine Rear Mounting Member Bolt (a):
55N·m (5.6 kgf-m, 40.5 lbf-ft)**

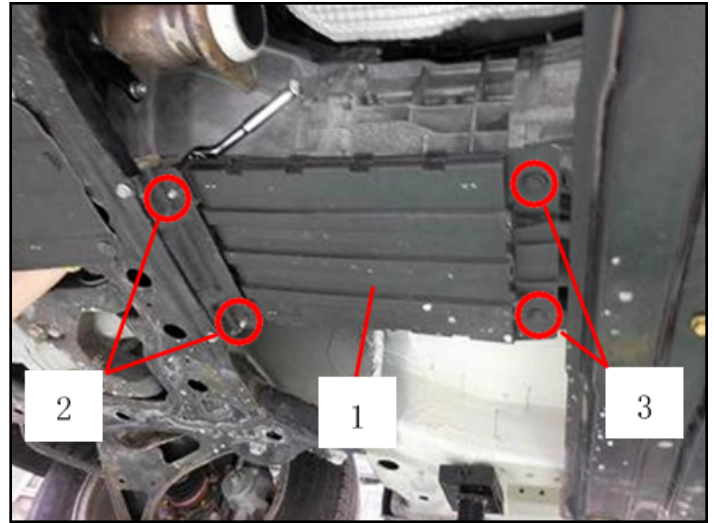
- 8) Remove the transmission jack and install the engine splash cover (1) using the bolts (2) and clips (3).

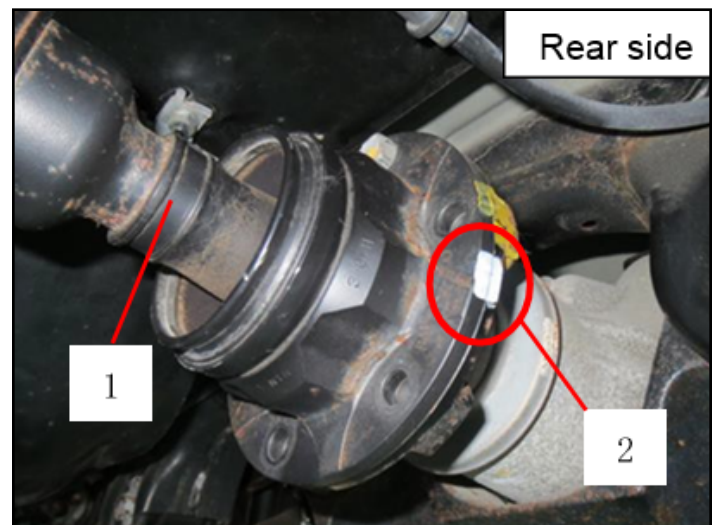
- 9) Align the marks made during disassembly and reinstall the rear propeller shaft at the rear axle. Tighten the rear propeller shaft bolts to the specified torque. Refer to Service Manual **Section 3D Propeller Shaft**.

**Rear Propeller Shaft Bolt: 50N·m
(5.1 kgf-m, 37 lbf-ft)**

**Rear propeller shaft nut: 50N·m
(5.0 kgf-m, 36.8 lbf-ft)**

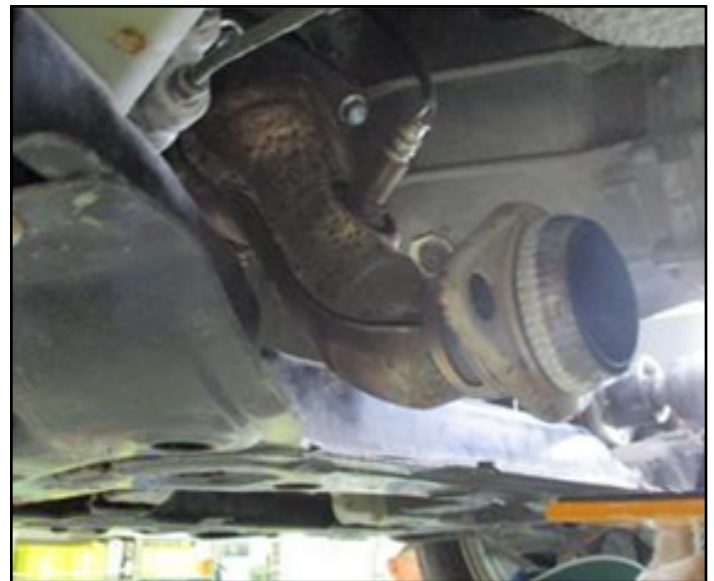
- 10) Install the exhaust pipe seal rings and muffler gasket, then install exhaust pipe No. 2 and the exhaust center pipe. Refer Service Manual **Section 1K Exhaust System**.

**Exhaust Pipe Bolt (a): 50N·m
(5.0 kgf-m, 36.8 lbf-ft)**

- Clean joint surfaces of exhaust pipe No. 2 and exhaust center pipe, and remove the adhesive substances from the joint surfaces.
- Do not reuse the old exhaust pipe seal rings and muffler gasket – replace them with new parts.

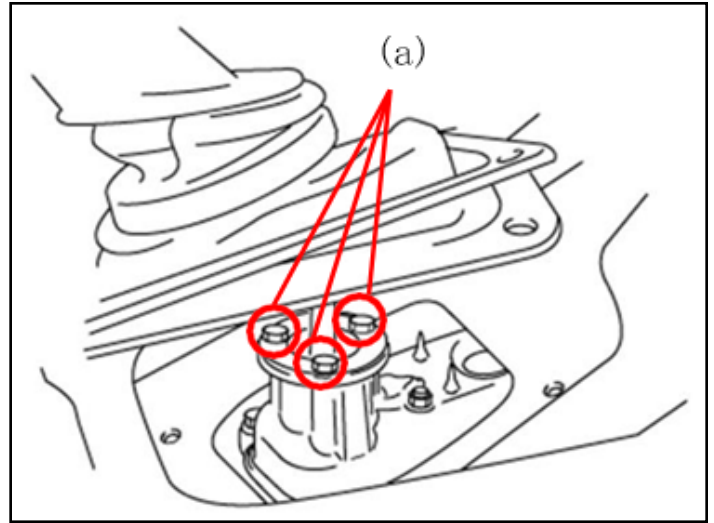
11) Install these parts in the following order:

- Shift control lever, control lever cover and bolts (a)
- Gear shift boot silencer (refer to the indexing notch in step 1D)
- Gear shift boot silencer (if equipped)
- Gear shift control lever boot No. 2
- Gear shift control lever silencer
- Gear shift control lever knob (apply Loctite® 242 Blue to the shift control lever threads before installing the shift knob)
- Gear shift chrome ring and boot

Tighten the case cover bolts to the specified torque.

**Case Cover Bolt (a): 10N·m
(1.0 kgf-m, 7.3 lbf-ft)**
