## SAFETY RECALL 17V-105 (TC 2017-088)

### DEALER INVENTORY WITH BODY AND CREW CABS AUTOMATIC TRANSMISSION MOUNTING BRACKET INSPECTION PROCEDURE

- 2015-2017MY N-Series Vehicles With Bodies Equipped with 4HK1 Diesel Engines (including Crew Cabs) and Produced Between 8/1/2014 and 5/18/2016

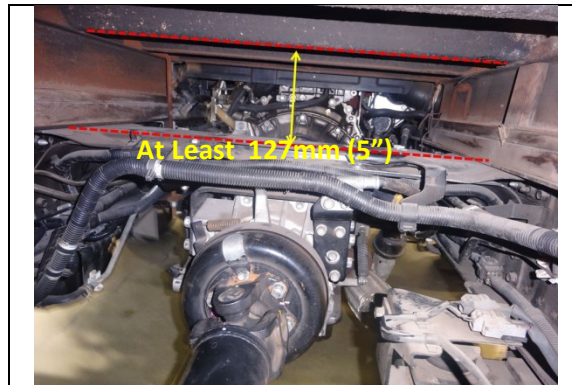
Figure 1

1. Ensure there is enough space between the lowest portion of the body floor and the transmission cross-member (Figure 1). At least 127 mm (5") is required to accurately perform the inspection. Make sure the area under the vehicle is well lit.
  - a. If the vehicle has a body with a hinged joint or a hydraulic mechanism to shift the body (e.g. a dump bed or a roll-off tow vehicle), move the body accordingly to access the cross-member. Make sure the moved body is secured in place before continuing with this procedure and then set the Parking Brake. Go to Step 6.

- b. For other affected vehicles, if there is at least 5 inches of clearance between the cross member and the body, or the vehicle is a crew cab, there is sufficient clearance to perform the inspection. Continue to Step 2.
- c. If there is less than 5 inches of clearance between the cross member and the body, this inspection cannot be completed and shims will need to be installed when they become available. **Hold this vehicle in Dealer Inventory until Campaign parts and additional repair information becomes available** and proceed directly to the Claim Information section.

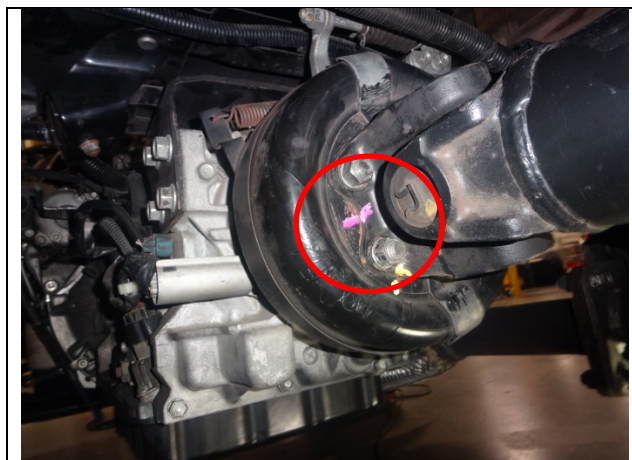
Figure 2

- 2. Block the wheels. Ensure the vehicle will not move while performing the procedure.
- 3. Place a match mark on the propeller shaft and parking brake drum using a marker or paint pen (Figure 2).

16. Torque all four (4) 14mm nuts to 51.2 Nm (37.8 ft/lbs).
17. Reinstall the DEF line bracket and torque the two (2) nuts to 37.3 Nm (27.5 ft/lbs).
18. Reinstall the propeller shaft using the four nuts and washers removed in Step 4. Ensure the match mark made in Step 3 lines up. Torque the four (4) nuts to 103.0 Nm (76.0 ft/lbs).

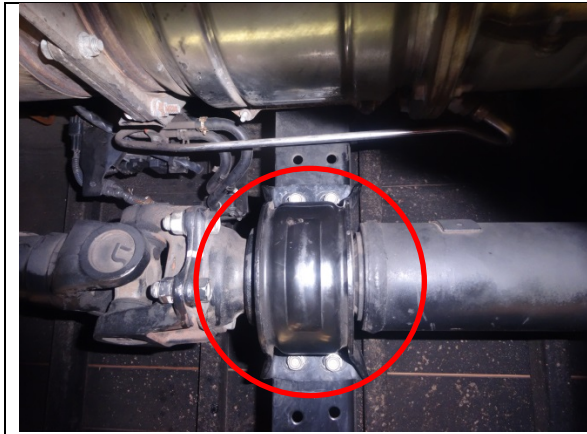
Figure 3

5. Remove the four (4) bolts that attach the center bearing bracket (if equipped) to the cross-member (Figure 3) and disconnect the propeller shaft from the transmission output flange. Lay the propeller shaft assembly aside underneath the SCR assembly (Figure 4).

19. Install the center bearing bracket and hand tighten the bolts (use an assistant as necessary to lift the propeller shaft in place at the center bearing bracket). Torque the four (4) center bearing bracket bolts to 40.0 Nm (30.0 ft/lbs).

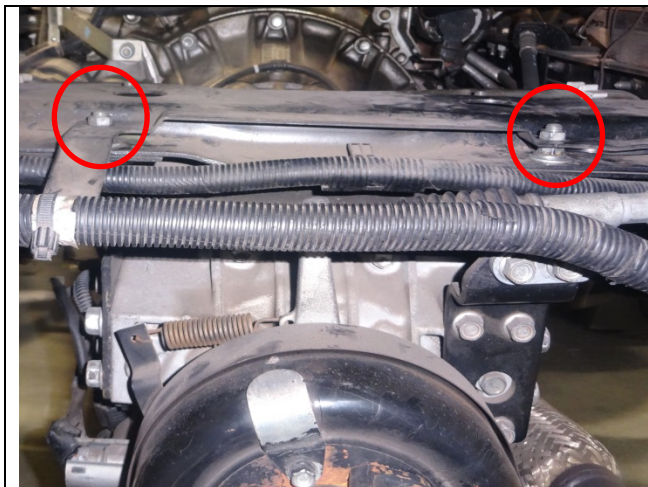
Figure 5

6. Remove the two (2) 14mm nuts that hold on the DEF line bracket (Figure 5). Move the DEF line bracket assembly back out of the way (Figure 6).

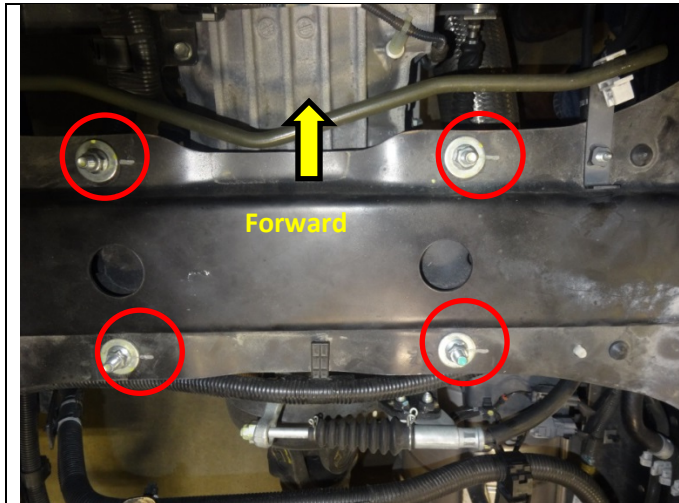
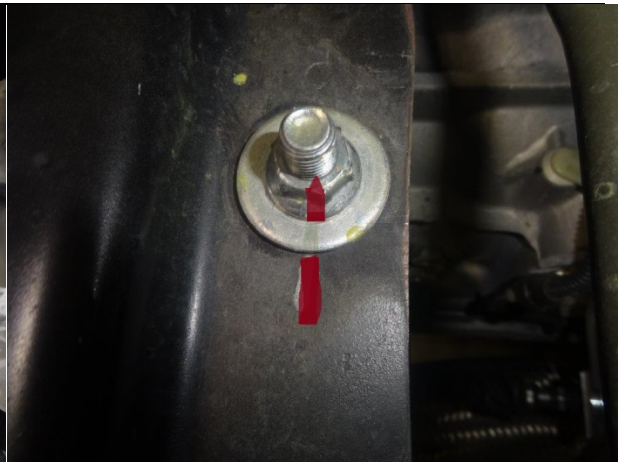
Figure 7

7. Thoroughly clean the area surrounding the four (4) transmission mounting locations (Figure 7).
8. Determine which procedure will be used to complete the inspection.
  - a. If you have the Brownline digital angle gauge or an equivalent, you may proceed to Step 12.
  - b. If you do not have a digital angle gauge, continue to Step 9.
9. Put a paint mark on each nut and the frame cross-member to mark the original position of each nut (Figures 7 and 8). Use an inspection mirror to assist in marking the front nuts.

10. Loosen one mounting nut 90° and then tighten the nut to 30.0 Nm (22.1 ft/lbs). Perform this procedure for all four (4) nuts.

**IMPORTANT: Tighten to exactly 30.0 Nm (22.1 ft/lbs). DO NOT tighten beyond 30.0 Nm (22.1 ft/lbs).**

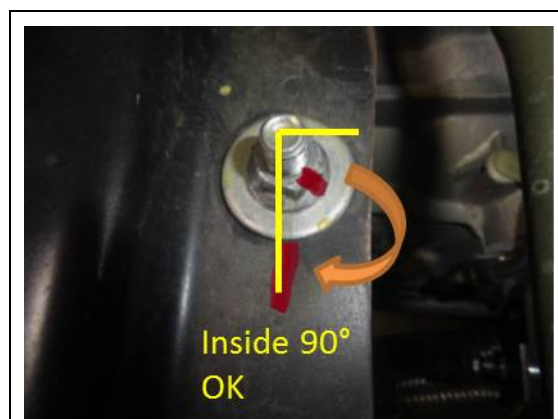
Figure 9

11. Check **each** nut to see if the paint mark on that nut is within the 90° loosening arc after torquing (Figures 9 and 10). Use an inspection mirror as necessary:

- a. If the paint mark on all four nuts stays within the 90° arc (as shown in Figure 9), the vehicle **passes** inspection. Proceed to Step 16.

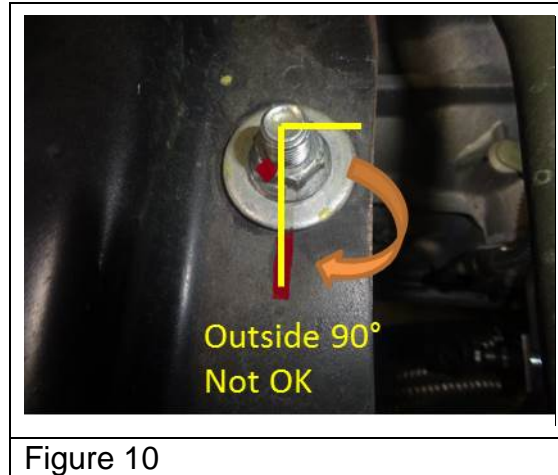
- b. If the paint mark on any of the nuts is not within the 90° arc (as shown in Figure 10), the vehicle does **not pass** inspection. **Hold this vehicle in Dealer Inventory until Campaign parts and additional repair information becomes available.** Proceed to Step 17.

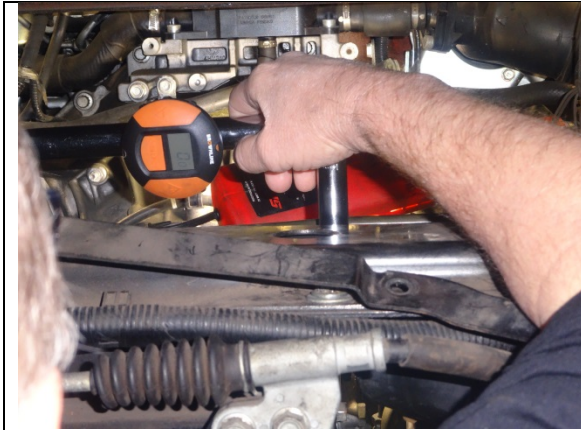
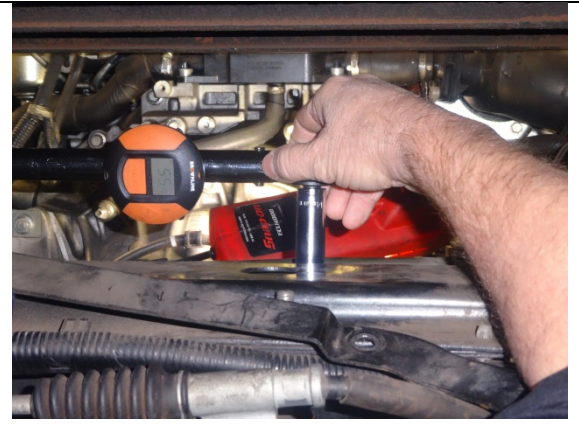
Figure 11

12. Set the torque wrench to 30.0 Nm (22.1 ft/lbs). Attach a 14mm deep socket. Set the ratchet head on the torque wrench to loosen. Set the digital torque angle gauge to measure 90° and attach it to the torque wrench where the gauge number display can be viewed while performing the procedure.
13. Place the torque wrench on a bracket nut and put a slight amount of loosening pressure on the wrench to take up any excess play. Press the “select” button on the angle gauge and loosen the nut until 90° has been reached (by readout or tone). Turn the ratchet head on the torque wrench to tighten. Place a slight amount of tightening pressure on the torque wrench to take up any excess play, but not enough to turn the nut. Press the “select” button on the angle gauge and slowly tighten the nut until the torque wrench clicks at 30.0 Nm (22.1) (Figures 11 and 12).

**IMPORTANT: Tighten to exactly 30.0 Nm (22.1 ft/lbs). DO NOT tighten beyond 30.0 Nm (22.1 ft/lbs).**

14. If 30.0 Nm (22.1 ft/lbs) of torque is achieved without the angle gauge reaching 90°, the nut **passes** inspection. If the 30.0 Nm (22.1 ft/lbs) of torque is only achieved after the torque angle gauge reaches or exceeds 90°, the nut does **not pass** the inspection.
