Safety Recall Campaign 020G: Transmission Control Harness Connector/E-Module Connector Inspection & Pin Rework – Retailer Best Practice

March 15, 2024

Document Topic	Date
<ul style="list-style-type: none"> Technical Service Bulletin (TSB) 24-01-022G – Remedy Available (Inspection ONLY) 	03/15/2024

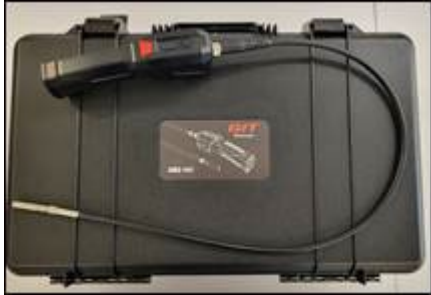
Tool Name	Part Number	Figure	Remarks
GIT Borescope	GODKDNN039

<p>This suggested tool, in conjunction with the STUI application, will be utilized to inspect and capture an image of the male E-Module connector as it is in an out-of-view location.</p> <p>This tool is available for purchase through GIT America at (833) 681-3926.</p> <p>If a borescope is not used for this case, a mirror and camera can be used as an alternative.</p>
Long Clip	N/A

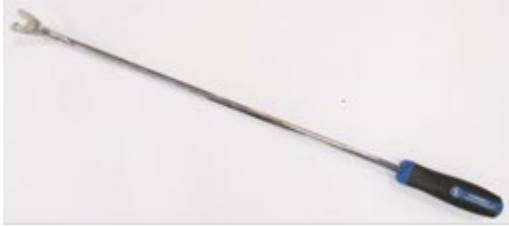
<p>This suggested and locally sourced tool will be utilized to detach/secure a hard-to-reach harness clip on top of the transmission housing.</p>
