# SAFETY RECALL

Date	Number	Release	Page
10.2015	<b>RVXX1504</b>	<b>01</b>	1 (11)

## Trailer Hand Brake Trim Panel, Replacement

**VN**

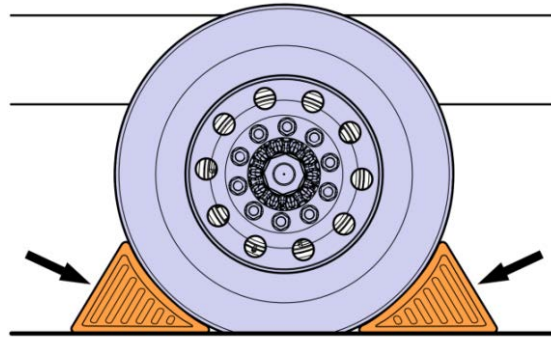
1. Secure the vehicle for service by parking on a flat and level surface, placing the transmission in neutral, applying the parking brake, turning the ignition key to the OFF position, and chocking the front wheels.

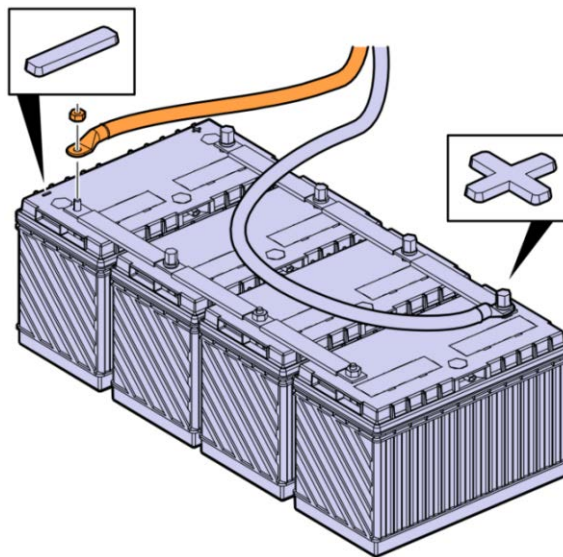
2. Disconnect the cable from the battery's negative (ground) terminal.

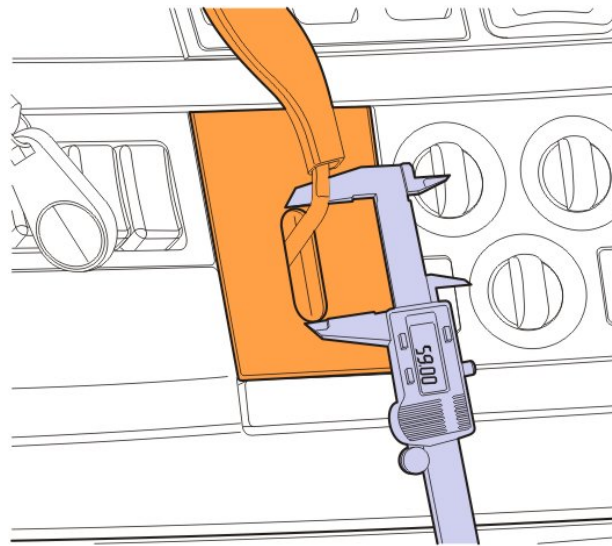
1. Using a caliper, measure the length of slot surrounding the trailer hand brake in the trim panel to determine if replacement of the trim panel is necessary. If trim panel replacement is necessary, proceed to step 2.

NOTE
If the slot in the trim panel is less than 59.0 mm (2.3 in), replace the trailer hand brake trim panel with trim panel (part number 84708234).

NOTE
If the slot in the trim panel is greater than 59.0 mm (2.3 in), proceed to <b>Commissioning the Truck for Operation</b> section.

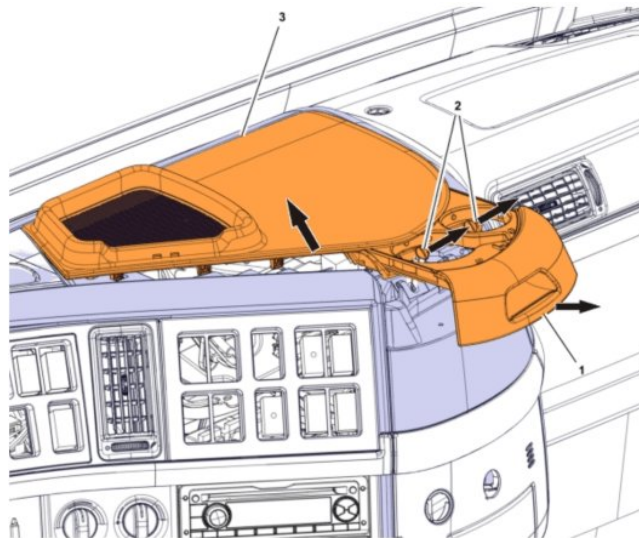
2. Open the cup holder.
3. Remove the panel screws.
4. Remove the fuse relay cover/cup holder.

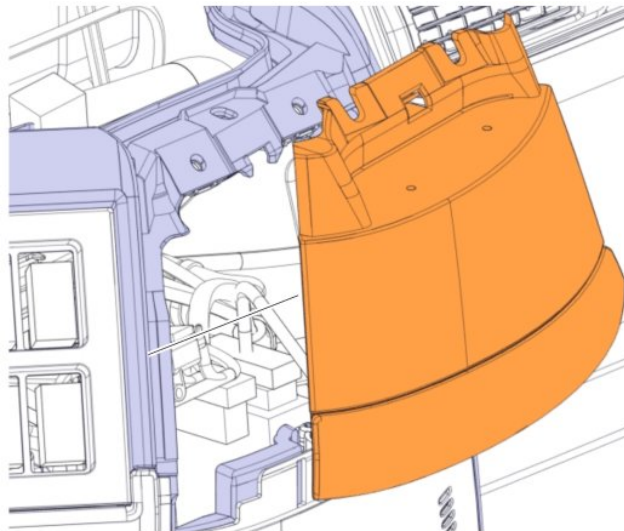
5. Remove the lower dash panel as shown in the figure below.

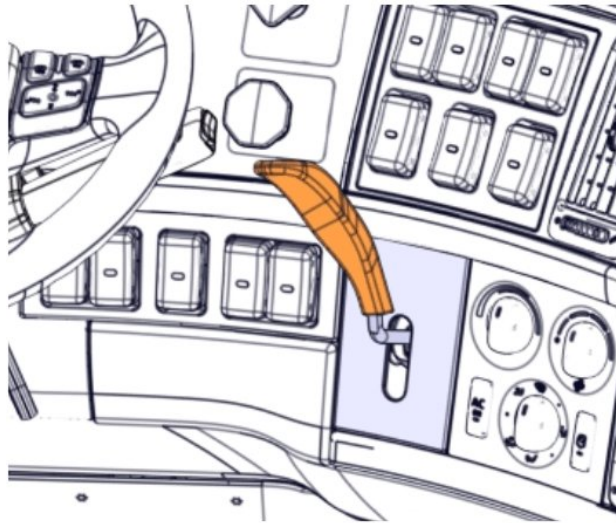
6. Remove the trailer hand brake knob.

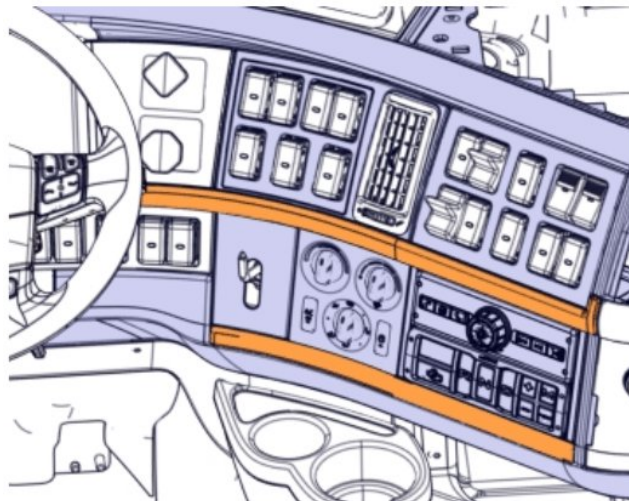
7. Remove trim sections shown below and store installation.

Take care not to damage the trim sections. Remove the trim sections starting from the left side to the right side to prevent damage to the trim retention tabs.

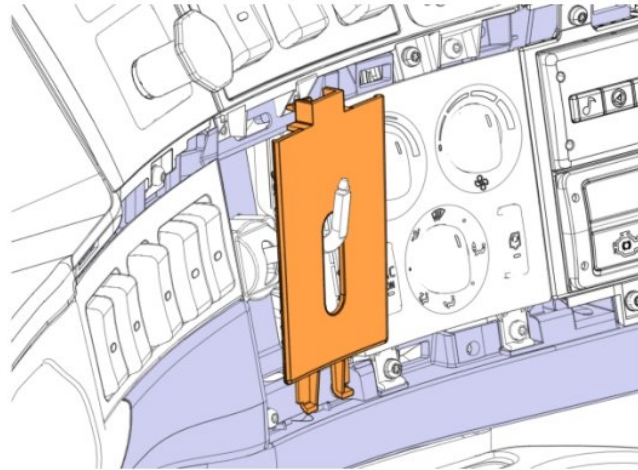
8. Grasp the trailer hand brake trim panel by the top, pull, lift up, and out.

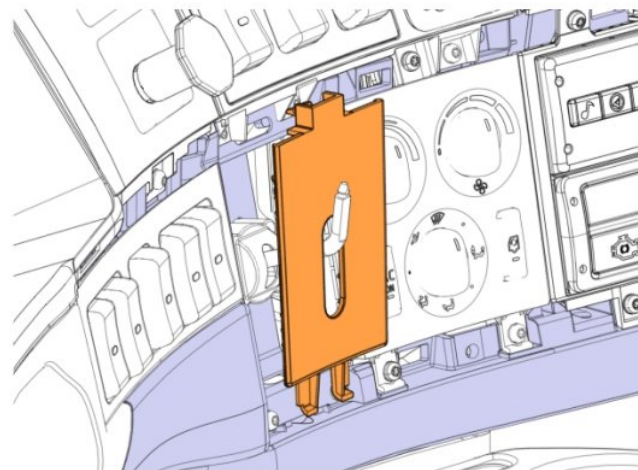
9. Install the replacement trailer brake trim panel.

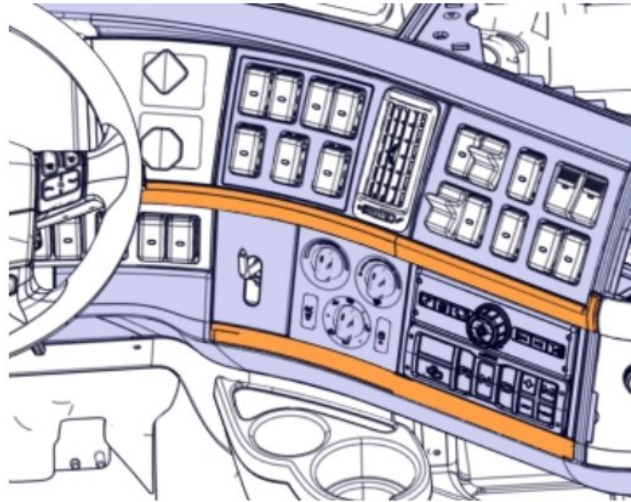
10. Install the previously removed trim sections.

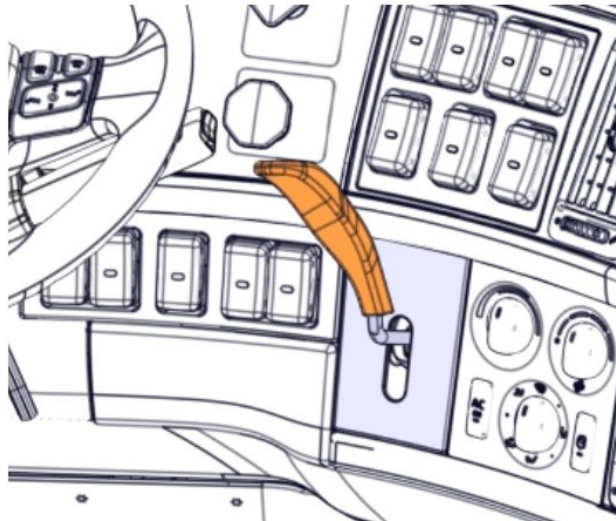
11. Install the trailer hand brake knob.

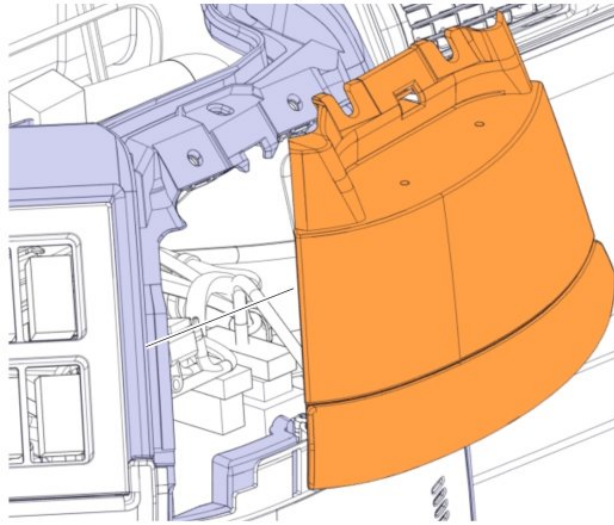
12. Install the lower dash panel.

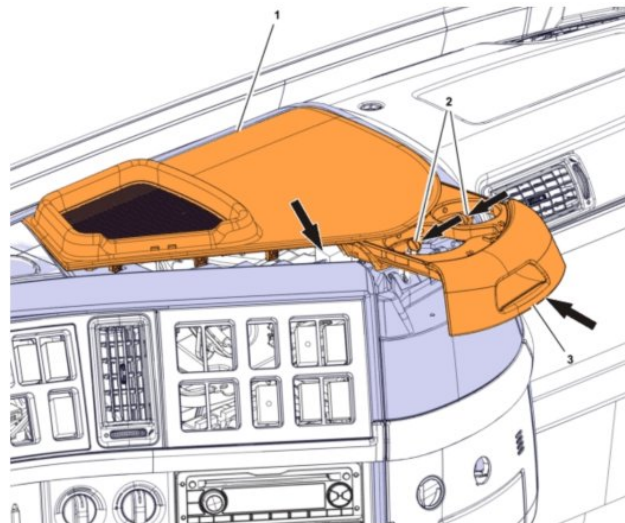
13. Install the previously removed fuse relay cover/cup holder.

14. Install the fasteners securing the fuse relay cover/cup holder.

15. Tighten the fasteners to  $3.4 \pm 0.6$  Nm ( $30 \pm 5$  in-lb).

16. Close the cup holder.

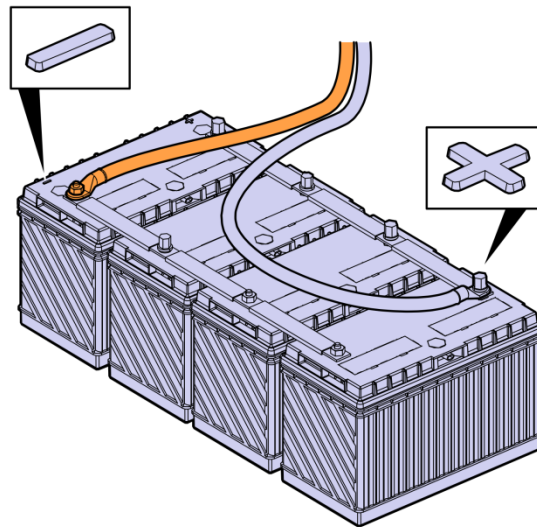
1. Connect the battery cable to the negative (ground) terminal.

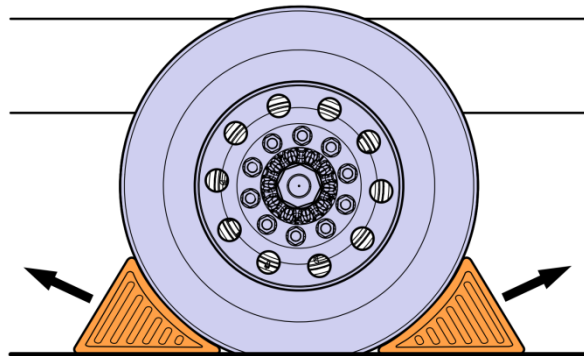
2. Remove the wheel chocks.
