Aftersales Bulletin

subject 00 72 67 01 00 Phantom Curtain Air Bag Inspection / Replacement

Reference C 12 2015 01

Published date 15 December 2015

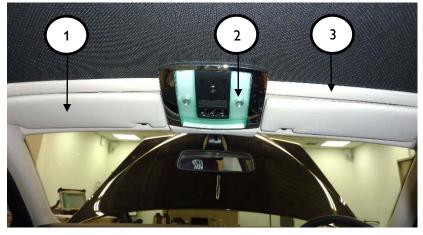
Removing and installing front roof frame trim REP 51 44 ... (If option code RS2 tilt/slide sunroof is installed the correct repair procedure must be followed as additional screw fixings are used).

Preliminary work required;

- 1. Removing and installing sun visor counter support REP 51 16 080
- 2. Removing and installing complete interior roof light (front) REP 63 31 000
- 3. Removing and installing front roof frame trim REP 51 44 ... (If option RS2 sunroof if installed the correct instruction must be followed)

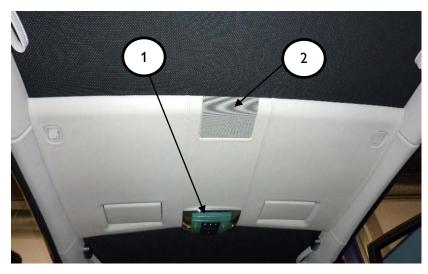
Removing and installing centre roof frame trim REP 51 44 ... (If option code RS2 tilt/slide sunroof is installed the correct repair procedure must be followed.)

Preliminary work required;
1. Removing and refitting rear console insert REP 51 44 180

- 2. Removing and installing module for interior movement detector REP 65 75 071
- 3. Removing and installing centre roof frame trim REP 51 44 ...

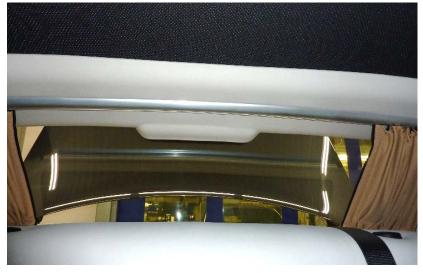
Removing and installing rear roof frame trim REP 51 44 ... (If one of the following option codes REA/REH/REK rear window curtains are installed, the correct repair procedure must be followed.)

Preliminary work required;
1. Removing a moving curtain /
Removing and installing rear
window curtain REP 51 46 ...

2. Removing and installing rear roof frame trim REP 51 44 ...

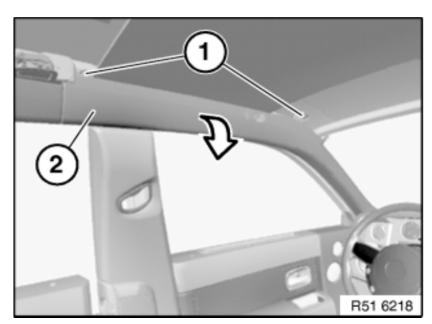
After removal of all roof frame trims, front and rear grab handles must be removed. The removal procedure is identical for both front and rear grab handles REP 51 16 480 / 51 16 450.

Removing and installing front roof pillar trim REP 53 43 201, remove screws (1) and remove trim (2) in direction shown.

Ensure trim and dash panel is protected during removal. Any clips damaged during removal must be replaced.

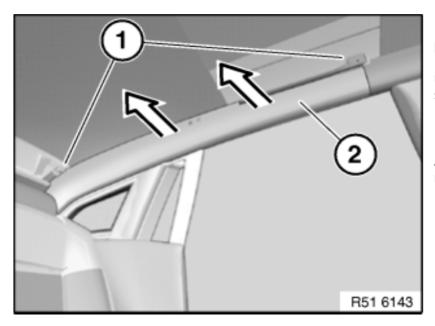
Removing and installing rear roof pillar trim REP 52 43 251. Remove screw fixings (1) and remove trim (2) in direction shown.

Any fixings damaged during removal must be replaced.

Trim parts removed from the vehicle must be stored safely to prevent unwanted damage.

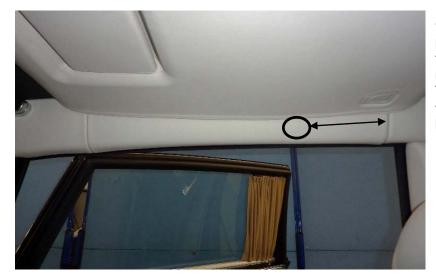
On EWB vehicles the rear roof pillar trim is extended. The front fixing is fragile and extra care must be taken during removal. The fixing is located 330mm from the front of the trim as highlighted.

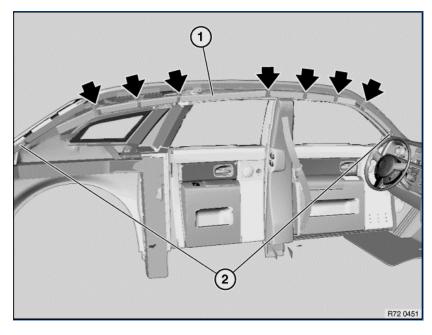
The curtain airbag fixings are now accessible. Remove 7 fixings per side (highlighted by arrows)

Removal is identical for both sides of the vehicle.

Fixings are single use and <u>must</u> be replaced if the airbag is refitted.

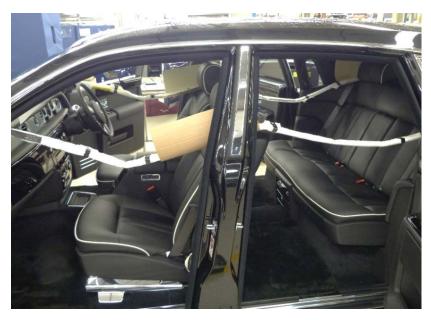
Lower the curtain airbag in preparation for inspection into the position shown.

The airbag material is fragile and must not be damaged.

The airbag brackets have sharp edges and suitable protection must be taken to protect leather.

If, after inspection the curtain airbag does not require replacement, the vehicle must be re-assembled. During the refitting of the curtain airbag, <u>new fixings bolts</u> must be used. Curtain airbag fixings must be tightened to a torque of 11 Nm (ISTA setting 72 12 2AZ).

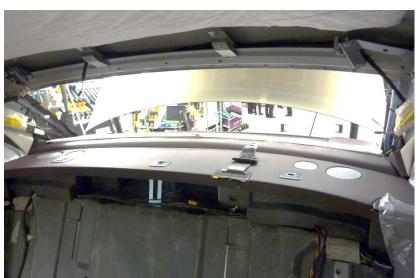
Removing and refitting front storage shelf (parcel shelf) REP 51 46 ...

A Removal of electric rear seats is recommended at this stage to allow better access and lower the risk of damage.

Preliminary work required; Version without electric rear seat adjustment; Removing and installing backrest for left or right rear seat (normal) REP 52 24 015

Version with rear electric seat adjustment; Removing and installing rear left or right rear seat REP 52 25 010

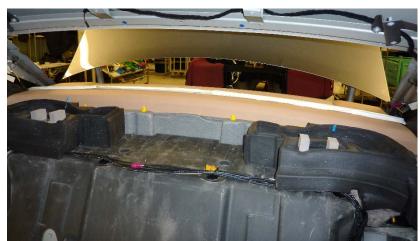
Removing and refitting rear storage shelf (parcel shelf) 51 46 000 (version with rear window curtain)

If rear window curtain is fitted the following instructions must be completed before the rear window storage shelf is removed;

- Instructions for removing a moving curtain REP 51 46 ... (the curtain should have previously been removed from the rail during the removal of the rear side pillar trim)
- Disconnecting Bowden cables of electric curtains 51 46 ...

Preliminary work required; Version with rear electric seat adjustment; Removing and refitting centre console (rear) REP 51 16 ...

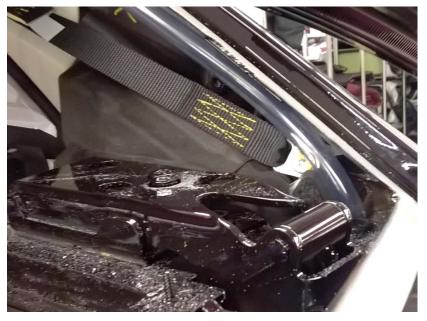
The rear airbag fixing is now accessible once both rear storage shelves are removed.

Any attempt to access the rear curtain airbag fixing may result in irreparable damage to the rear storage shelf trim.

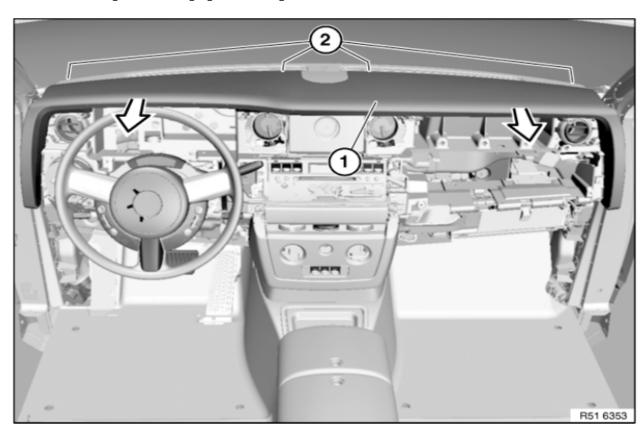
Removing and installing instrument trim panel trim (2) completely following ISTA REP 51 45 030 *Preliminary work required;*

- Removing and installing airbag module for passenger knee protection REP 72 12 006
- Removing and installing right glove box REP 51 16 360
- Removing and installing instrument panel REP 62 11 280
- Removing and refitting driver's side knee-level air vent REP 64 22 ...
- Removing and installing centre fresh air grille trim REP 51 45 ...
- Removing and installing right fresh air grille trim REP 51 45

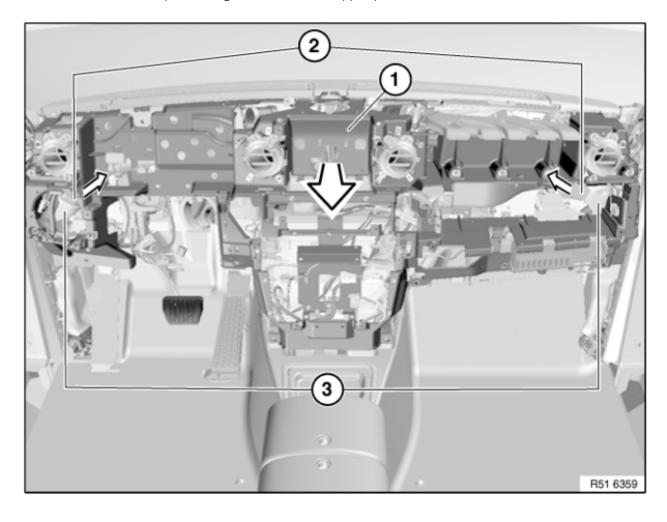
Removing and installing dashboard support REP 51 45 ...

• Only follow removal instructions until the front curtain airbag fixing can be accessed. The dashboard support does not require complete removal.

- Removing and installing airbag module on passenger side REP 72 12 000
- Removing and installing complete display unit REP 65 52 ...
- Removing and installing emergency operation REP 24 50 010
- Removing and installing light switch unit REP 61 31 033
- Removing and installing complete steering column REP 32 31 090 (Steering column does not need full removal only detaching from dashboard support)

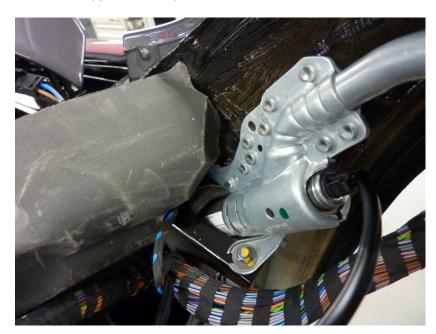
The front fixings of the airbag are now accessible, once the dashboard support has been moved forward.

(For clarity purposes only the dashboard support is removed, fixings can be accessed without complete dashboard support removal).

Removing and installing/replacing left curtain airbag ISTA REP 72 12 045 (remaining two fixings)
