Service Bulletin

16-010

April 15, 2016 03186 Version 4

Safety Recall: Takata Driver's Airbag Inflator

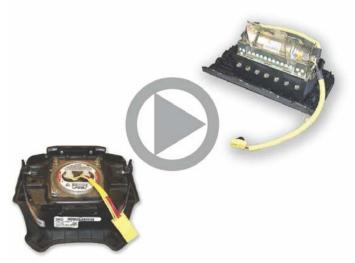
6. Remove or cut the horn plate (depending on model applicability).

The horn plate needs to be cut or removed because it blocks the inflator. Make sure you use the correct method for the vehicle you are working on because some vehicles will require cutting or removing the horn plate. Refer to the video for more information.

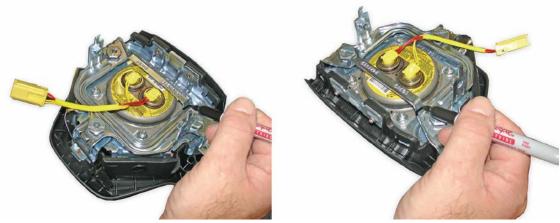
2007-12 RDX - Cut the horn bracket plate

• Using a marker, draw a line on the horn plate as shown.

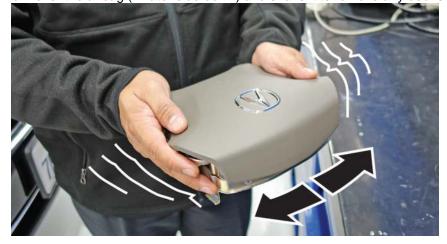
8. Use shop air to clean any debris that may be on the inflator, then remove the inflator from the airbag.

- Do not allow any debris to enter the inflator opening in the airbag.
- Do not deploy the inflator. The inflator must be returned to its supplier in the box the new inflator came in.
 Follow the shipping instructions supplied with the inflator kit. If you have any questions about shipping, call Warranty Parts Inspection (WPI) at 937-642-2737.
- 9. Turn over the airbag (inflator side down) and shake it to remove any debris from the inflator opening.
