April 15, 2016

03187 Version 4

Safety Recall: Takata Driver's Airbag Inflator

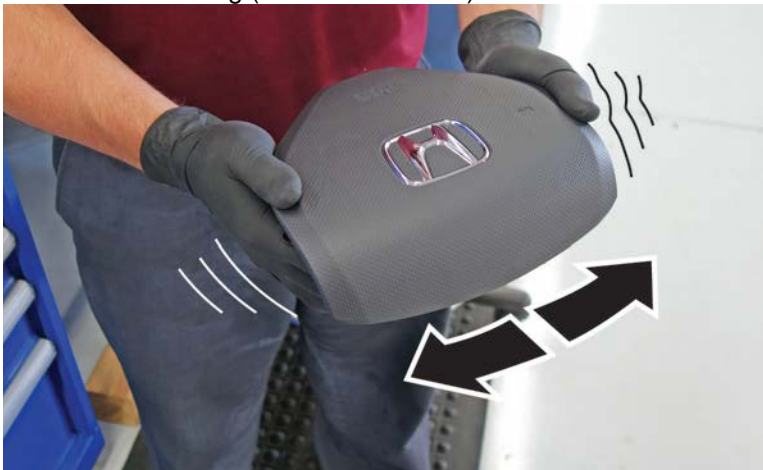
8. Use shop air to clean any debris that may be on the inflator, then remove the inflator from the airbag.

- Do not allow any debris to enter the inflator opening in the airbag.
 - Do not deploy the inflator. The inflator must be returned to its supplier in the box the new inflator came in. Follow the shipping instructions supplied with the inflator kit. If you have any questions about shipping, call Warranty Parts Inspection (WPI) at **937-642-2737**.
9. Turn over the airbag (inflator side down) and shake it to remove any debris from the inflator opening.

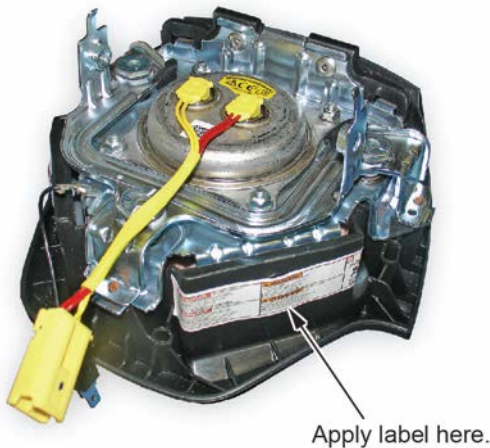
- Install and torque the new locknuts to **4.0 N·m (3.0 lb-ft, 36 lb-in)**.
- If the inflator kit came with a label, attach it to the airbag assembly as shown.
