03188 Version 7

Safety Recall: Piston Pin Snap Ring InspectionSupersedes 16-017, dated March 1, 2016, to revise the information highlighted in **yellow**.**AFFECTED VEHICLES**

Year	Model	Trim	VIN Range
2016	Civic with 2.0L engine	ALL	Check the iN VIN status for eligibility

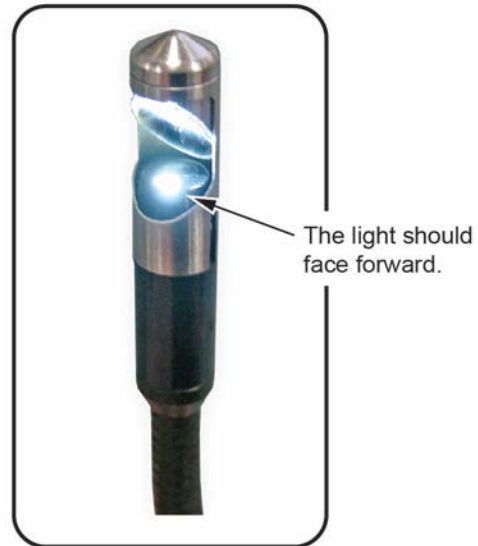
2. Install the 90-degree mirror accessory by aligning the alignment dot with the slot.

NOTE: Make sure the mirror tip is very clean before inspecting. A dirty mirror can give distorted images.

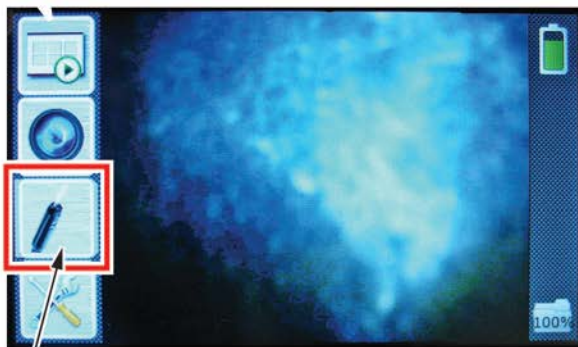
SCOPE TIP SYMBOL

3. Set the borescope to use the 90-degree mirror. You need to do this every time you turn on the borescope or it will be difficult to maneuver the probe. Select the tip, then select the 90-degree tip icon.

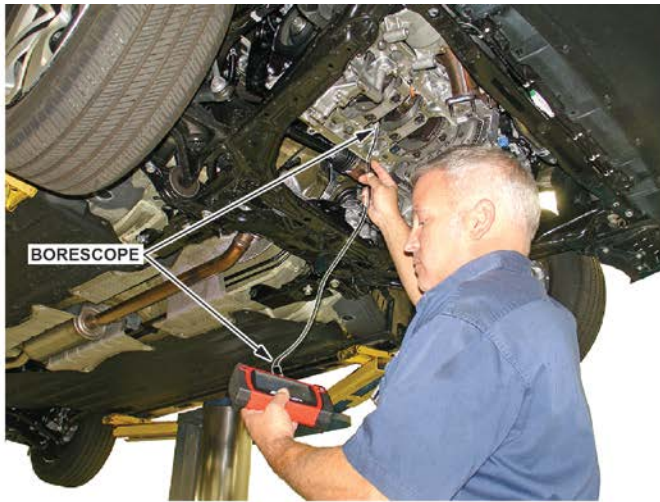
FACTORY
BLACK
MARKS

NOTE: You may notice a black mark on the snap ring and piston. This is a factory check mark and could be mistaken for the snap ring gap.

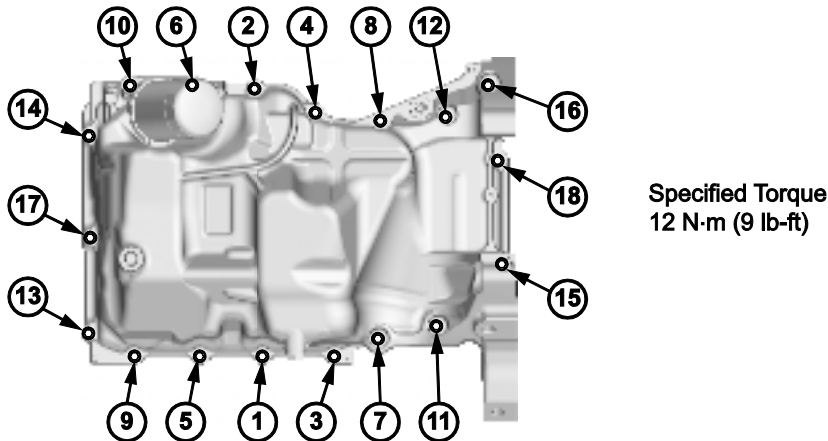
**Specified Torque
12 N-m (9 lb-ft)**

NOTE: When installing the oil pan, apply a 2.5 mm bead of Honda Bond HT to the mounting surface. Install the oil pan within 5 minutes and torque the bolts in three steps in the sequence shown below. In this specific application no cure time is required.
