April 1, 2016

03605 Version 2

## Noncompliance Recall: 2004–07 Accord Front Passenger Airbag

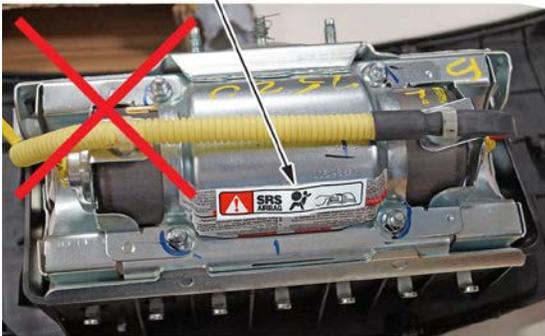
- If there is nothing unusual about the airbag or the inflator, go to step 6.
- If there are any unusual markings, like an incorrect label or a model year written in marker, the airbag and inflator may be a counterfeit part. For more information about counterfeit airbags, you can refer to [safercar.gov](http://safercar.gov), enter keywords **MANAGING COUNTERFEIT**, and select **Recommended Dealer Guidance for Managing Counterfeit Air Bags** from the list. **If you suspect that the airbag or inflator is counterfeit, do not continue this procedure.** Contact your DPSM for assistance.

NON-STANDARD SAFETY LABEL

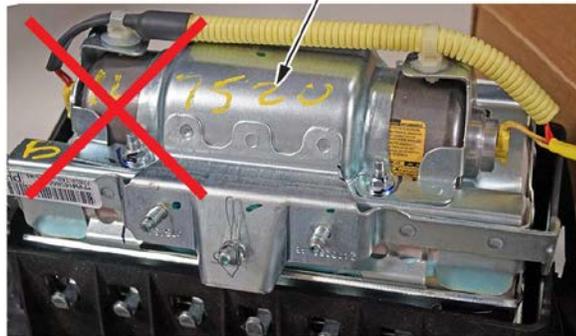
GREASE PENCIL OR PAINT MARKINGS

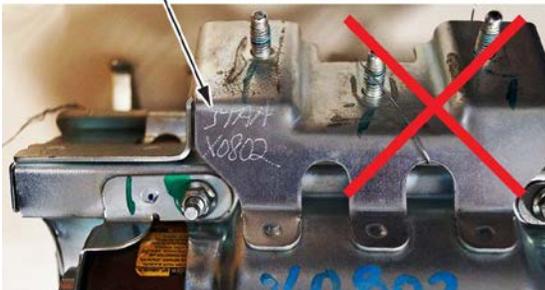
HAND ENGRAVING

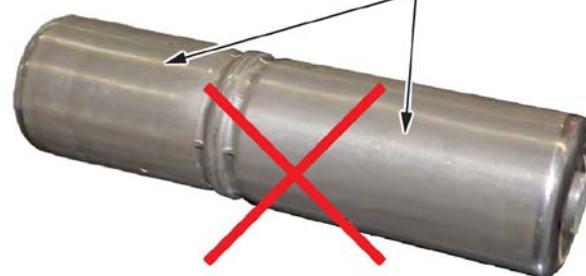
NO LABELS ON INFLATOR

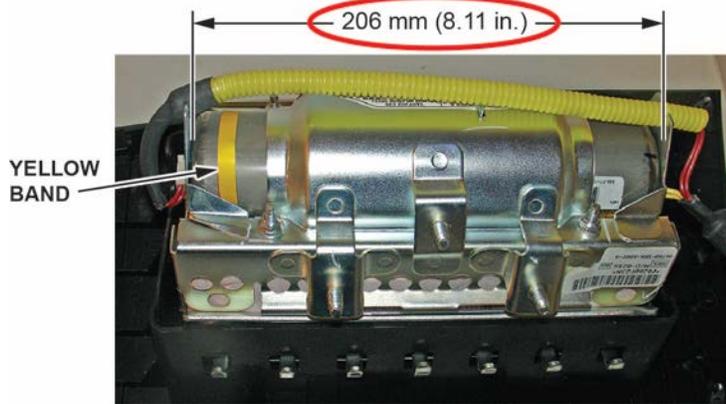
6. Measure the length of the airbag inflator and check for a yellow band around the inflator.
- If the inflator is 206 mm (8.11 in.) long and has a yellow band around it, the vehicle is OK and no further action is needed. Reinstall the airbag in the reverse order of removal.

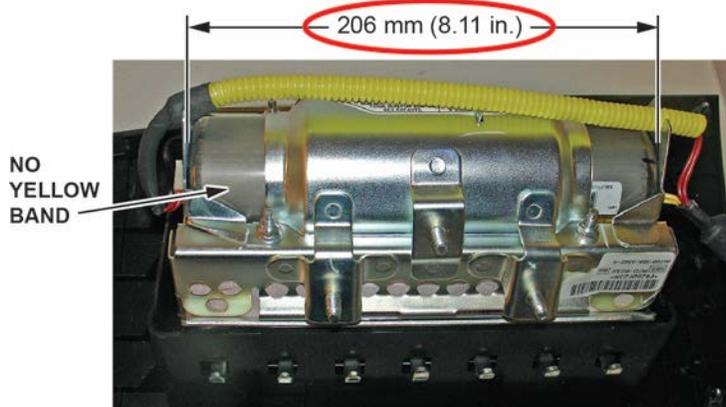
- If the inflator is 206 mm (8.11 in.) long but does not have a yellow band around it, go to S/B 15-067 and replace the inflator under the recall. Since the airbag is already removed, start at S/B 15-067 REPAIR PROCEDURE Step 6.

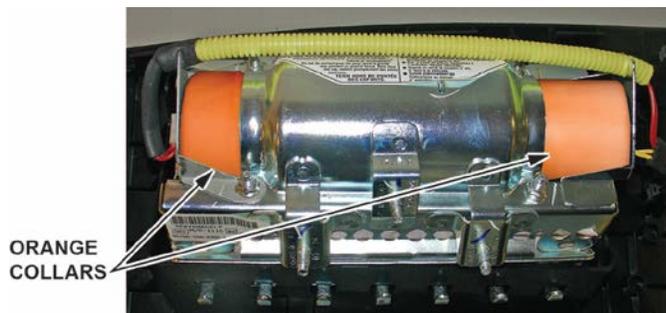
- If the inflator has orange collars, the vehicle is OK and no further action is needed. Reinstall the airbag in the reverse order of removal.

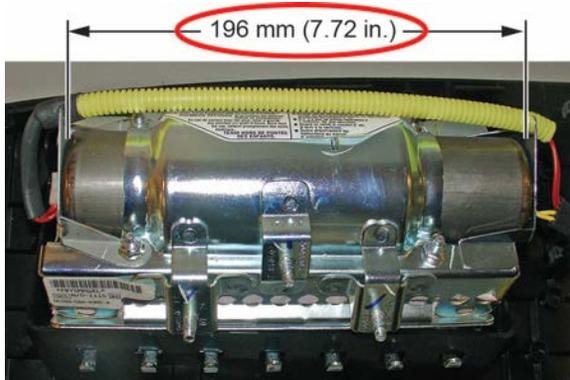
- If the inflator is 196 mm (7.72 in.) long, order an airbag assembly, then go to REPAIR PROCEDURE AND RETURNING THE INFLATOR.

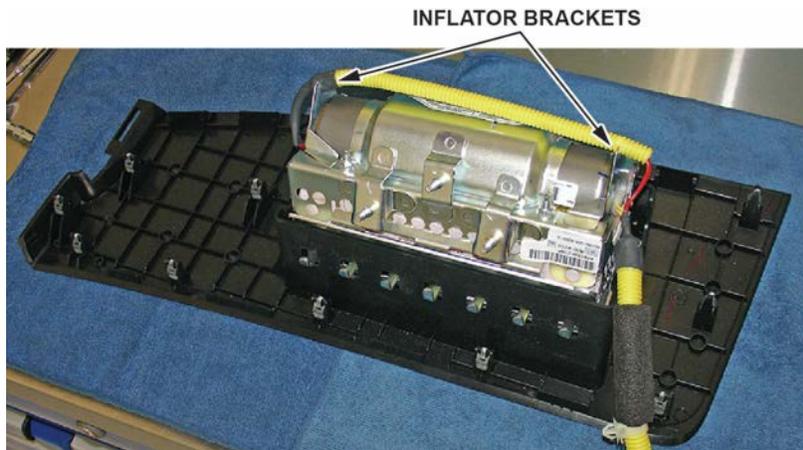
1. Remove the harness from both ends of the inflator brackets.

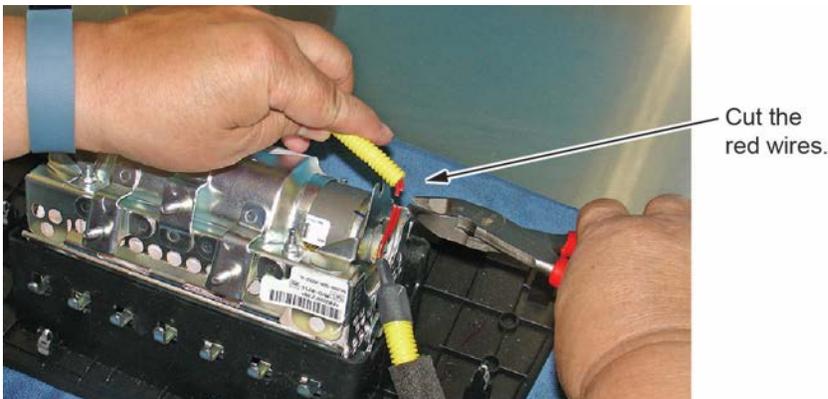
NOTE: **You must cut and short the wires** as indicated to prevent accidental deployment.

- Cut the red wires as shown.

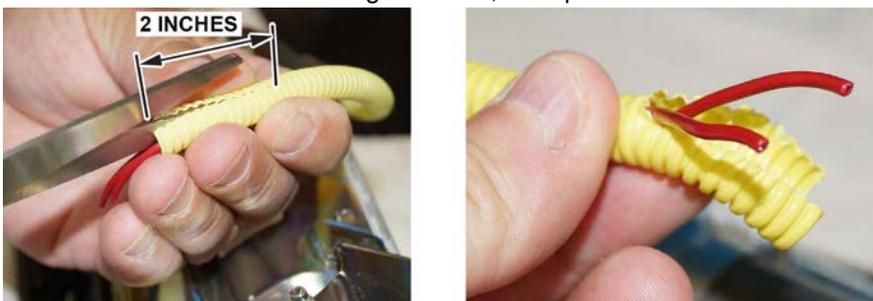
- Cut about 2 inches of the corrugated tube, then pull out the two red wires.

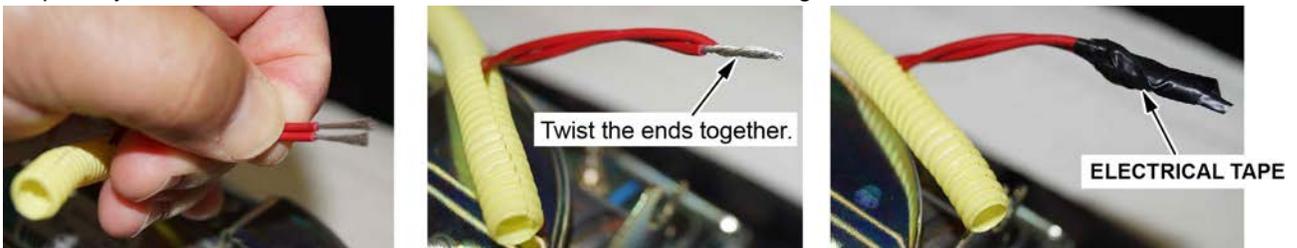
- Strip away about 1 inch of the wire insulation, then twist the wires together.

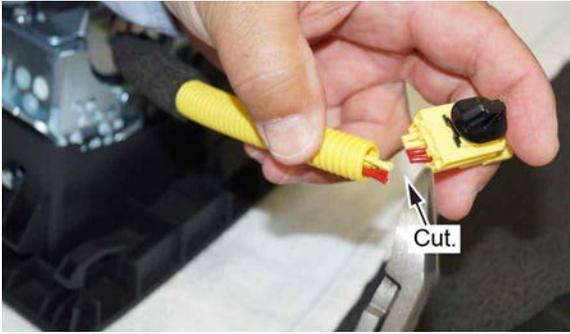
- Cut all four wires to remove the connector.

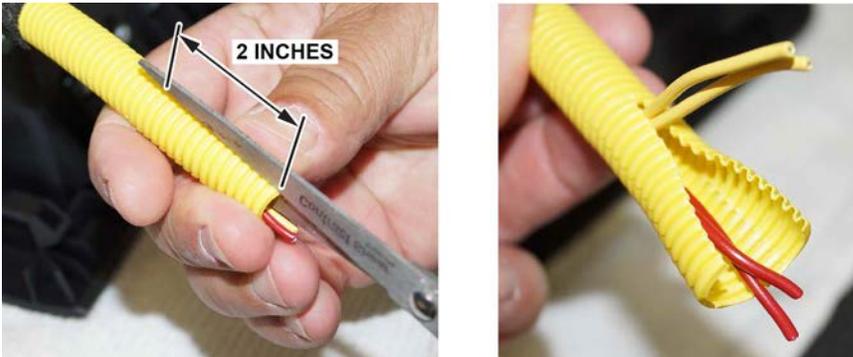
- Cut about 2 inches of the corrugated tube, then pull out the yellow wires.

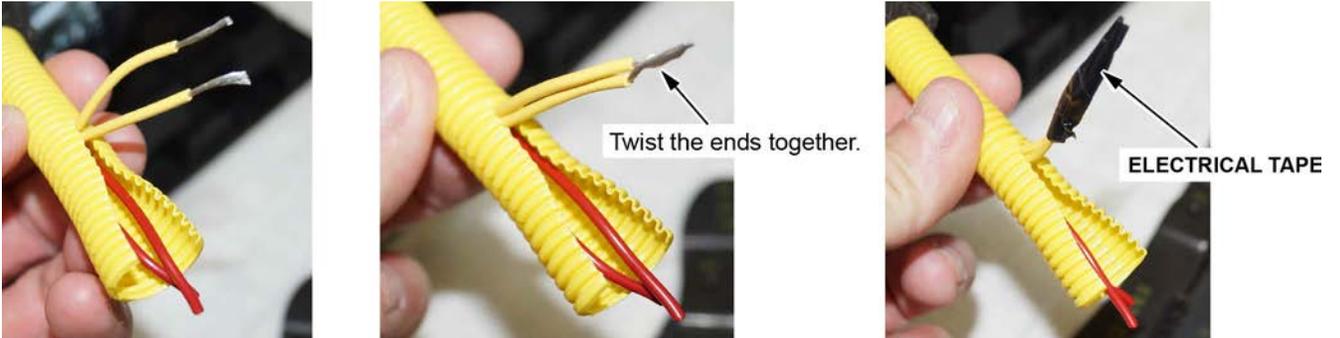
- Strip away about an inch of the wire insulation, then twist the wire ends together.

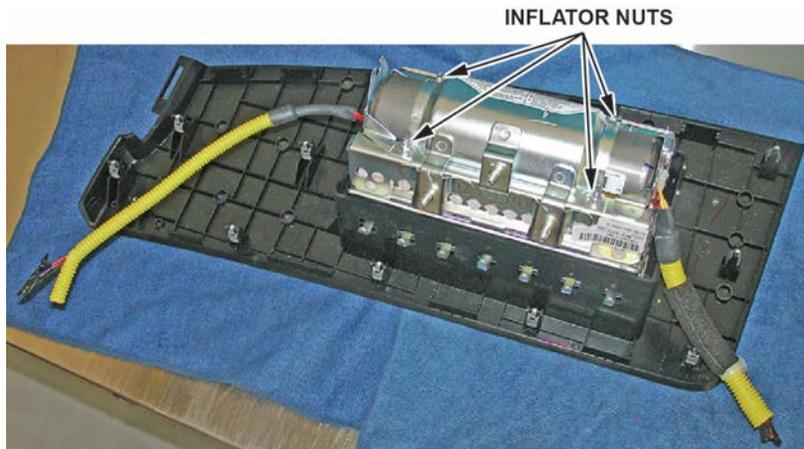
- Remove the four inflator nuts.

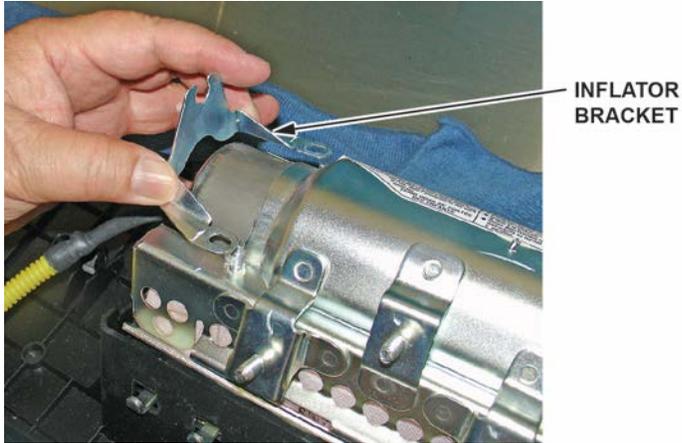
5. Remove the inflator bracket.

NOTE: You can only remove one of the brackets, as the other is welded to the airbag housing.

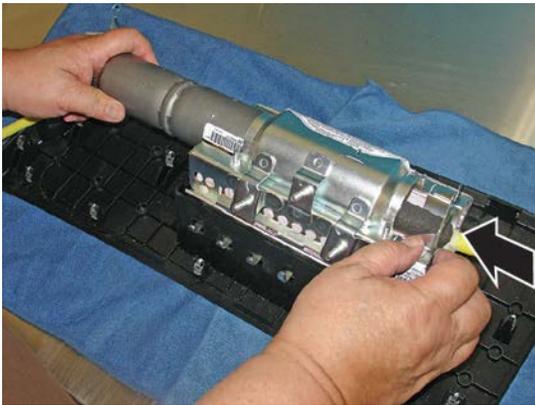
6. Remove the inflator by pushing it out.

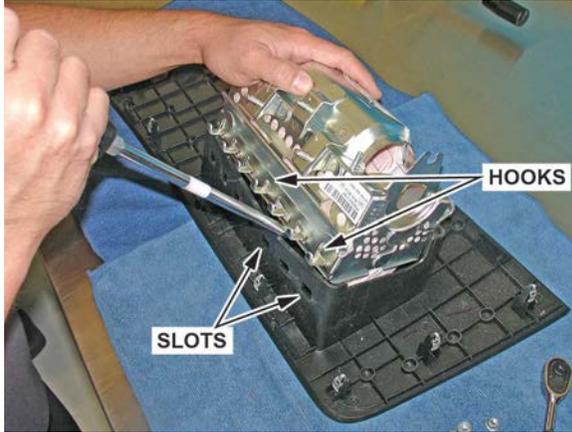
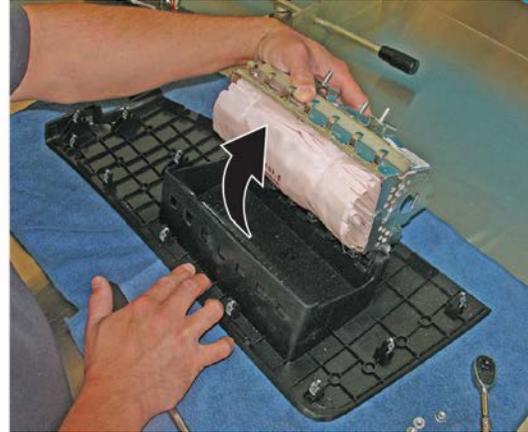
- Using an applicable tool, gently pry open the original airbag cover as shown so that the hooks can be removed from the slots, then separate the original airbag from the original airbag cover.
