GROUP	MODEL
Safety Recall Campaign	2013MY Forte (TD)
NUMBER	DATE

VOLUNTARY SAFETY RECALL CAMPAIGN

SC 132 (REV 1 6/28/2016)

SUBJECT: FRONT SEAT BELT ASSEMBLY (SC 132)

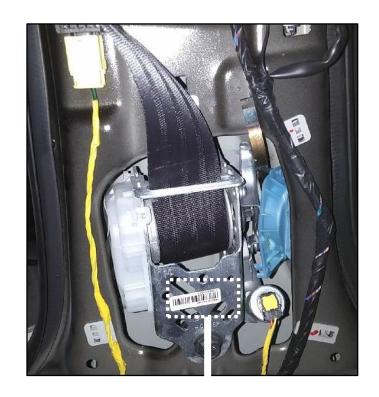
- Remove the center pillar lower trim by referring to "Body (Interior and Exterior)
 → Seat Belt → Front Seat Belt → Repair Procedures" in the applicable Workshop Manual.
- 2. Check the manufacturing date in the LOT number on the front seat belt assembly as shown.

If the LOT number indicates a manufacturing date (A) of "120905," replace the seat belt assembly.

(Refer to the "Replacement Procedure" on Page 3.)

- 4. If the date (A) on the label is **not** "120905," no further action on this assembly is required. Reassemble the trim pieces.
- 5. Repeat Steps 1-4 for the opposite side belt assembly.
